Geotechnical Investigation and Slope Stability Assessment

Final (4th Revision)

Proposed Humanics Sanctuary and Sculpture Park
3400 Old Montreal Road
Part of Lot 7, Concession 1, Old Survey
Ottawa (Formerly Township of Cumberland), Ontario

OTT-00229886-A0

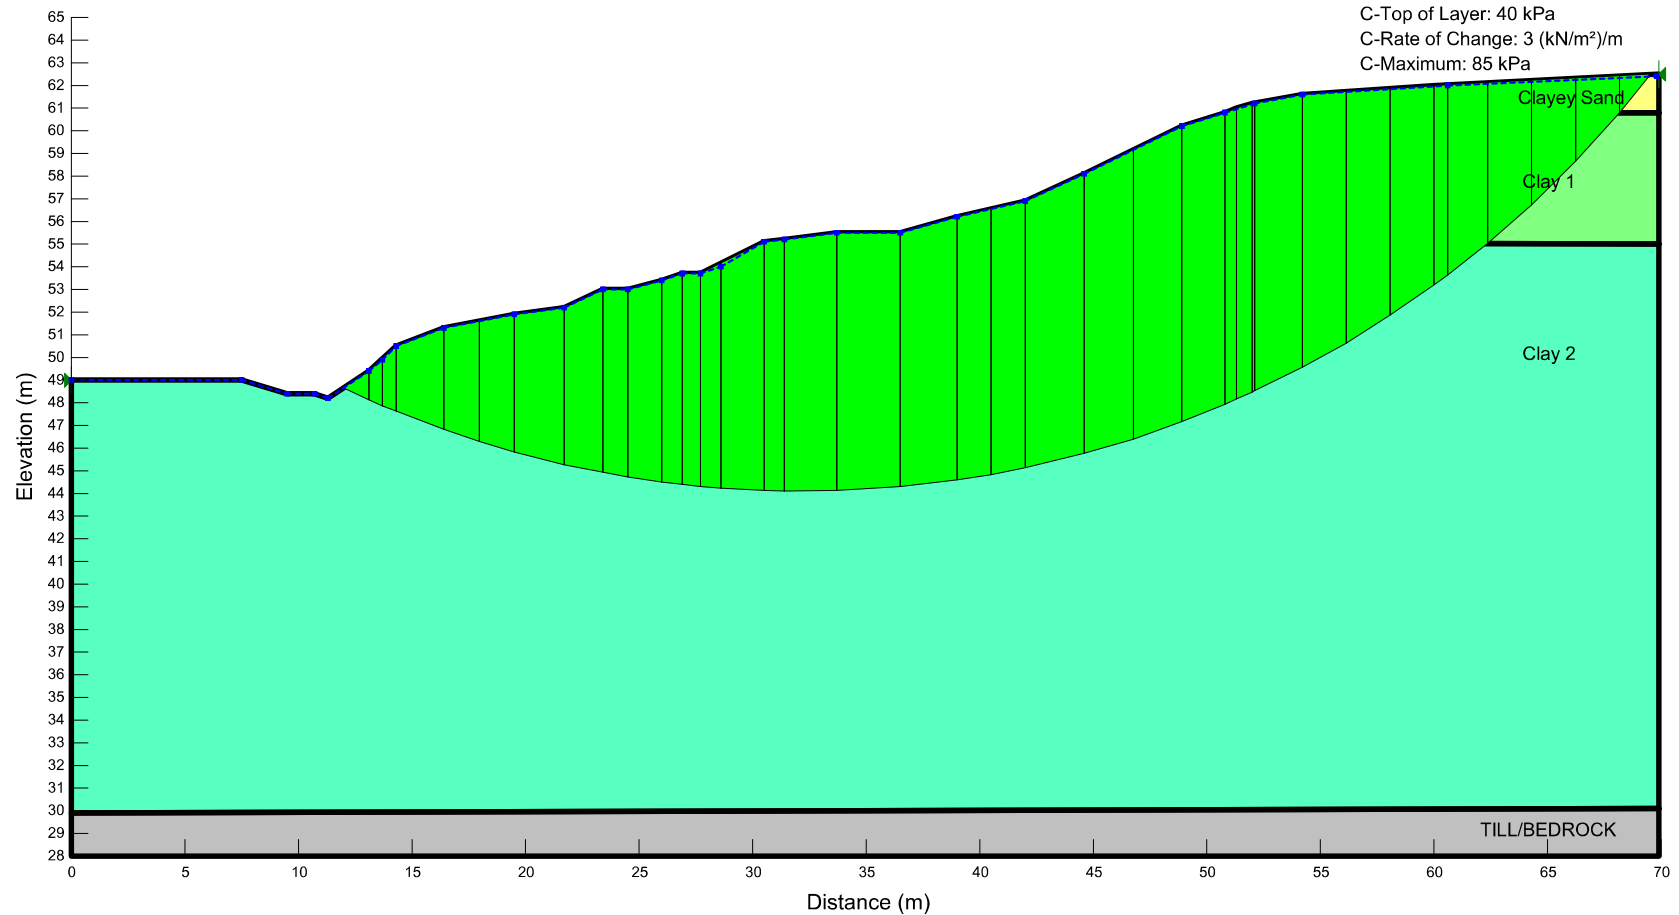
Figure 31

Project : OTT-00229886-A0
SLOPE STABILITY ASSESSMENT
3400 Old Montreal Road, Cumberland, On.
Slope Stability Analysis - Existing Slope
Section - F-F - Effective Stress Analysis
Set Back Determination

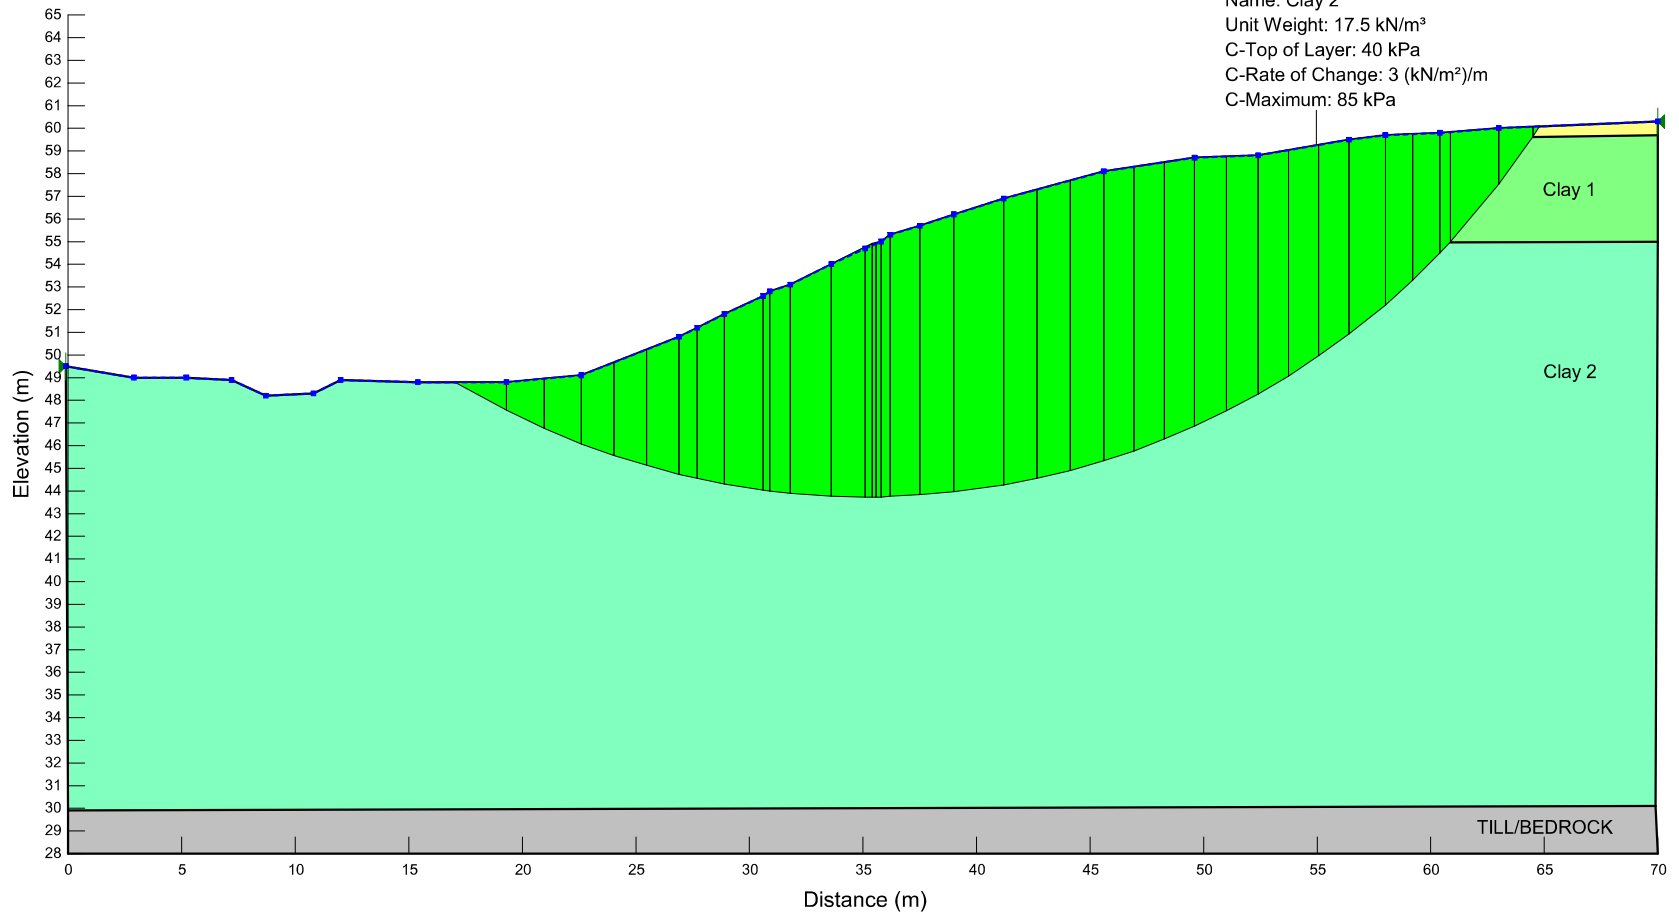
Project : OTT-00229886-A0
 SLOPE STABILITY ASSESSMENT
 3400 Old Montreal Road, Cumberland, On.
 Slope Stability Analysis - Existing Slope
 Section -F-F - Total Stress Analysis - Seismic

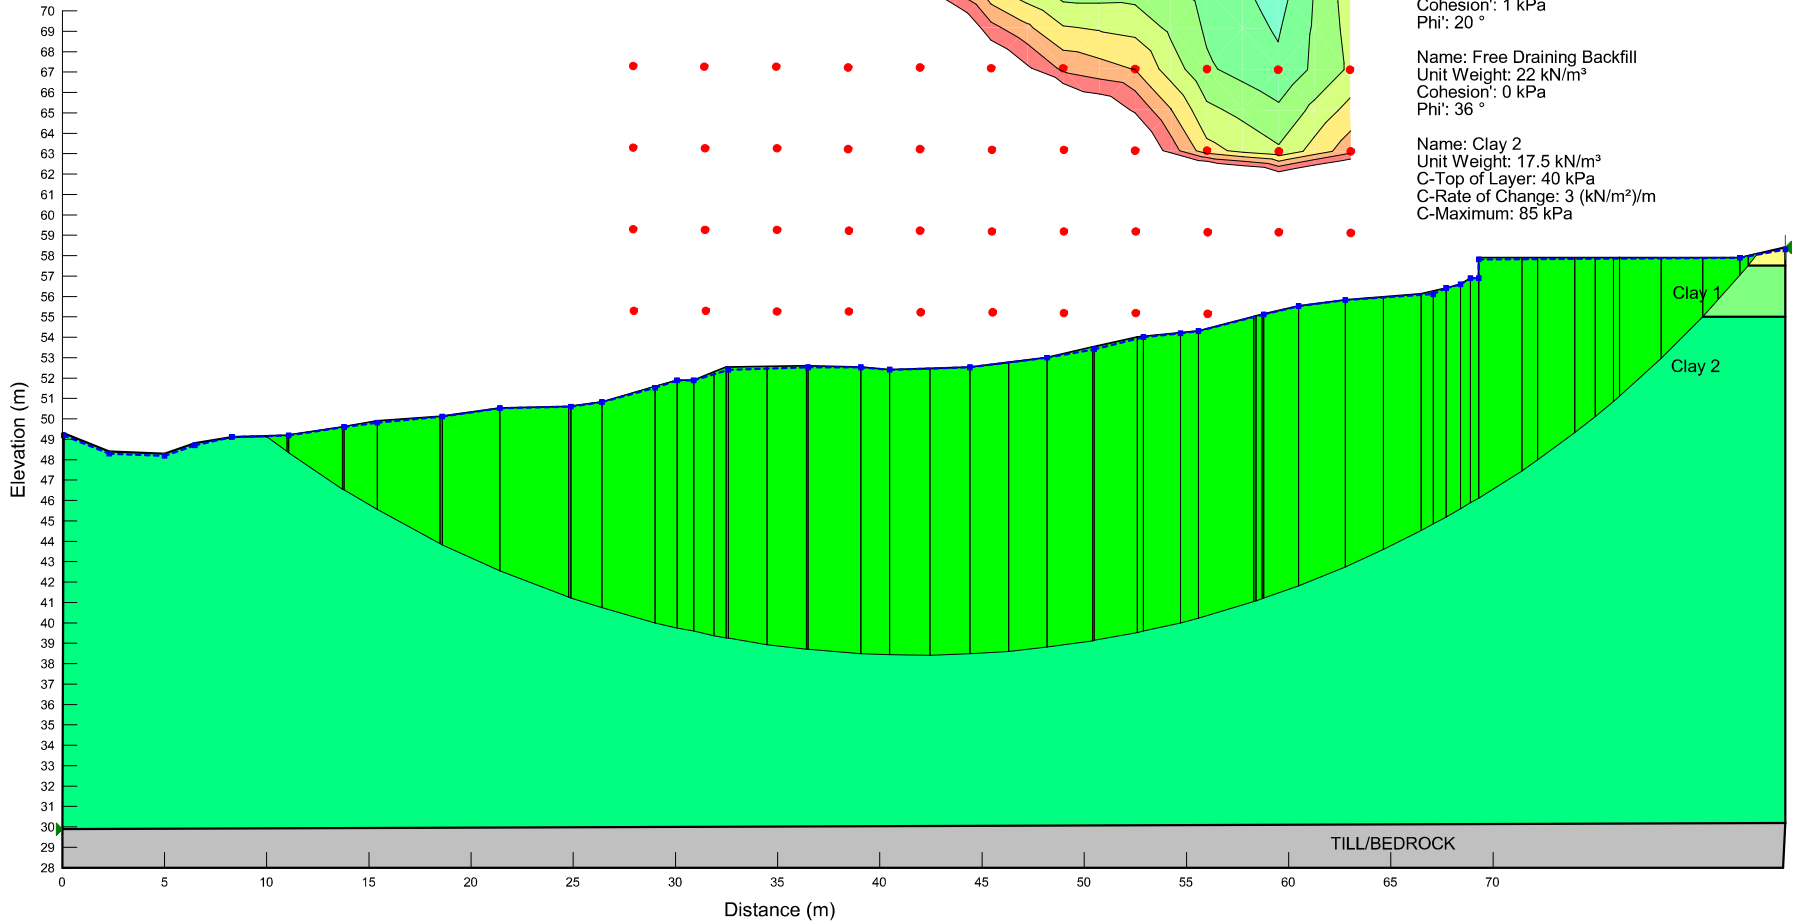
Figure 35

Slope Stability Analysis - Existing Slope & Proposed Retaining Wall
Section - G-G - Total Stress Analysis

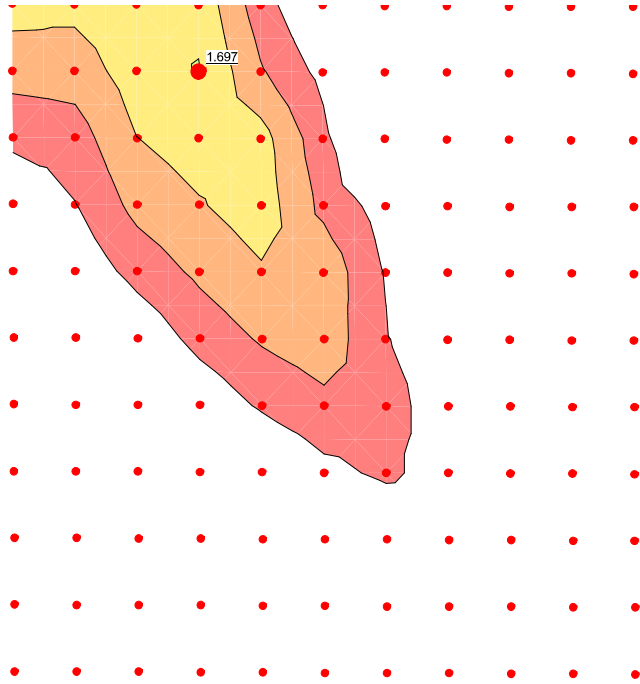
Figure 36

Slope Stability Analysis - Existing Slope & Proposed Retaining Wall
Section - G-G - Total Stress Analysis - Seismic

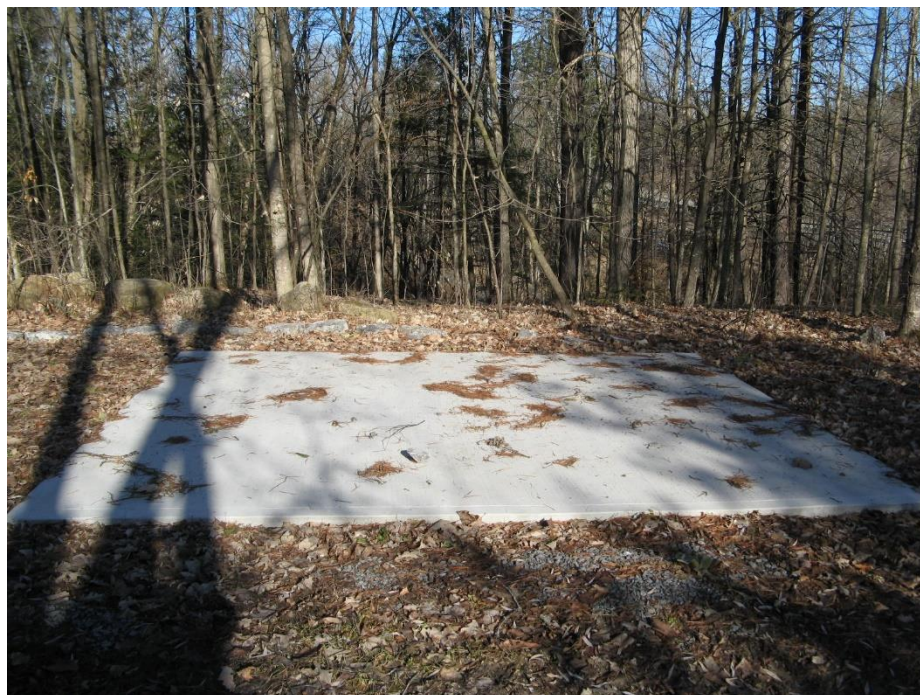
The footprint of both gazebos will be at the outer edge of an upland mixed forest. This forest was described by McIntosh Perry (2017) as a dry-fresh hardwood – hemlock mixed forest. The concrete slab for the south gazebo is existing (Photo 2) and the location of the north gazebo currently contains a small stockpiling area of larger cobbles (Photo 1). No additional trees will be removed for the gazebo construction. Examples of the larger adjacent trees to be retained include sugar maples up to 25cm diameter at breast height (dbh), bur oaks and white spruce in the 35 – 40cm dbh range and a 50cm dbh white pine. Smaller yellow birch, red maple, and poplars are also present. There are dirt and wood chip pathways in the vicinity of the gazebo locations (Photo 3), along with the gravel driveway entrance south off Old Montreal Road to the east of the gazebo locations. The driveway, parking areas, and pathways are all made of permeable material.

Photo 2 – Proposed location of the Canadian Charter of Rights and Freedoms gazebo (south gazebo). View looking west towards the crest of slope and Beckett's Creek tributary ravine
