**PATERSON
GROUP**

July 19, 2022
File: PE4937-LET.04

Subject: **Phase II - Environmental Site Assessment Update
Navan at Renaud Road
Ottawa, Ontario**

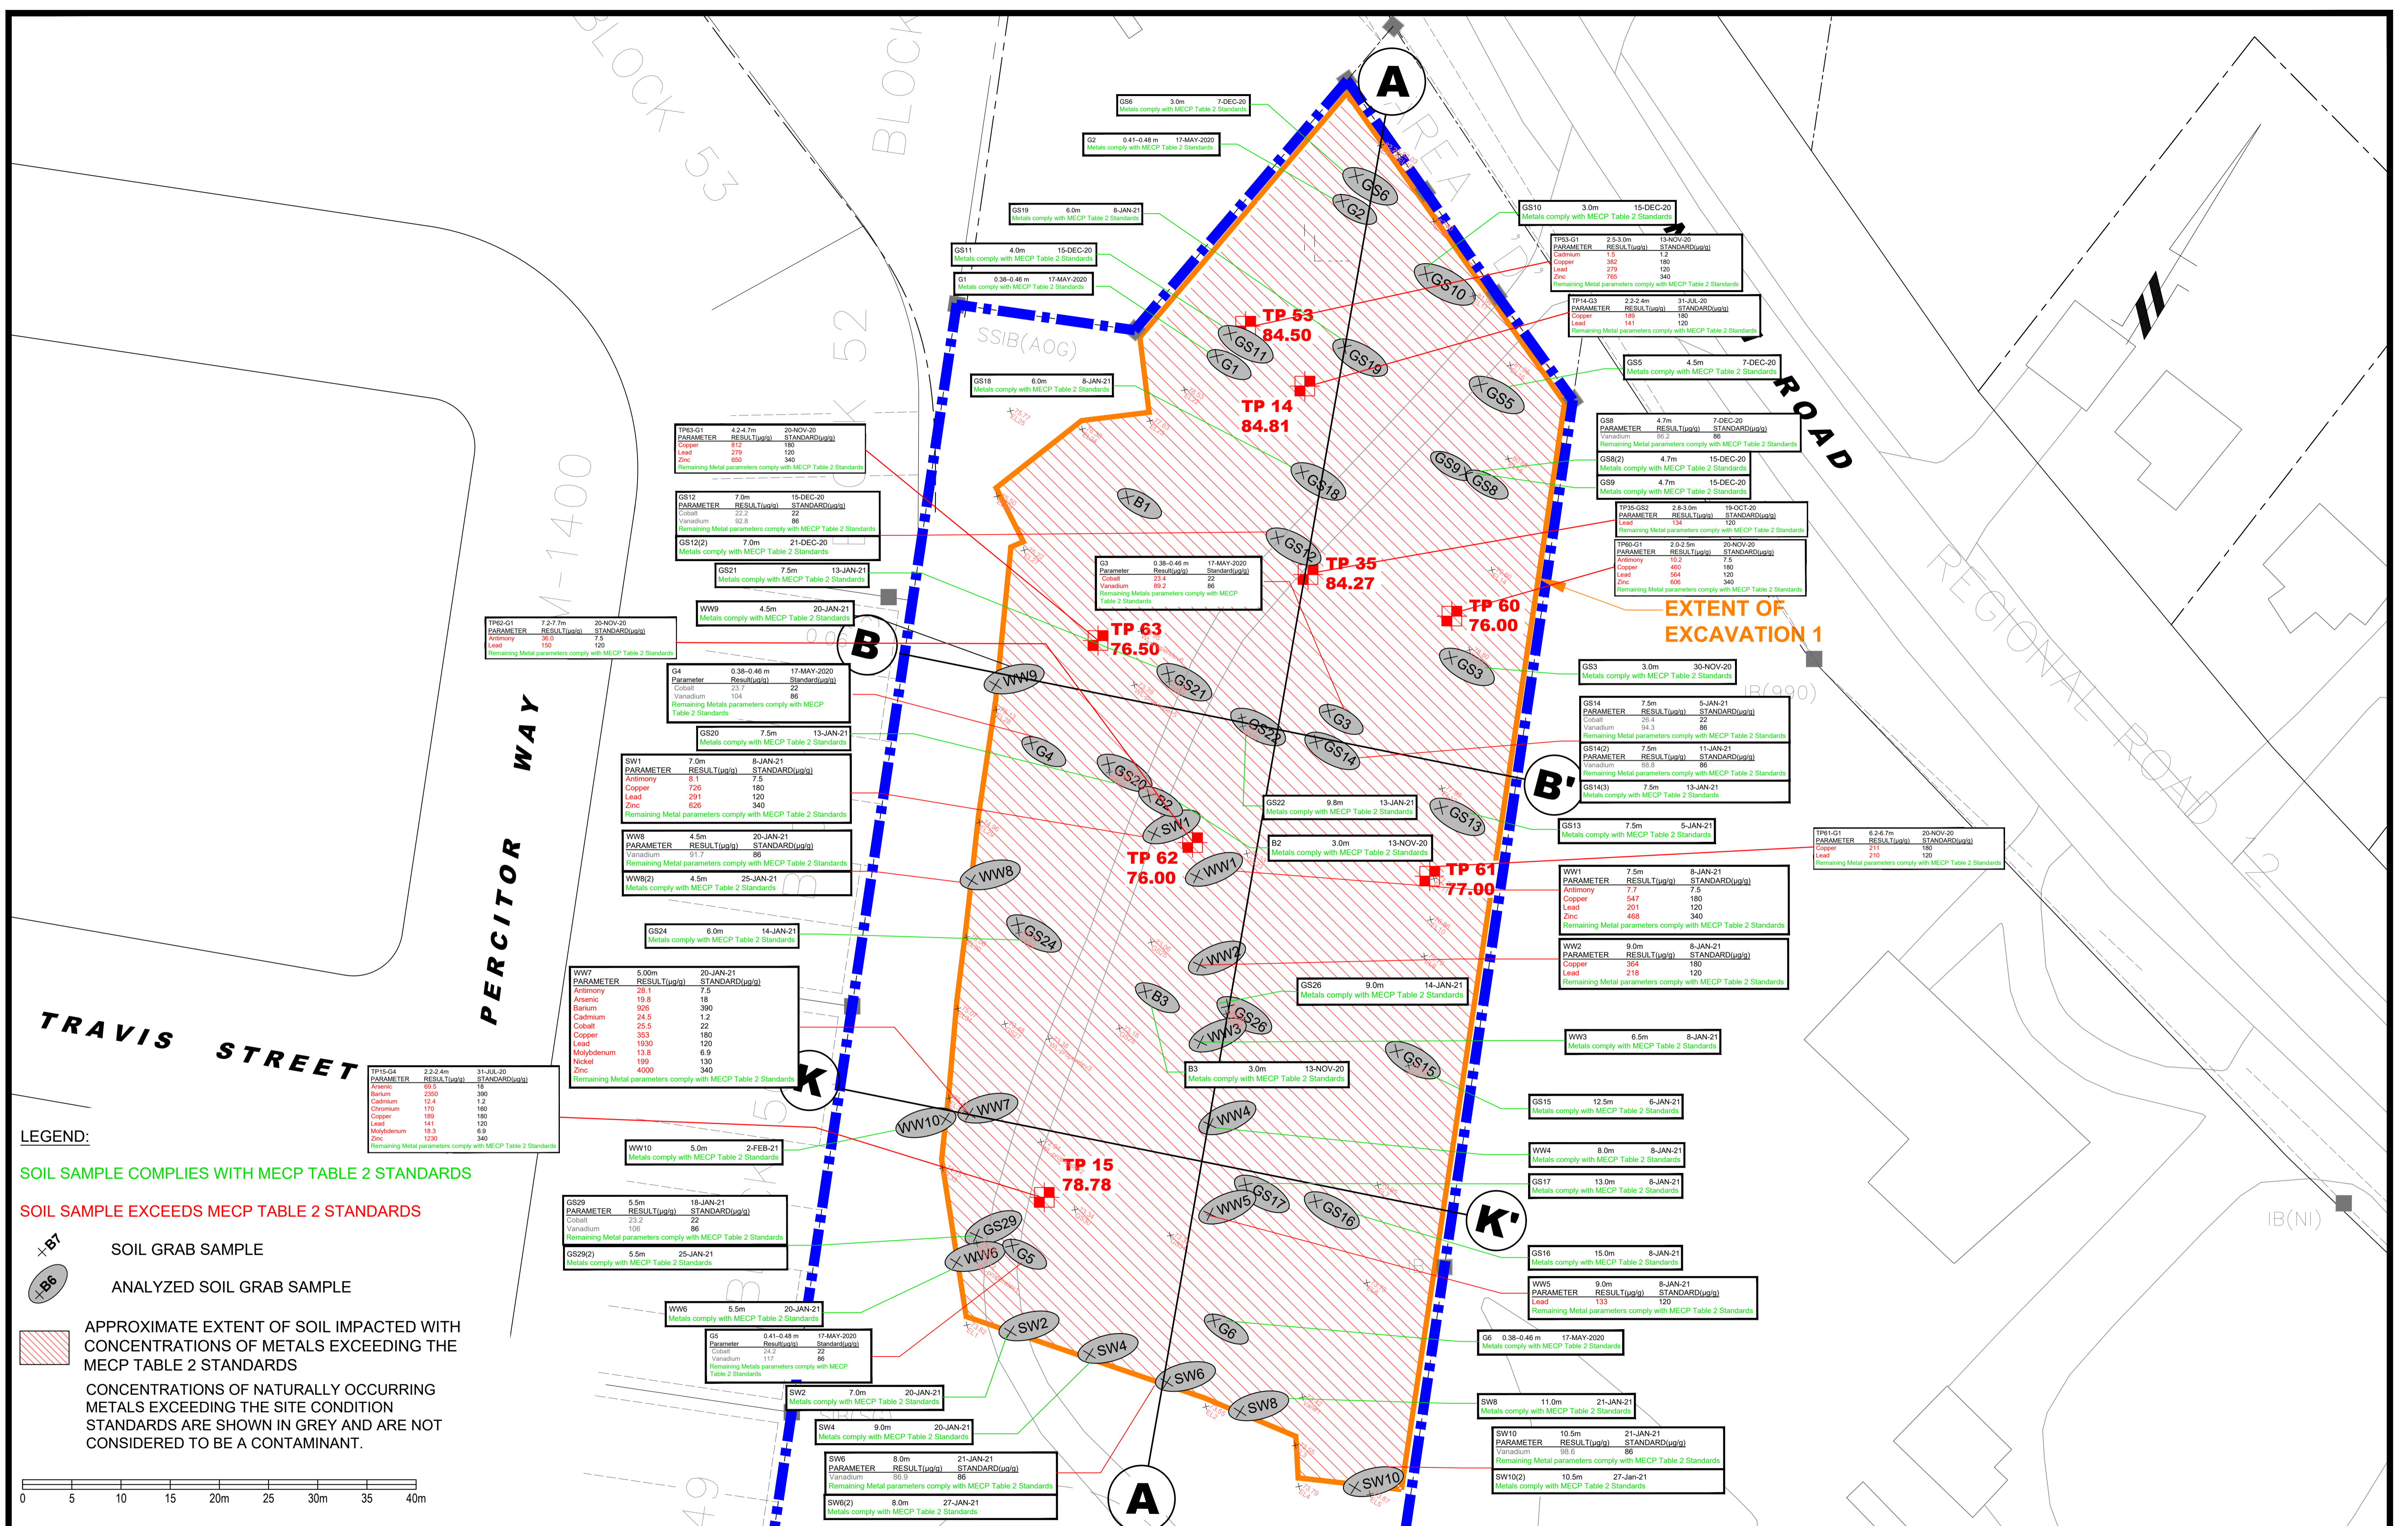
Scale:	1:1000	Report No.:	PE4937
Drawn by:	RG	Drawing No.:	PE4937-4
Checked by:	JC	Revision No.:	0
Approved by:	MB		
Date:	03/2021

As shown on Drawing PE4937-4, samples from across the RSC property exceeded the Site Condition Standards (SCS) for Barium, Cobalt, and Vanadium, however the remaining metals parameters listed above only exceeded the site condition standards in the northwest corner of the RSC property.

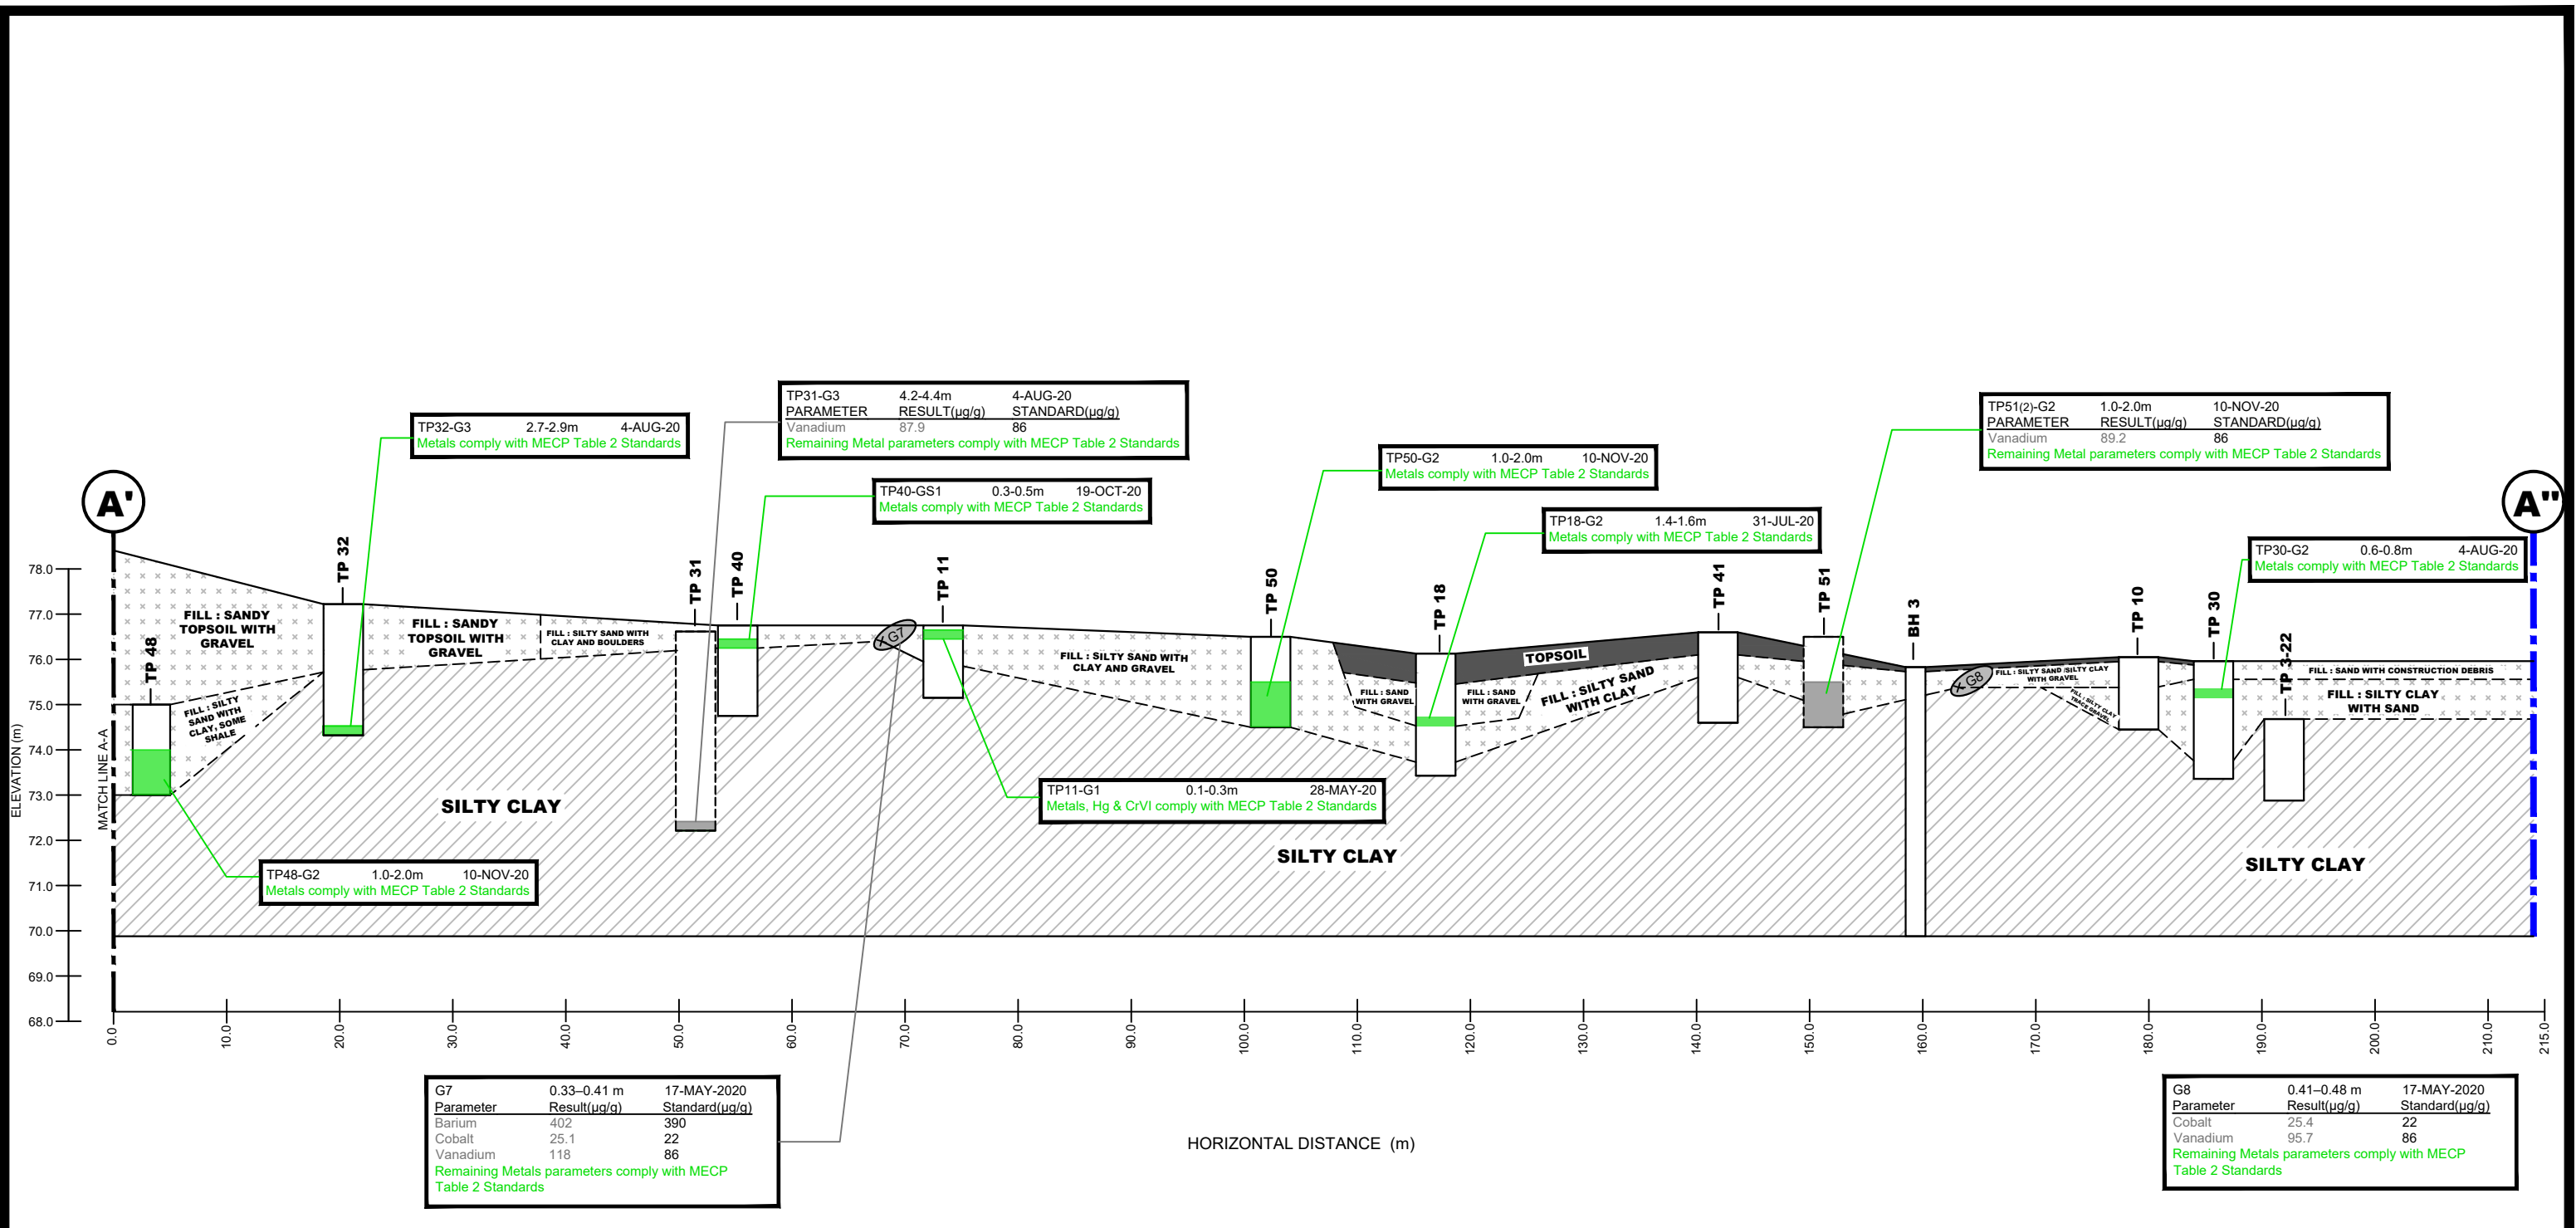
CAIVAN COMMUNITIES
PHASE II - ENVIRONMENTAL SITE ASSESSMENT
RENAUD ROAD AT NAVAN ROAD
 OTTAWA, ONTARIO
 Title: **CROSS SECTION A-A' - SOIL (METALS)**

APPROXIMATE EXTENT OF SOIL WITH CONCENTRATIONS OF METALS EXCEEDING THE MECP TABLE 2 STANDARDS

CONCENTRATIONS OF NATURALLY OCCURRING METALS EXCEEDING THE SITE CONDITION STANDARDS ARE SHOWN IN GREY AND ARE NOT CONSIDERED TO BE A CONTAMINANT.

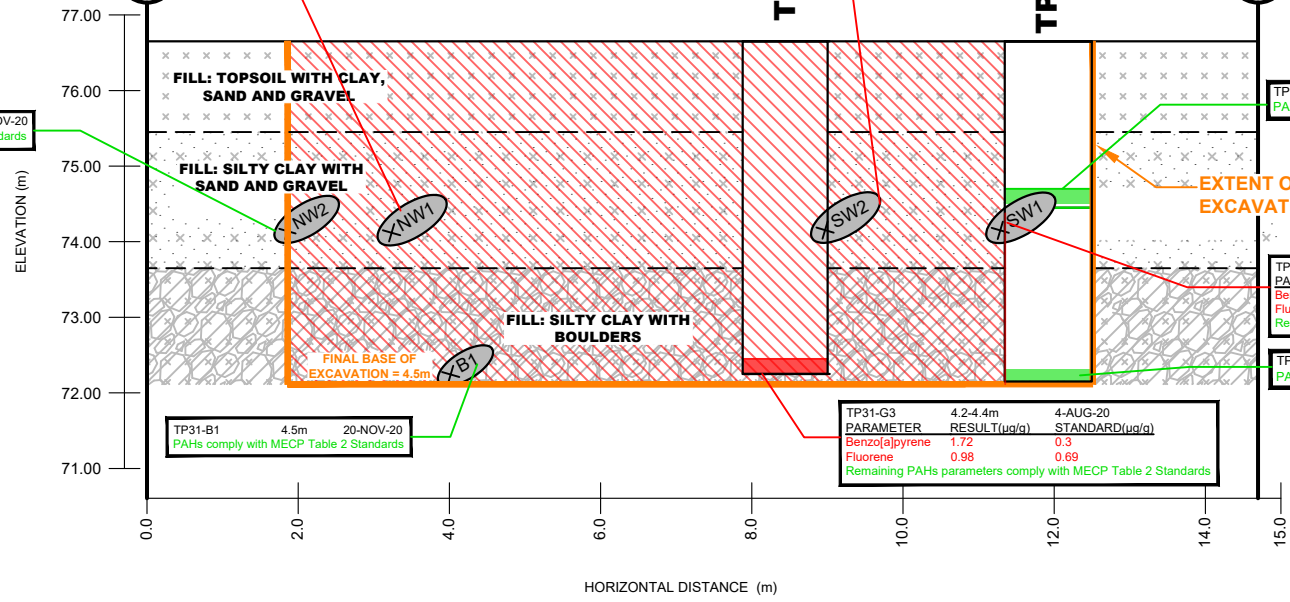
TP1-22-G2	2.50m	24-JUN-2022
PAHs comply with MECP Table 2 standards

TP31-SW1	2.5m	20-NOV-20
PARAMETER	RESULT(µg/g)	STANDARD(µg/g)
Benzo[a]pyrene	0.38	0.3
Fluoranthene	1.24	0.69
Remaining PAHs parameters comply with MECP Table 2 Standards

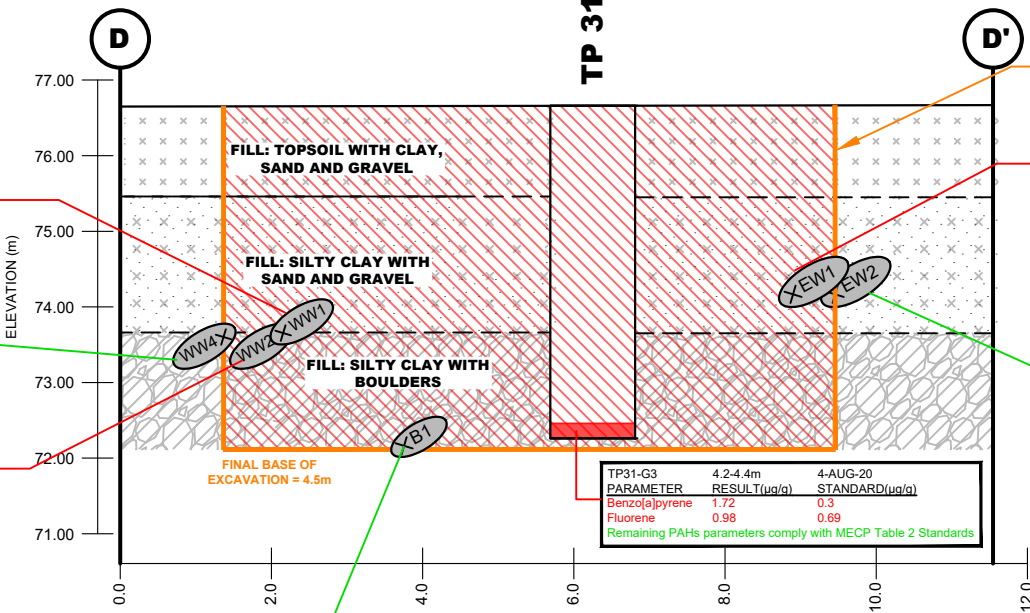
TP31-B1	4.5m	20-NOV-20
PAHs comply with MECP Table 2 Standards

TP31-G3	4.2-4.4m	4-AUG-20
PARAMETER	RESULT(µg/g)	STANDARD(µg/g)
Benzo[a]pyrene	1.72	0.3
Fluorene	0.98	0.69
Remaining PAHs parameters comply with MECP Table 2 Standards
