Landslide Hazard Assessment

Proposed Multi-Storey Building

3030 Saint Joseph Boulevard
Ottawa, Ontario

Report PG6609 - 2 dated February 12, 2024

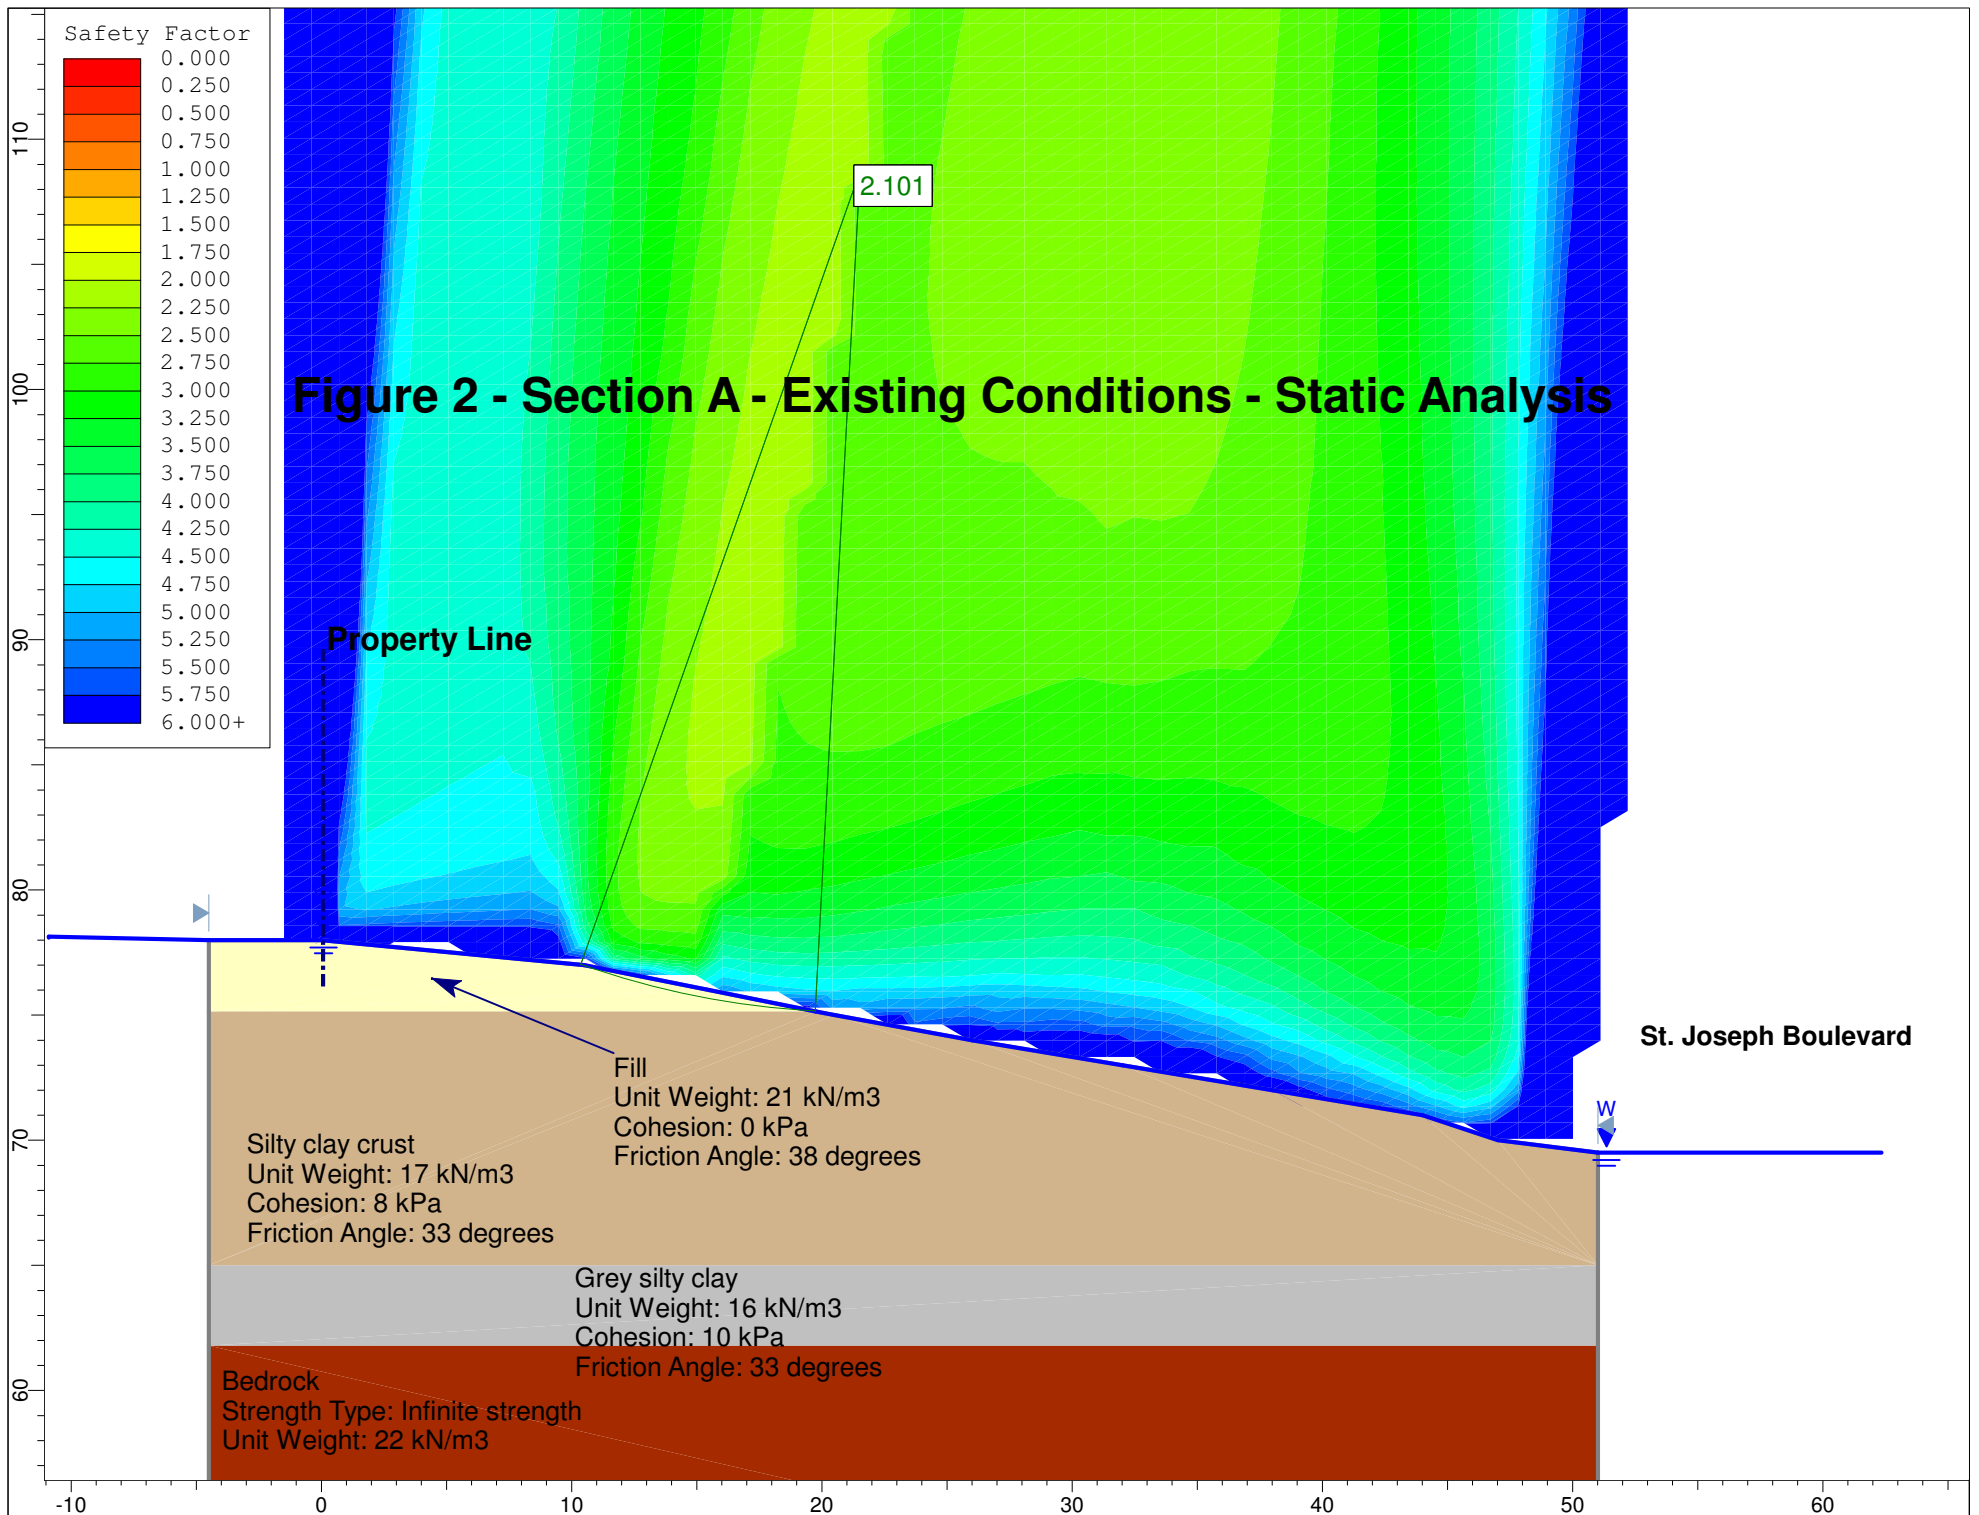
The results for the existing slope conditions at Section A and Section B are shown in Figure 2 and Figure 4 in Appendix 2. The factor of safety was found to be greater than 1.5 for Section A and B when analyzed under static conditions. It should be noted that a slope stability analysis was completed for Section A due to the steepness of the slope observed, which was considered to be a worst-case scenario for the subject site. Section B was analyzed to include the adjacent slope opposite of Duford Drive. Section C was analyzed considering the upper 2 m of the slope face to be fully saturated and the remainder of the slope is saturated below the long-term groundwater table at the former slope failure location. A global slope stability factor of safety of greater than 1.5 was determined for Section C based on our analysis.

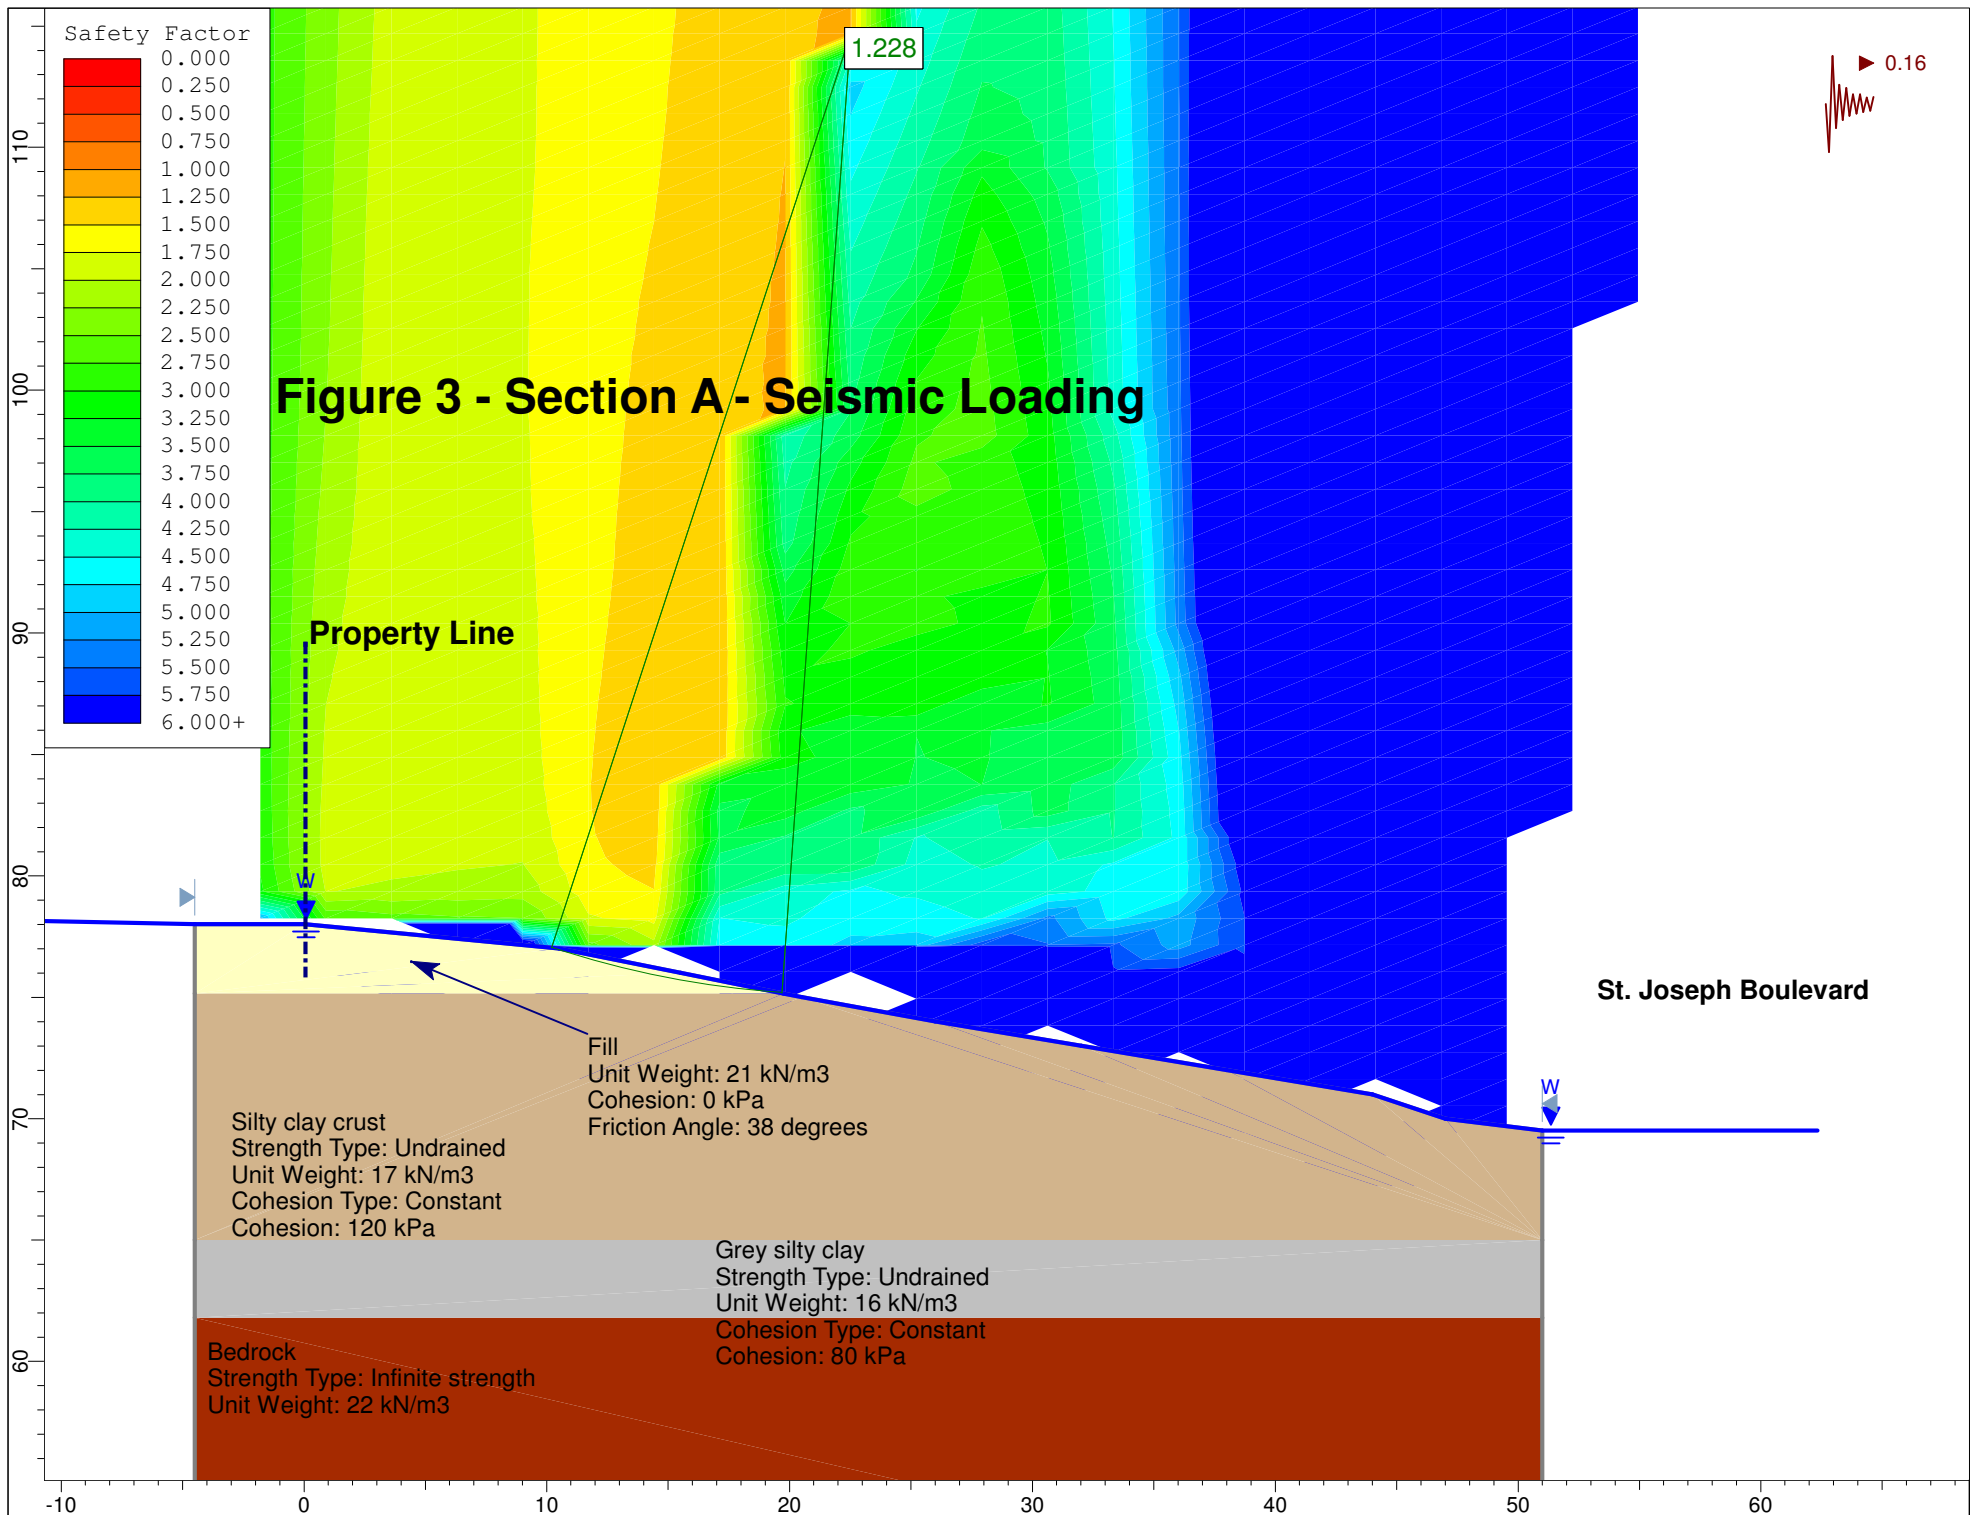
The results of the analyses including seismic loading are shown in Figure 3, Figure 5, and Figure 7B for the slope sections and attached in Appendix 2 of this report.
