Geomorphological and Erosion Assessment, Tributary of Bear Brook

6160 Thunder Road and 5368 Boundary Road
City of Ottawa

Submitted:
August 16, 2024

GEO Morphix Project No. 23111

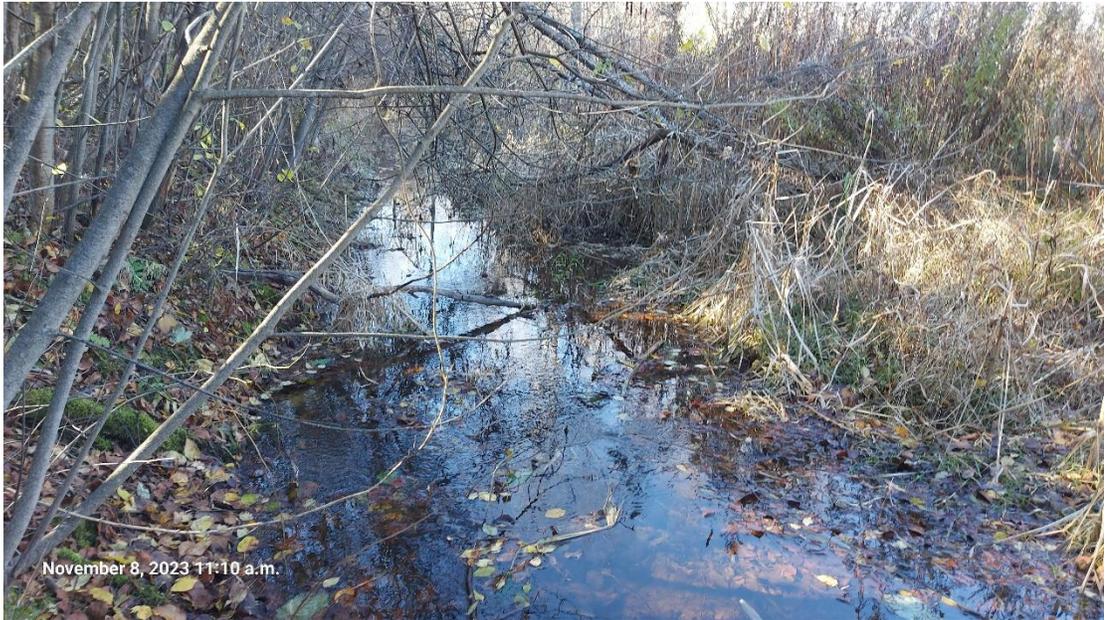
Photo 1
Tributary of Bear Brook
Reach BBT-1

Photograph taken at the upstream extent of **BBT-1**, facing downstream. The riparian zones along the entire reach were immature hardwoods and mature softwoods as a part of a plantation along the left bank, and grasses/herbaceous vegetation and manicured grass as part of a private property along the right bank.

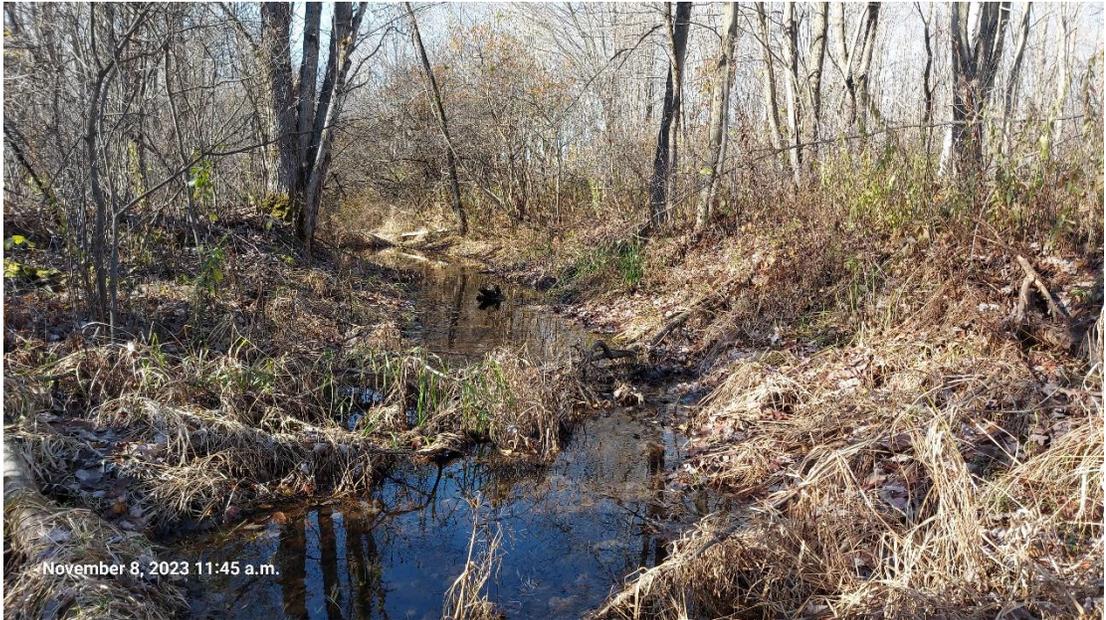
Photo 5
Tributary of Bear Brook
Reach BBT-2

Photograph taken at the upstream extent of **BBT-2**, facing downstream. The riparian corridor transitions to herbaceous vegetation, grasses, and mature hardwoods.

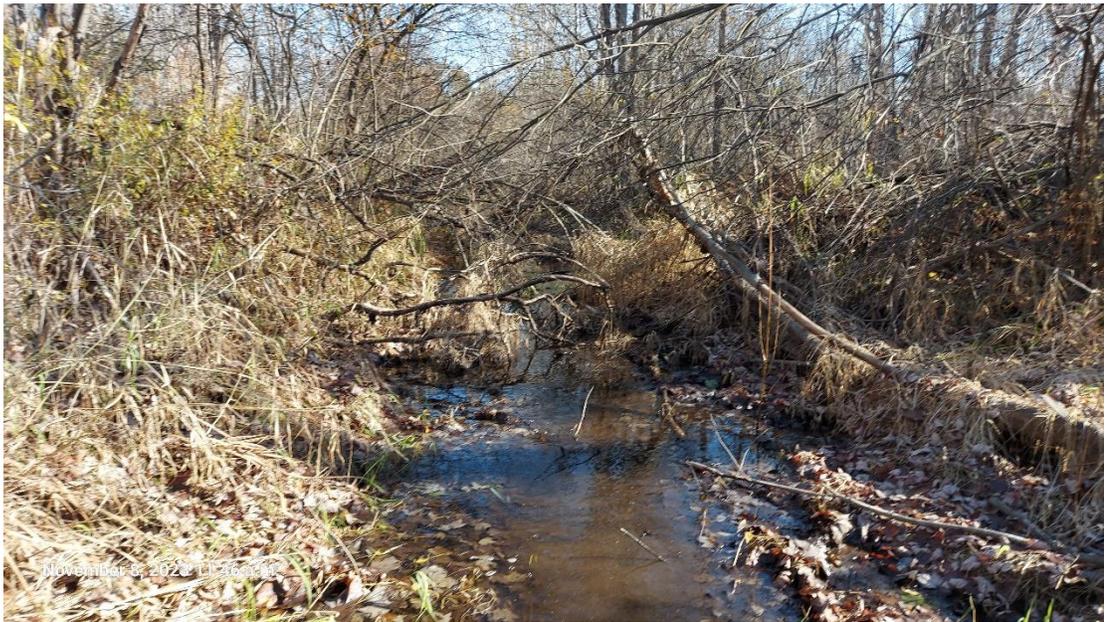
Photo 6
Tributary of Bear Brook
Reach BBT-2

Photograph taken facing downstream along **BBT-2**. Woody debris in the channel and down trees have created riffles and pools resulting in areas of deposition and pools.

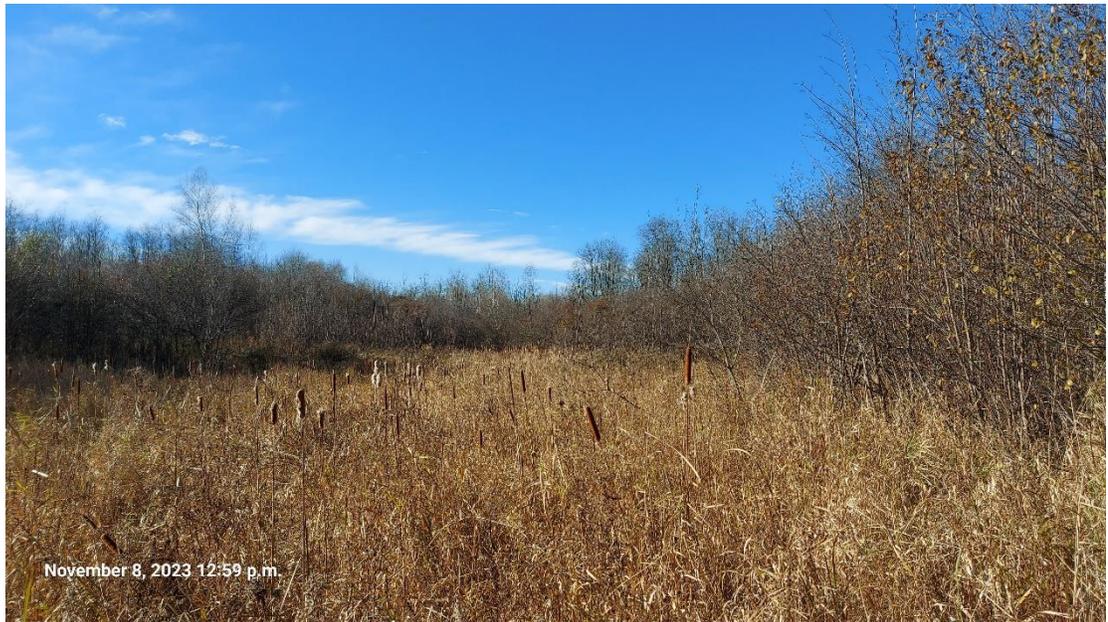
Photo 13
Tributary of Bear Brook
Reach BBT-4

Photograph taken at the upstream extent of **BBT-4**, facing downstream. Field observations suggested this portion of the reach was also part of a historical beaver pond. The channel separates into multiple flow paths travelling within the wide floodplain.

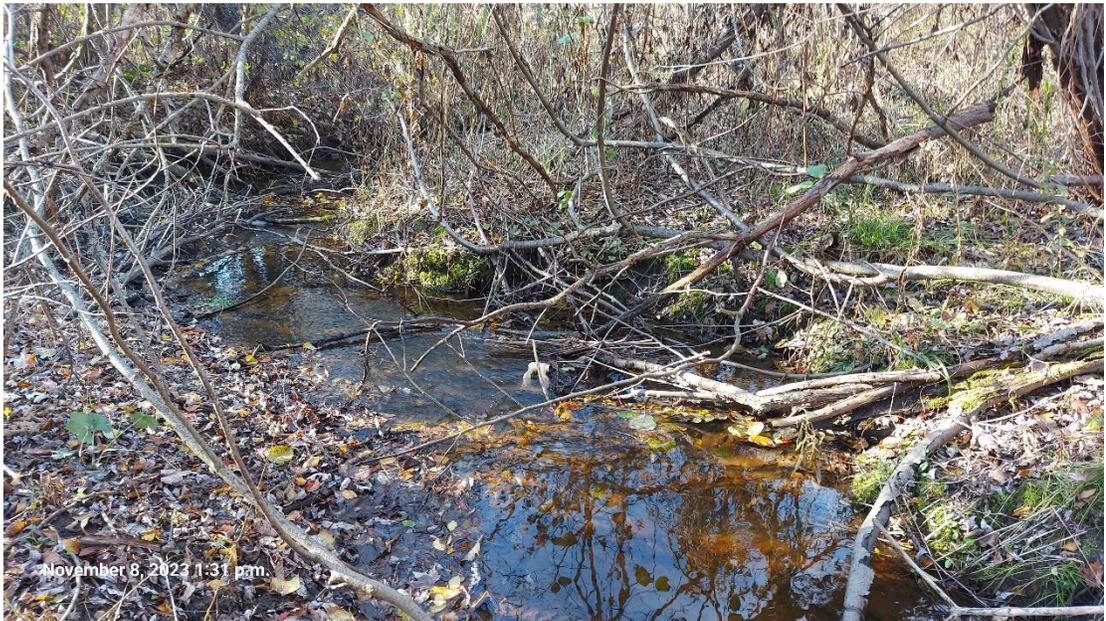
Photo 16
Tributary of Bear Brook
Reach BBT-5

Photograph taken facing downstream along **BBT-5**. Woody debris was present in the channel and cutbanks throughout the reach, forming riffle-pool sequences.

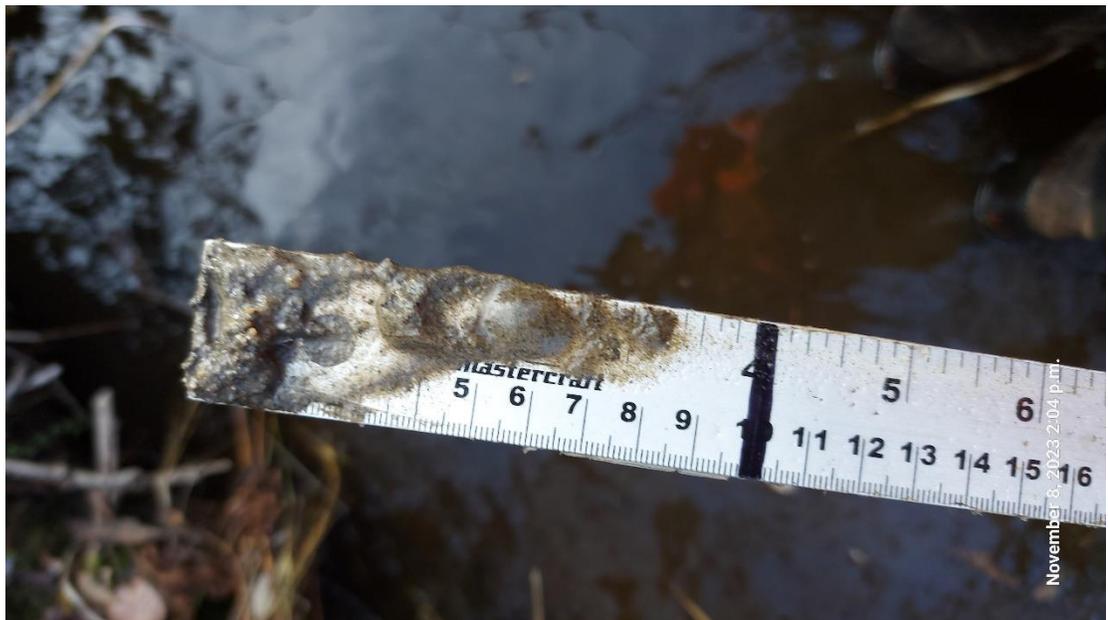
Photo 18
Tributary of Bear Brook
Reach BBT-5

Channel bed substrate along **BBT-5** was composed of coarse silt and fine sands.

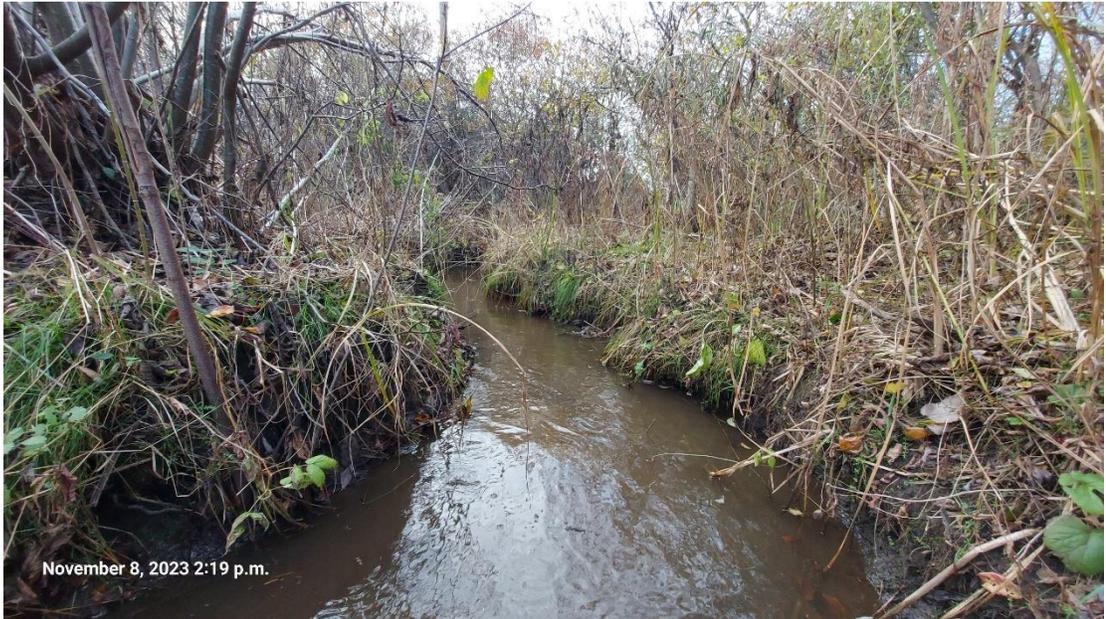
Photo 19
Tributary of Bear Brook
Reach BBT-6

Photograph taken facing downstream along **BBT-6**. The riparian corridors were primarily grasses and herbaceous vegetation with establish hardwoods and shrubs.

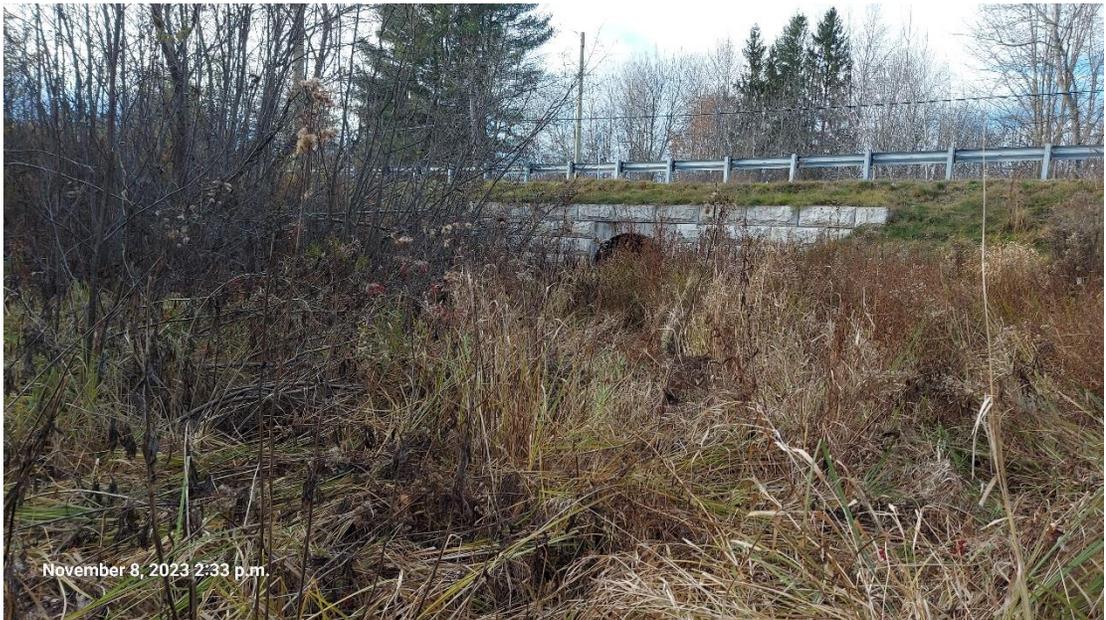
Photo 22
Tributary of Bear Brook
Reach BBT-6

Photograph taken at the downstream extent of **BBT-6**. The watercourse passes through a densely vegetated section and under thunder road through a culvert.

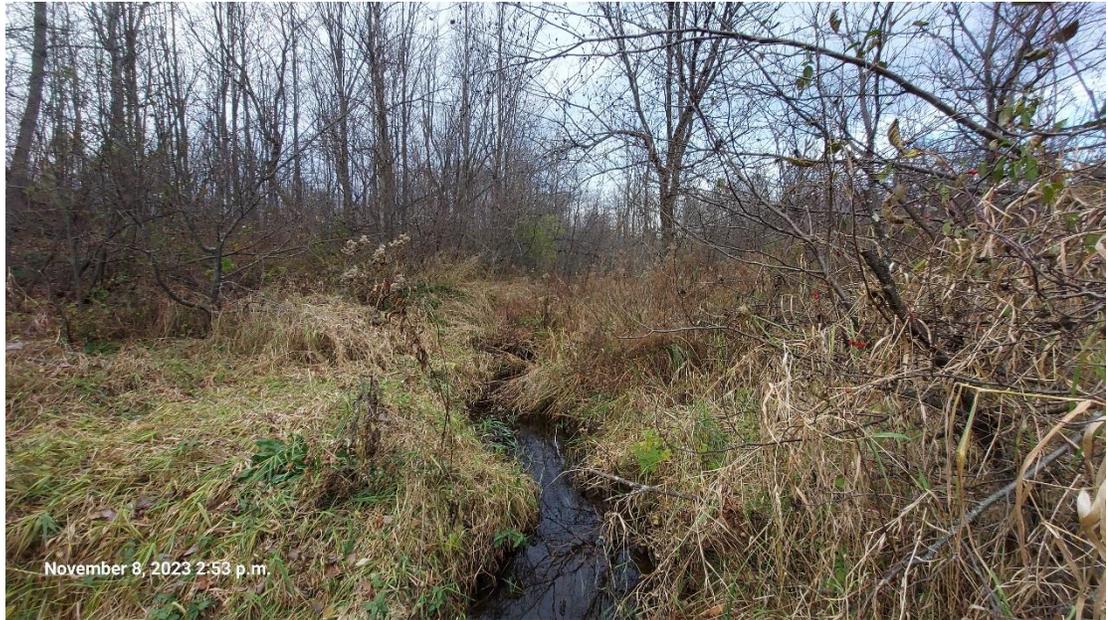
Photo 23
Tributary of Bear Brook
Reach BBT-7

Photograph taken at the upstream extent of **BBT-7**, facing downstream. The riparian corridor transitions from predominantly herbaceous vegetation to a mix of trees and grasses.

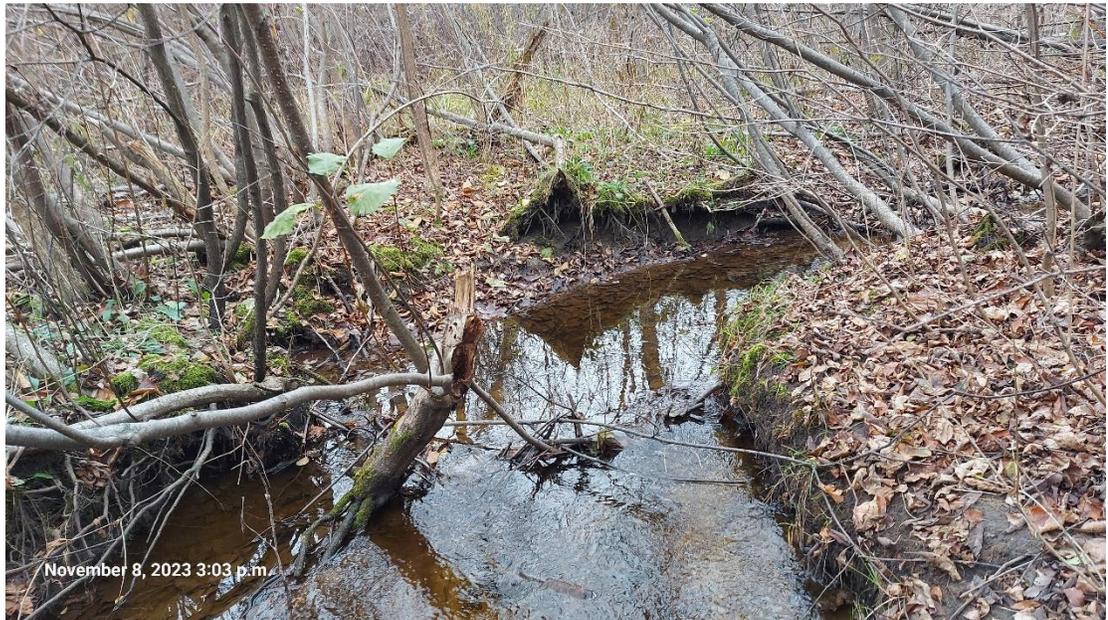
Photo 24
Tributary of Bear Brook
Reach BBT-7

Photograph taken facing downstream along **BBT-7**. The watercourse exhibited a meandering planform within a confined valley.

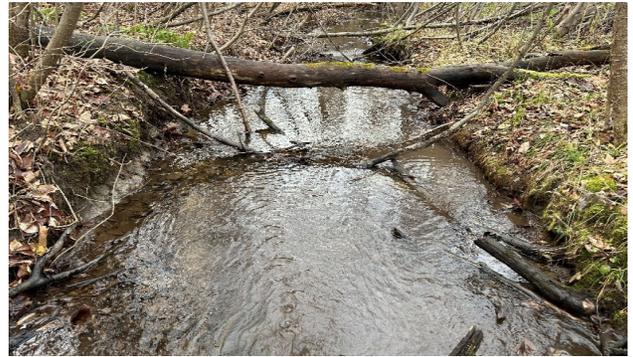
Photograph at cross section 4 (looking downstream)

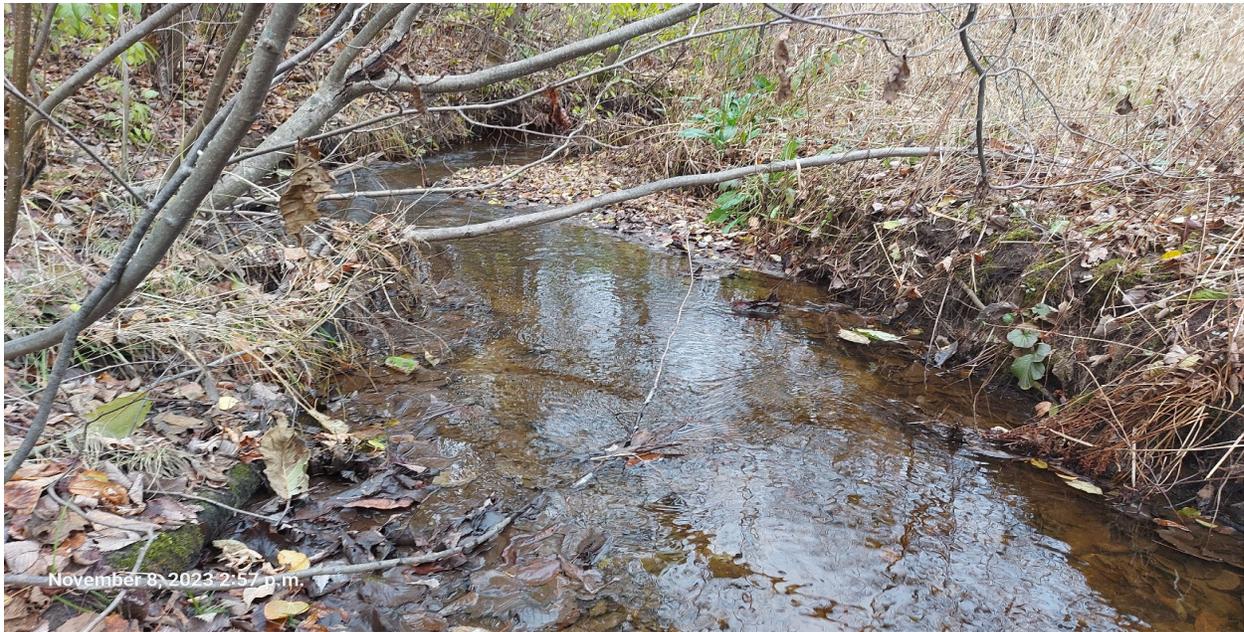
Reach BBT-7 begins downstream of a large culvert crossing under Thunder Road. The watercourse is confined in a valley through this reach and residential properties border the top of the valley slope. Land cover within the valley is primarily forested with some open areas covered in herbaceous vegetation. The channel has an irregular meandering planform through BBT-7. Exposed tree roots and hooked and leaning trees were frequently observed. Some point bar deposition combined with outside bend scour was observed along meanders. The geomorphic units were predominantly runs, with some riffles and pools. A high density of woody debris within the channel created the conditions for many of the geomorphic units observed, such as backwatering forming a pool.

Facing Downstream at cross-section 1
