# TREE CONSERVATION REPORT

1047 Richmond Road

August 23, 2024

Submitted as part of Site Plan Control Application

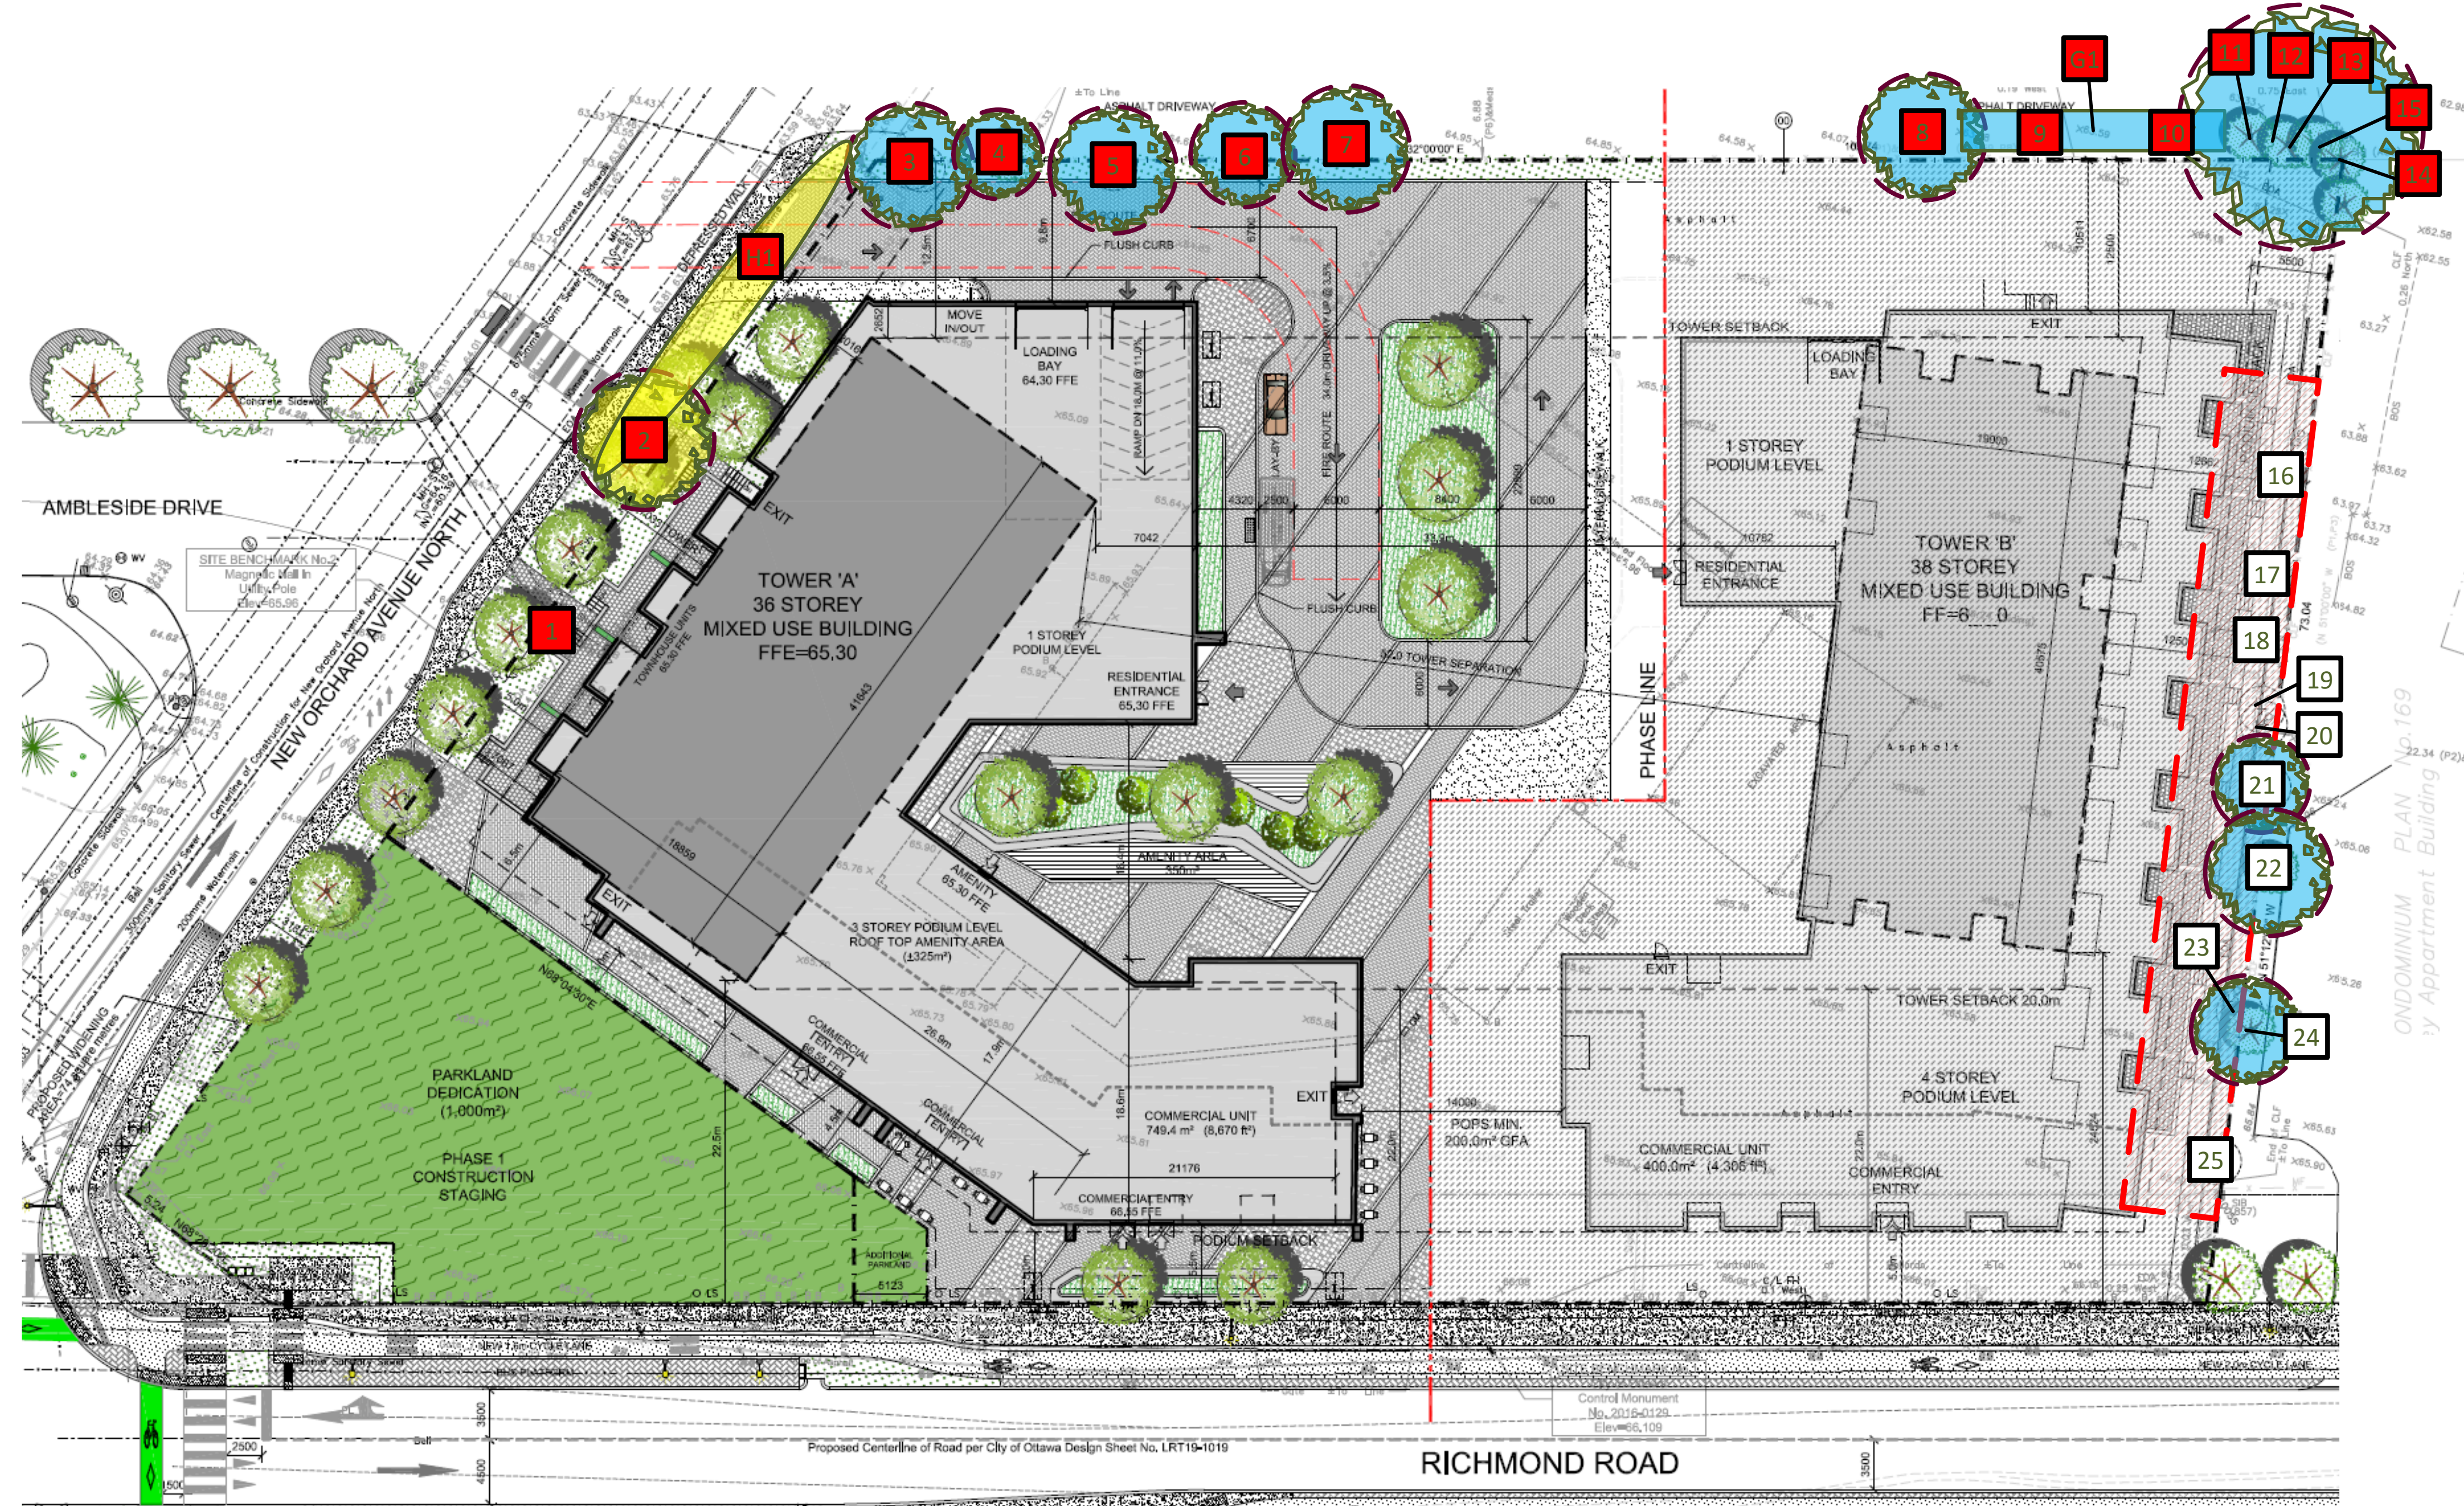
**TCR Map 2 – 1047 Richmond Road**

Tree	Species	DBH (cm)	Tree Condition	Forester recommendation
1	Siberian elm ( <i>Ulmus pumila</i> )	16	Fair: being defoliated; codominant stems @3m	Remove due to level of site activity.
2	Manitoba maple ( <i>Acer negundo</i> )	45 (estimate)	Poor: very weak foliage at top; fungal bodies at base; cavities; epicormic shoots throughout	Remove due to level of site activity.
3	Siberian elm ( <i>U. pumila</i> )	41	Fair/Good: slight lean South; black bark high in canopy	Remove due to proximity of proposed laneway.
4	American elm ( <i>U. americana</i> )	24	Dead	Remove – dead.
5	Manitoba maple ( <i>A. negundo</i> )	42	Fair/Poor: wound and hollow at base; weak foliage; branch attachment wound @4m	Remove due to proximity of proposed laneway.
6 <sup>a</sup>	Manitoba maple ( <i>A. negundo</i> )		Poor: large stump with single remaining stem - cavity, wound and decay in that stem	Remove due to proximity of proposed laneway.
