October 7, 2024

# RE: TREE CONSERVATION REPORT - 384 ARLINGTON AVENUE, OTTAWA

Table 1. Species, ownership, diameter, condition, and status of trees at 384 Arlington Avenue.

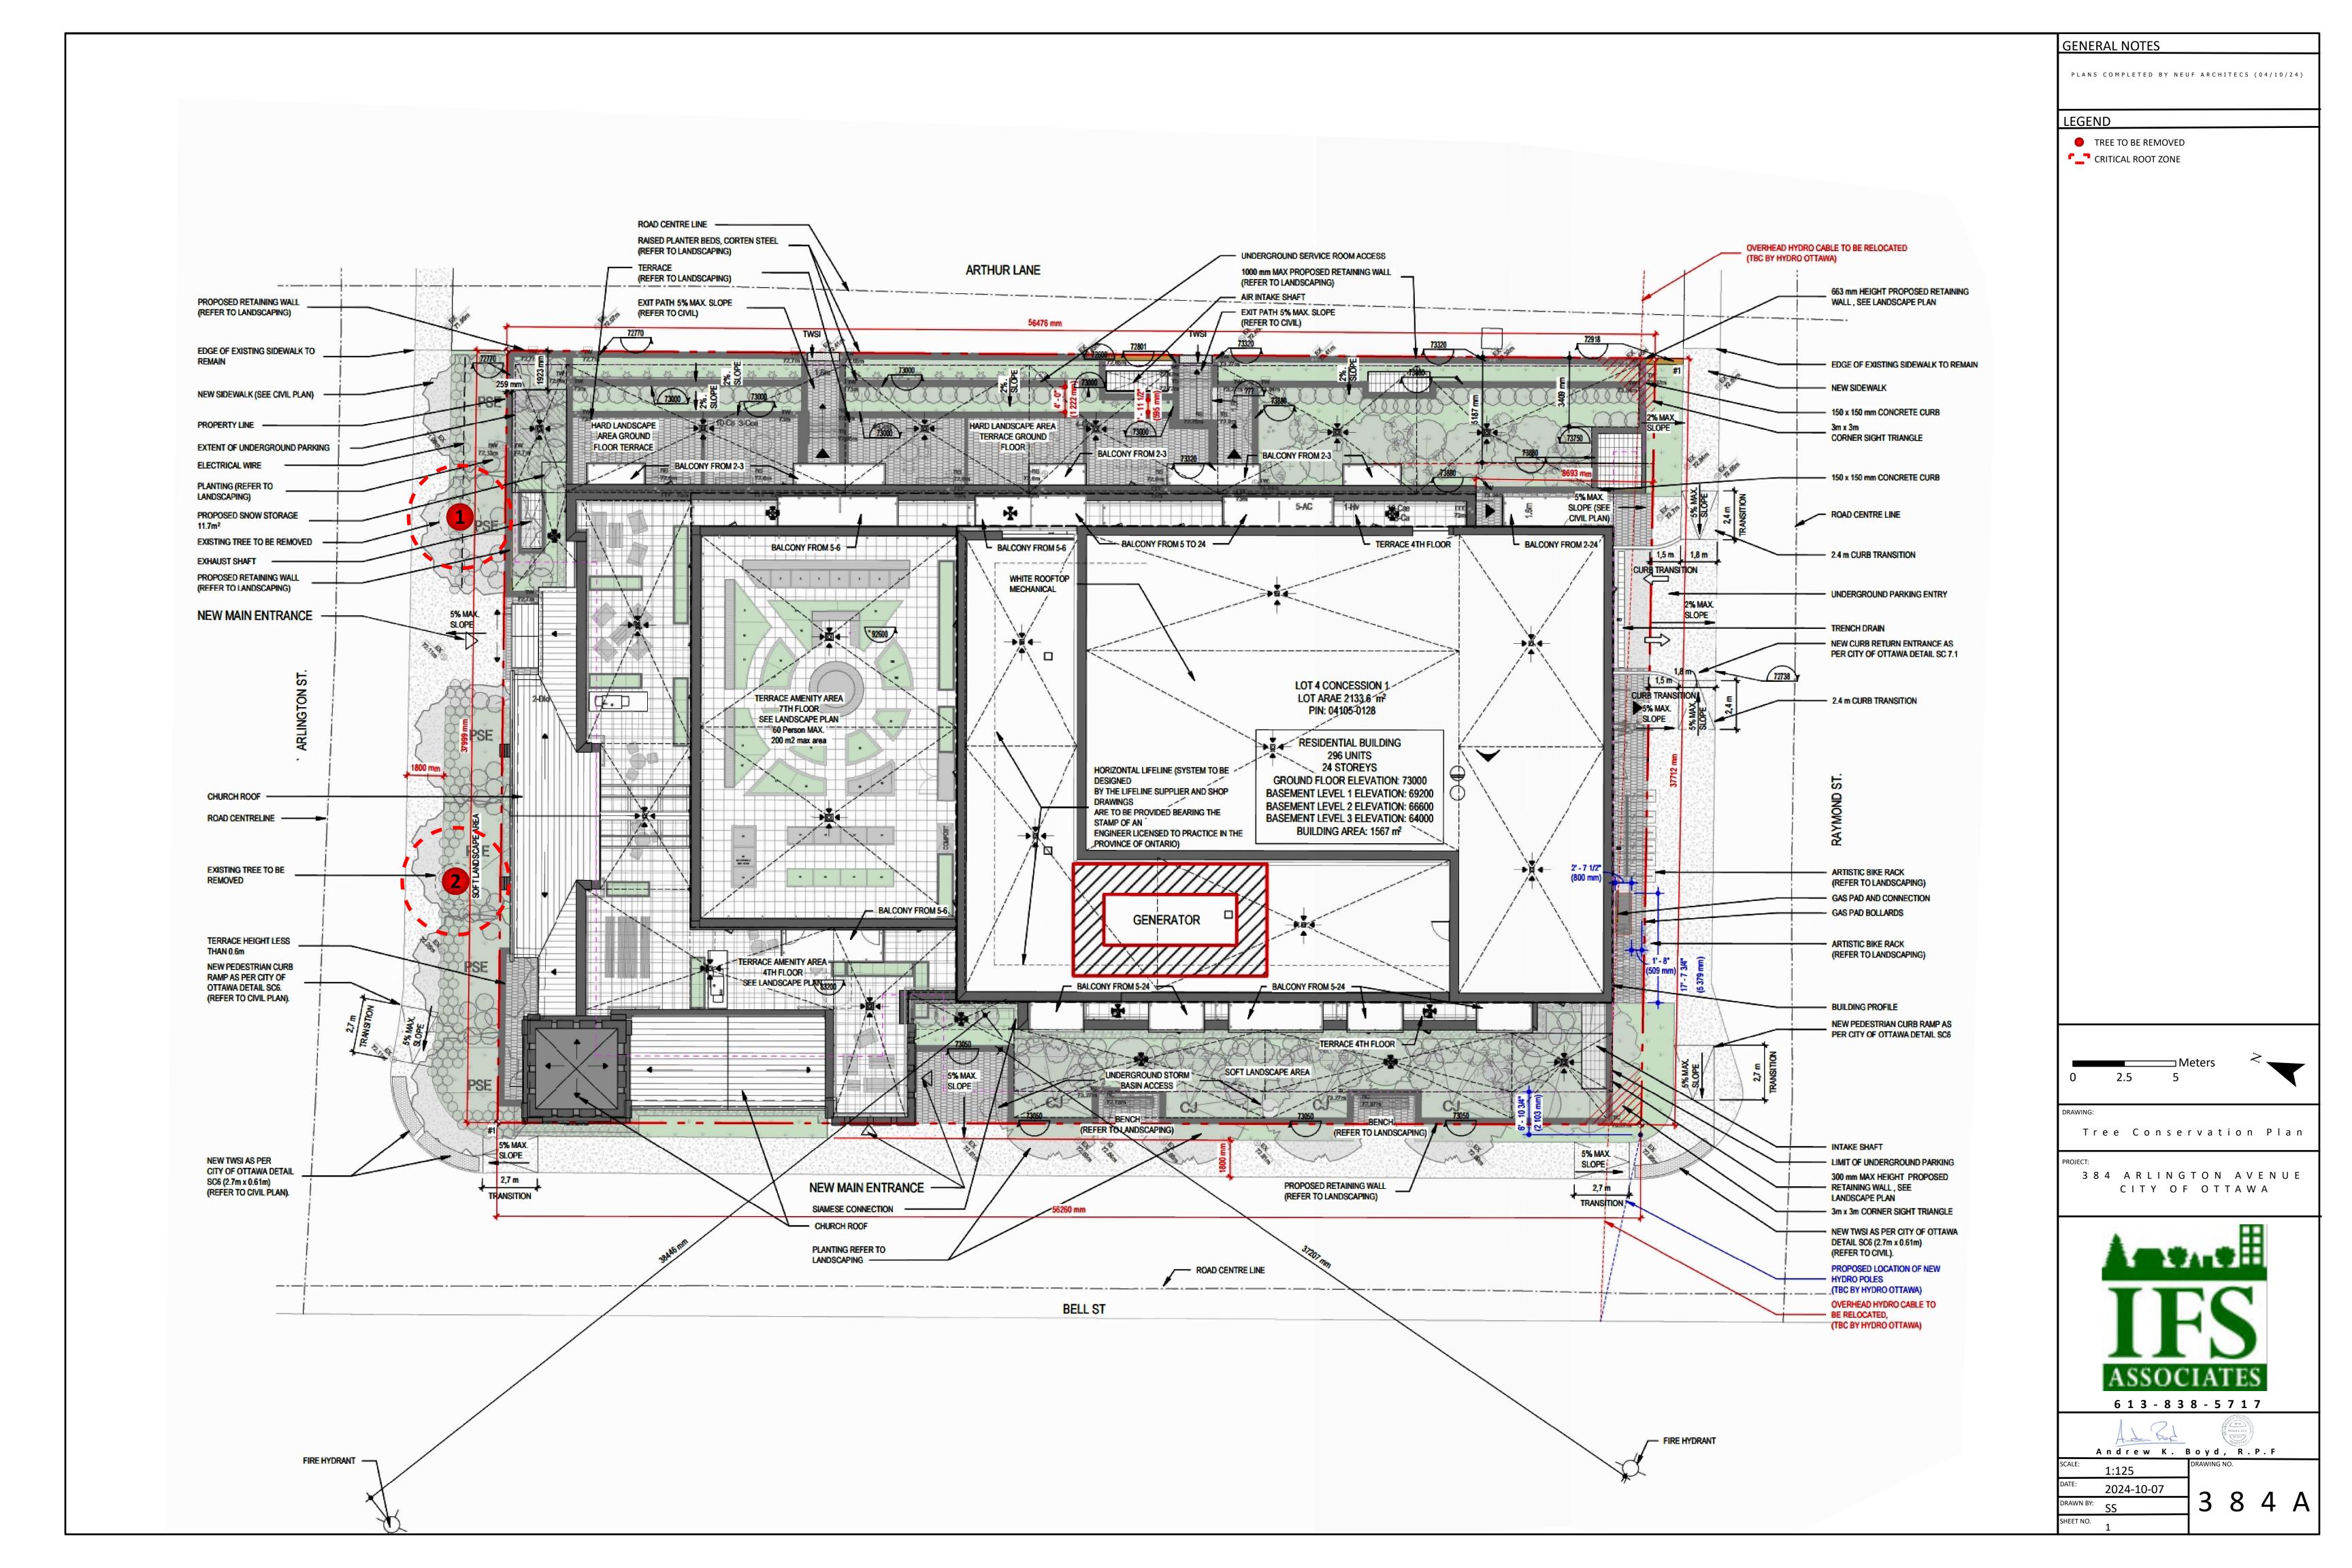
Tree	Tree	Owner-	DBH <sup>1</sup>	Tree condition, age class, condition notes &
No.	Species	ship	(cm)	<b>Preservation Status</b> (to be removed or preserved and
		•	, , ,	protected)
1	Crab apple	City	24.8	Good; mature; co-dominant stems at 2.25m; crown
	(Malus spp.)			dense with epicormic growth; generally symmetric;
				minor basal sprouting; major wound with decay and
				cavity in north stem at 2-2.5m; cultivar; to be removed
				(conflicts with construction)
2	Crab apple	City	26.4	Poor; mature; single dominant stem for most of height
	(Malus spp.)			(lateral stem at 2m on northwest is dead); heavily
				divergent towards northwest; opposing stem wounds at
				2m on northeast with decay and 2m on northwest also
				with decay; heavy basal sprouting; tree is in decline;
				cultivar; to be removed (conflicts with construction)

As noted above, neither tree can be retained because of the excavation required for the new building and access for the structural reinforcements required for the conservation of the existing church frame.
