TREE CONSERVATION REPORT

2506 Innes Road

Dendron Forestry Services

September 16, 2024

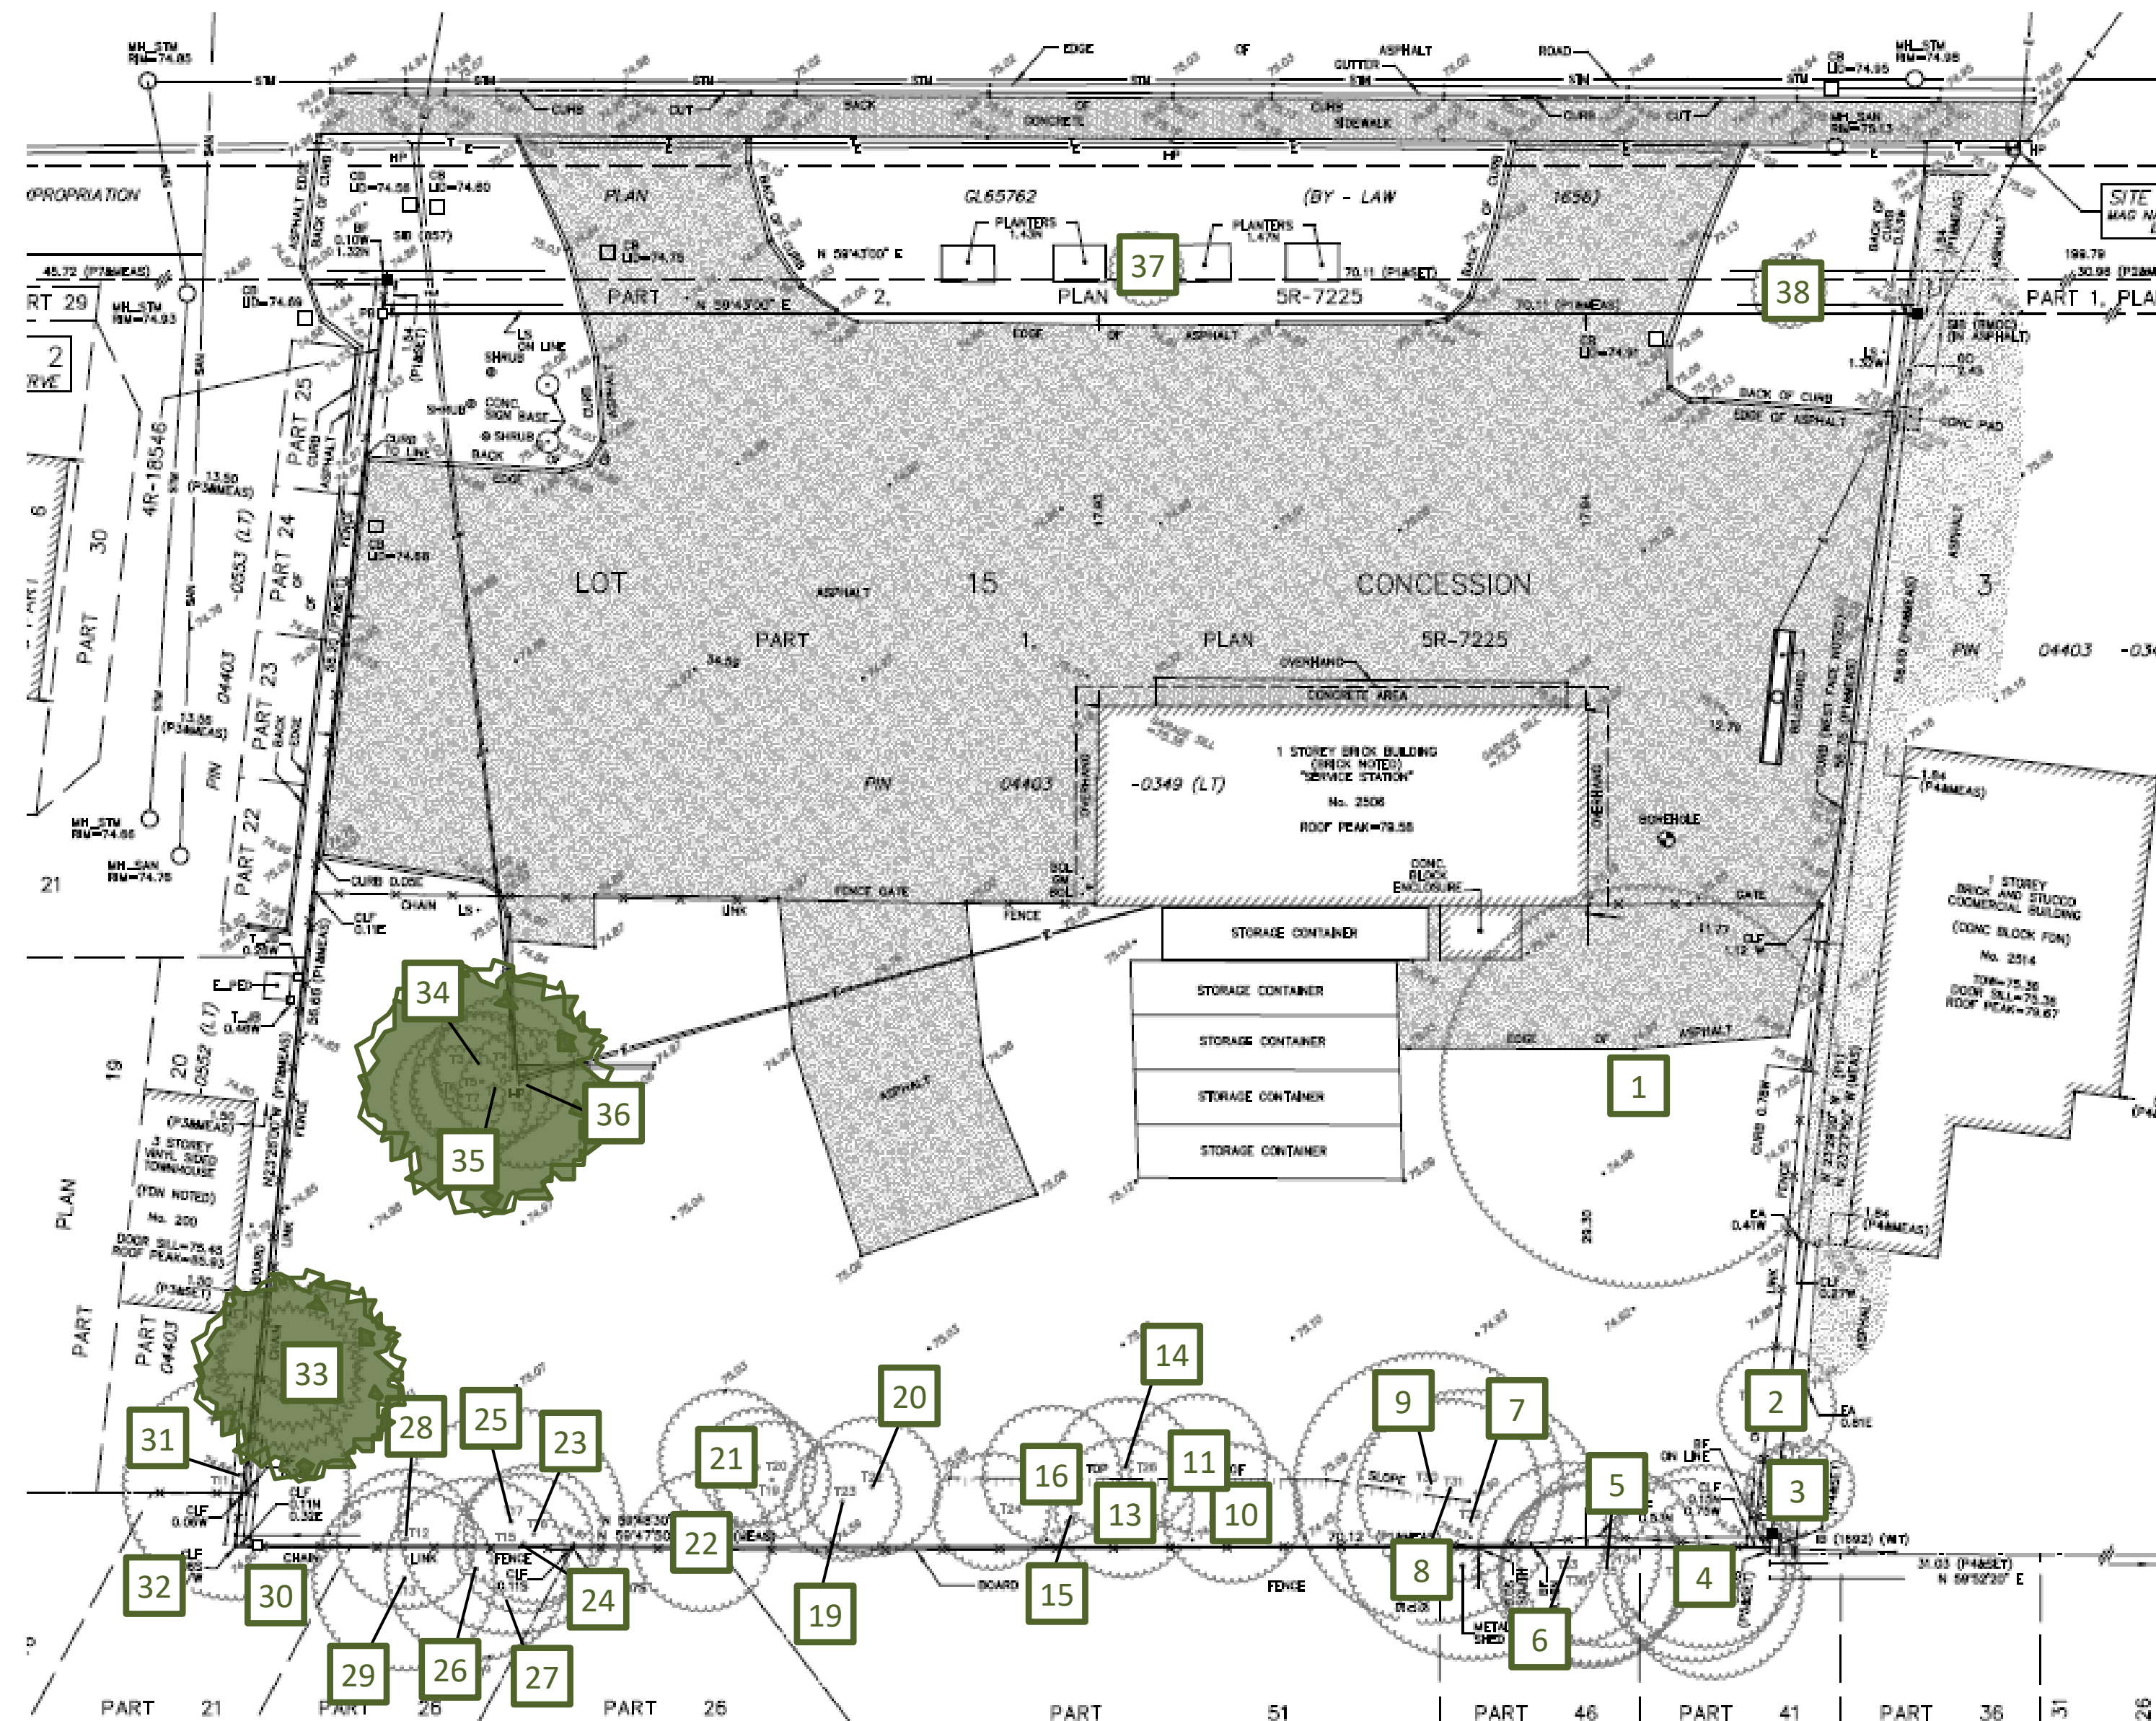
TCR Map – 2506 Innes Road
 Tree layer prepared by
 Dendron Forestry Services
 Existing Vegetation, November 16, 2023
 For more information, please contact: info@dendronforestry.ca

22	Freeman maple (<i>Acer freemanii</i>)	17	Subject property	Good
23	Black cherry (<i>Prunus serotina</i>)	12	Subject property	Fair: lean corrected through growth
24	Black cherry (<i>Prunus serotina</i>)	15	Subject property	Fair/Poor: growing on fence; significant lean
25	Manitoba maple (<i>Acer negundo</i>)	17	Subject property	Fair
26	Scot's pine (<i>Pinus sylvestris</i>)	33	Adjacent – 45 Glen Park	Fair
27	Hackberry (<i>Celtis occidentalis</i>)	16, 4 (estimated)	Adjacent – 45 Glen Park	Fair: suppressed
28	Black cherry (<i>Prunus serotina</i>)	15, 12	Subject property	Fair: codominant stems @ 1.3m
29	Scot's pine (<i>Pinus sylvestris</i>)	28 (estimated)	Adjacent – 45 Glen Park	Fair: thin crown
30	Scot's pine (<i>Pinus sylvestris</i>)	30 (estimated)	Adjacent – 45 Glen Park	Fair: asymmetrical crown
31	Freeman maple (<i>Acer freemanii</i>)	50 (estimated)	Adjacent – 200 Scotland	Fair: large branch attachment wound; small cavity with decay possible; slight lean to the west

32	Scot's pine (<i>Pinus sylvestris</i>)	30 (estimated)	Adjacent – 43 Glen Park	Fair/Poor: very thin crown
33	Eastern white cedar (<i>Thuja occidentalis</i>)	12 stems 5-30	Subject property	Good/Fair
34	Norway maple (<i>Acer platanoides</i>)	13	Subject property	Good
35	Manitoba maple (<i>Acer negundo</i>)	7 stems 11-25	Subject property	Fair/Poor: spreading form
36	American elm (<i>Ulmus americana</i>)	24	Subject property	Good
37	Tree lilac (<i>Syringa reticulata</i>)	8	City	Fair
38	Serviceberry (<i>Amelanchier spp.</i>)	6	City	Fair
