TREE CONSERVATION REPORT

5580 Manotick Main Street

February 3, 2025

Tree Conservation Report v2.0

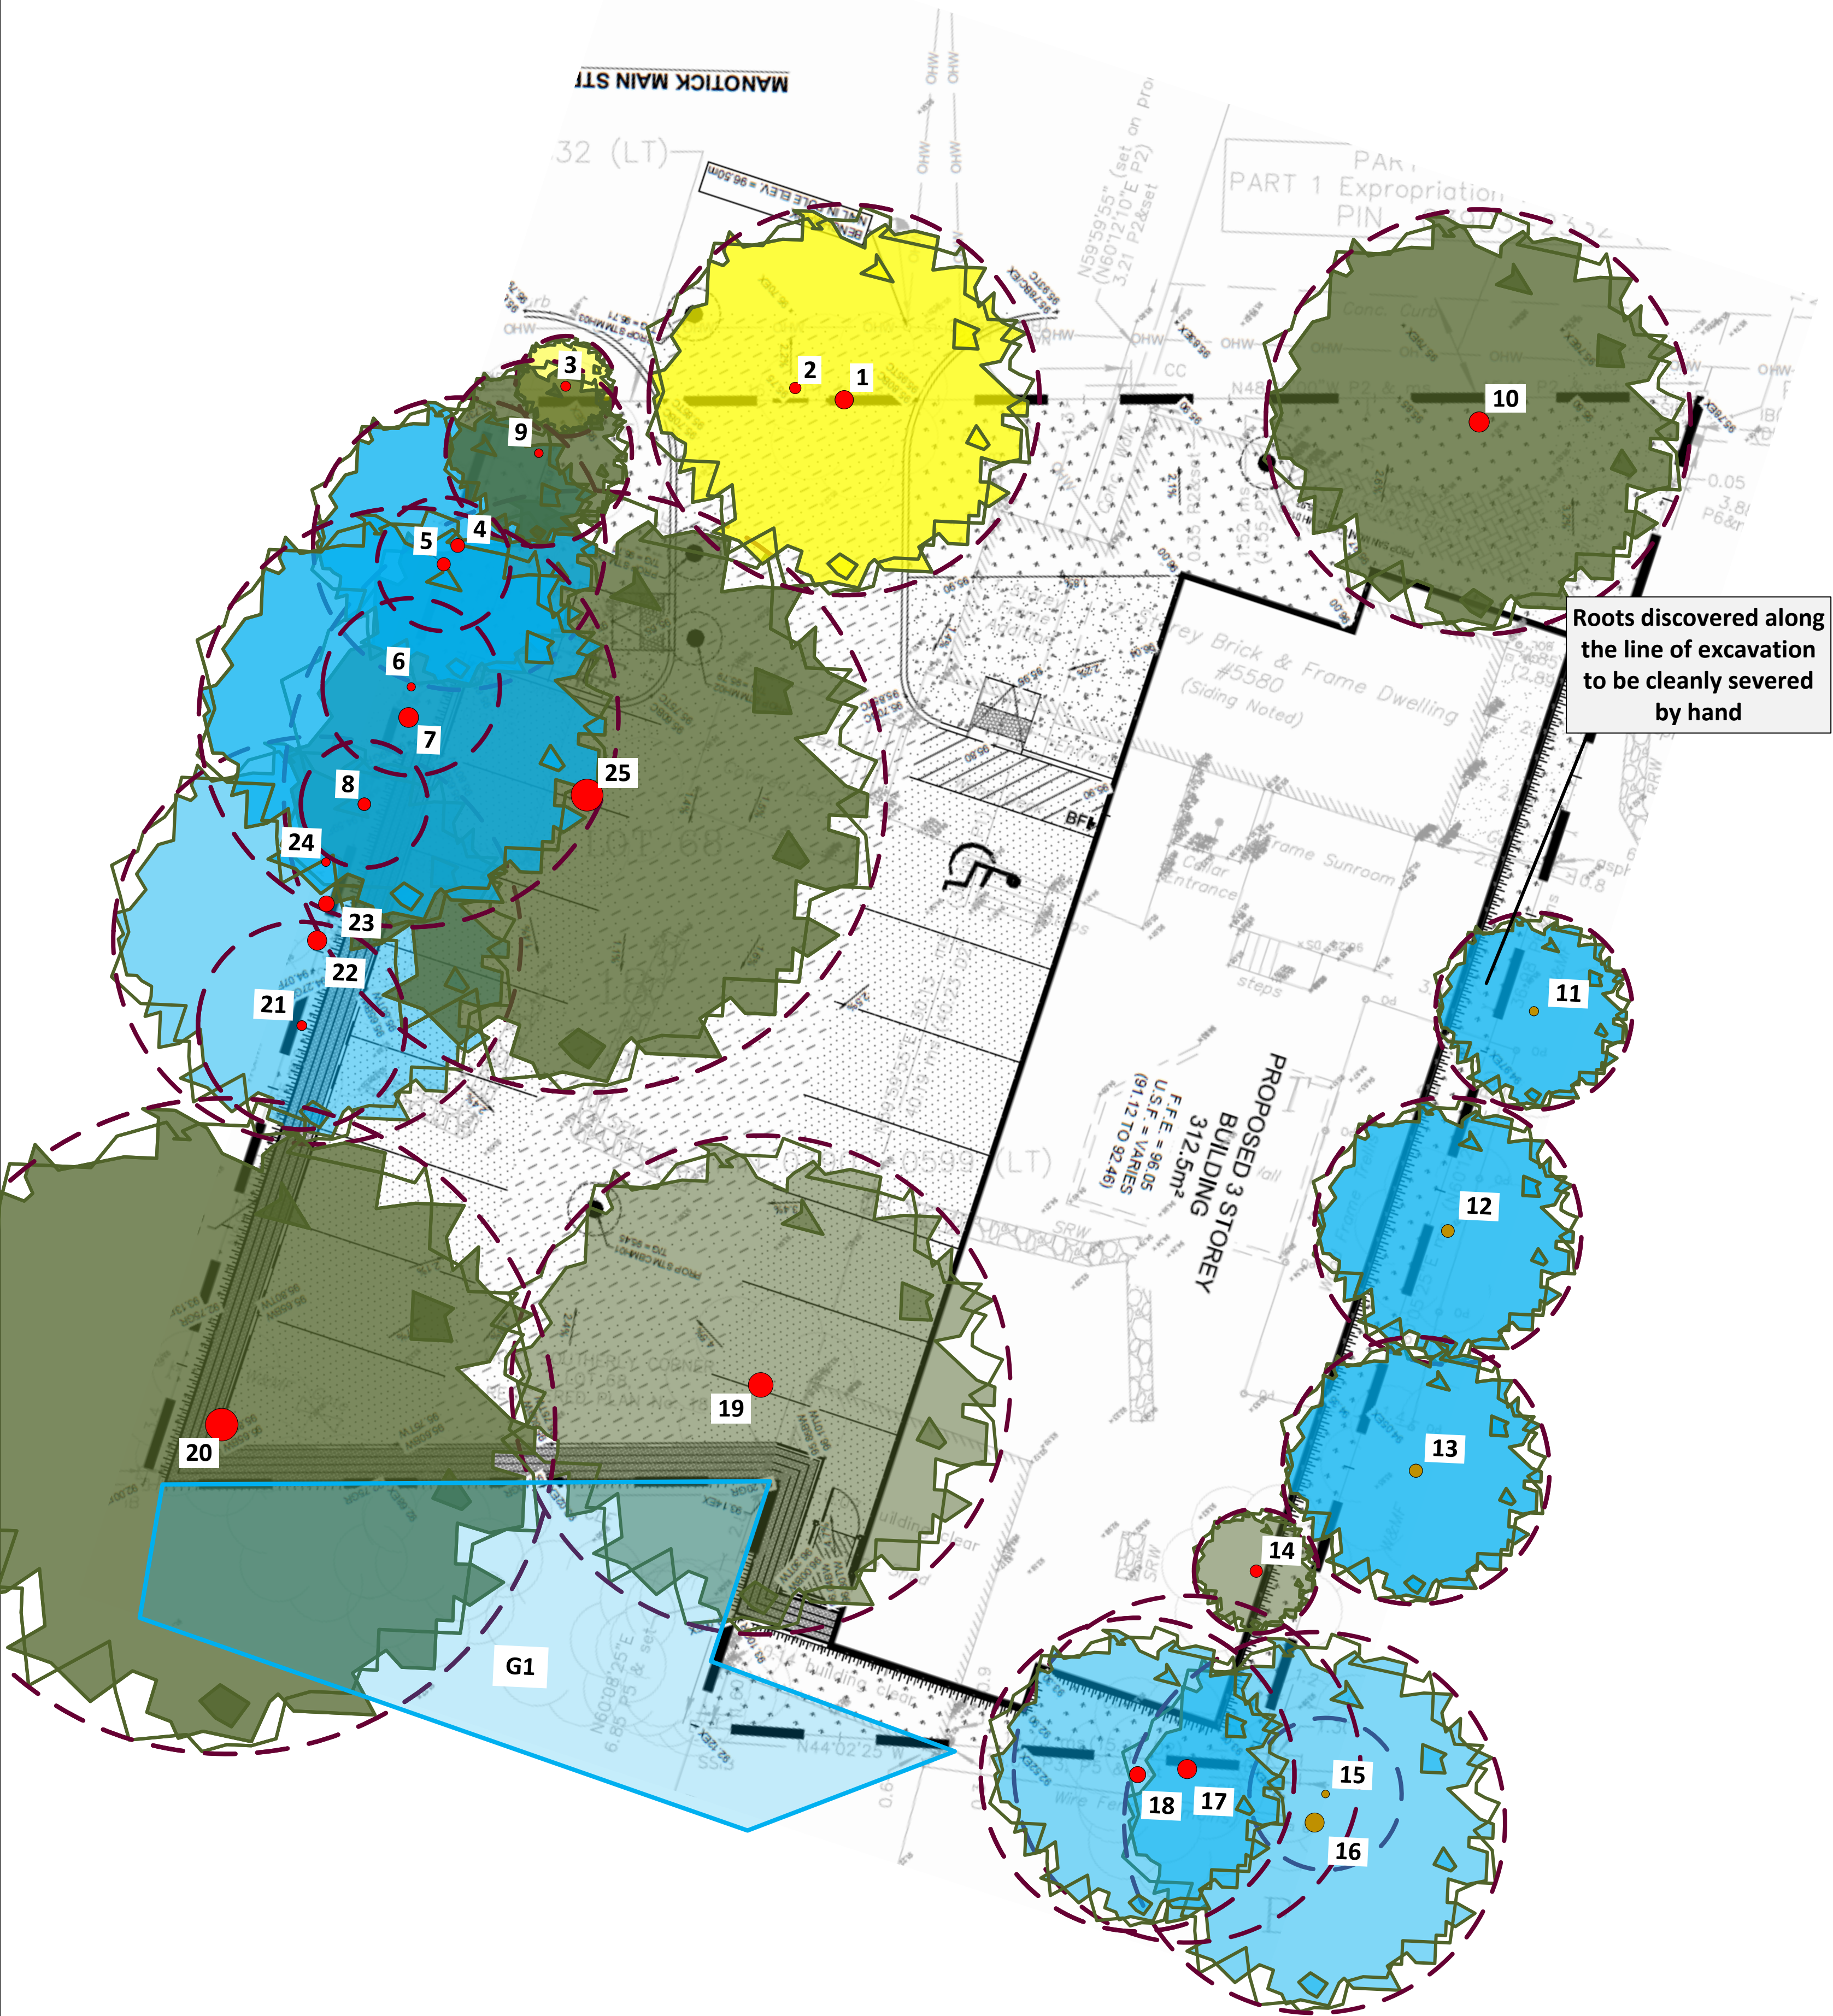
TCR Map #2 – 5580 Manotick Main

Tree ¹	Species	DBH (cm)	Tree Condition	Forester recommendation
1	Bur oak (<i>Quercus macrocarpa</i>)	51	Fair: pruned around wires – asymmetrical crown – pruning wounds with decay – epicormic shoots	Remove – in line with proposed entryway.
2 ^a	Norway maple (<i>Acer platanoides</i>)	8	Good/Fair: leaning to road for sunlight	Remove – in line with proposed entryway.
3 ^a	Norway maple (<i>Acer platanoides</i>)	7, 5, 6, 8	Fair/Poor: stems are sprouts from old stump; leaning heavily; growing under wires	Remove due to health status.
4	Black locust (<i>Robinia pseudoacacia</i>)	38	Fair: poor growing location; crowded	Remove – opportunities to retain may be explored during site works.
5	Norway maple (<i>Acer platanoides</i>)	17	Fair: young and vigorous; poor growing location; suppressed by larger trees	Remove – opportunities to retain may be explored during site works.
6	Norway maple (<i>Acer platanoides</i>)	23	Fair: young and vigorous; poor growing location; suppressed by larger trees	Remove due to grade changes to install parking.

7	Black locust (<i>Robinia pseudoacacia</i>)	54	Fair: codominant stems @1.5m – included bark at union; dead branches; poor growing location	Remove due to grade changes to install parking.
8	Norway maple (<i>Acer platanoides</i>)	16	Fair: young and vigorous; poor growing location; suppressed by larger trees	Remove due to grade changes to install parking.
9 ^a	Norway maple (<i>Acer platanoides</i>)	24	Poor: growing around roof of shed	Remove due to growing conditions and site works.
10 ^a	Norway maple (<i>Acer platanoides</i>)	55	Poor/Fair: canker in canopy; slight lean to west; poor form at base; large dead branch	Remove due to health status and grading requirements.
11	Black locust (<i>Robinia pseudoacacia</i>)	25	Fair/Poor: grade raised around base; wound – possibly canker	Retain - approximately 1.5m from excavation – any roots encountered are to be cleanly severed along the line of excavation.

17	Black locust (<i>Robinia pseudoacacia</i>)	45 (estimate)	Fair/Poor: very little live canopy remaining	Remove due to health status and proximity of excavation. Permission required from neighbor for removal.
18	Manitoba maple (<i>Acer negundo</i>)	40 (estimate)	Fair: heavy lean northwest; vigorous growth	Remove due to proximity of excavation. Permission required from neighbor for removal.
19	Bur oak (<i>Quercus macrocarpa</i>)	65	Good/Fair: some crossing branches; branch stubs from pruning with epicormic shoots	Remove – in line with proposed parking.
20	Manitoba maple (<i>Acer negundo</i>)	85	Poor: decay and fungal bodies at base; lean to northwest; woodpecker activity in canopy	Remove – in line with proposed parking.
21	Manitoba maple (<i>Acer negundo</i>)	27	Poor: top has been removed – only sprouts remain as canopy	Remove due to grade changes to install parking.
22	Black locust (<i>Robinia pseudoacacia</i>)	53	Poor: Very little live canopy	Remove due to grade changes to install parking.

23	Black locust (<i>Robinia pseudoacacia</i>)	43	Poor: large wound on trunk – decay present	Remove due to grade changes to install parking.
24	Manitoba maple (<i>Acer negundo</i>)	24	Poor: crack in trunk; lean to northeast	Remove due to grade changes to install parking.
25	Norway maple (<i>Acer platanoides</i>)	66, 43	Poor: canker on smaller stem; decay at main union – 10cm deep hole – small crack from this hole to base; large branch stub	Remove due to health status and impacts from construction – in line with proposed parking.
G1	Norway and Manitoba maples (<i>A. negundo</i> & <i>A. platanoides</i>)	12 stems 8-29cm	Fair: young trees, mostly vigorous; growing on slope, shaded	Retain to provide canopy coverage after construction. Grade changes not to occur past property line.
