HERITAGE IMPACT ASSESSMENT & CONSERVATION PLAN*

168 -174 MURRAY STREET, OTTAWA

Owner: David Yoo
Address: 168 – 174 Murray Street, Ottawa, Ontario

Revised March 2025

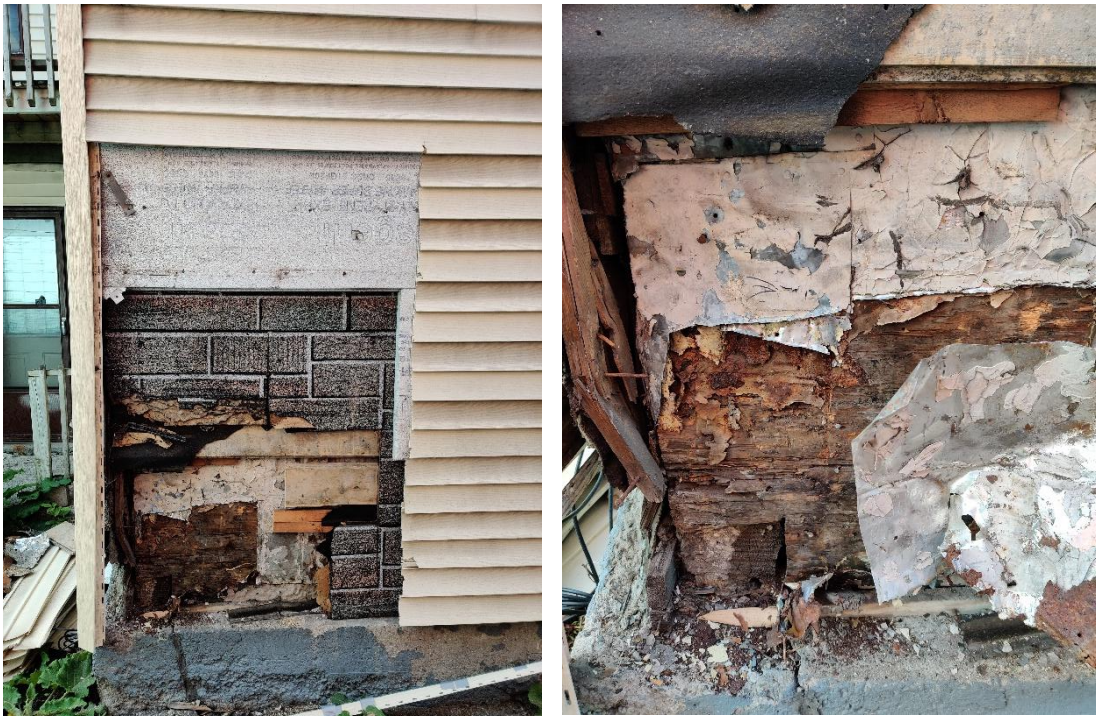
Figure 35: 1861 Census documents the McManus family owned a 66 x.99 lot at 168 Murray and were living in 1.5 storey log house. The Lowertown building inventory recorded that the building was constructed in 1876 based on Fire Insurance plans. The two views illustrate the multiple layers of finishes including squared timber, tin panels insulation, ridged insulation, and vinyl siding. Source David Yoo 2022.

Following the removal of later claddings, the log siding can undergo thorough inspection to assess the condition of the logs on the east elevation and identify any covered openings.

10. On the east elevation, the squared timber log will be exposed and repaired.
