**Tree Conservation Report
for 6259, 6267, 6271 and 6273 Renaud Road, Ottawa**

June 26, 2025

Final Report

Project Number: RICH 1637.4

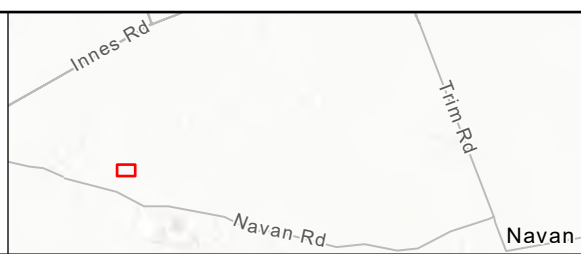
Figure 2. Site trees

In total, 197 trees were identified, situated onsite or immediately adjacent to site boundaries. Existing trees on the Site range in size from 9 cm to 91 cm DBH and represent 24 different species. The majority of trees (158) assessed are situated entirely within Site boundaries and owned by Richcraft. Five trees are situated along the Site boundaries and reflect shared ownership between Richcraft and adjacent landowners. Thirty-four (34) trees are situated on adjacent lands, 32 of which are City-owned trees on adjacent public lands, while two are privately owned. Two cedar hedgerows are present on the Site that do not meet tree size requirements (Figure 2).

The Site does not contain any Butternut trees (*Juglans cinerea*; listed as Endangered under the ESA and SARA). One Black Ash tree (*Fraxinus nigra*; Endangered under the ESA) was observed onsite, situated adjacent to the north property boundary (Figure 2, Figure 3). The Black Ash tree measured 9 cm DBH; winter conditions precluded a comprehensive assessment. Based on initial observations on size and condition, species and habitat protections under the ESA are anticipated to apply per O.Reg. 6.24 and O.Reg. 7.24.

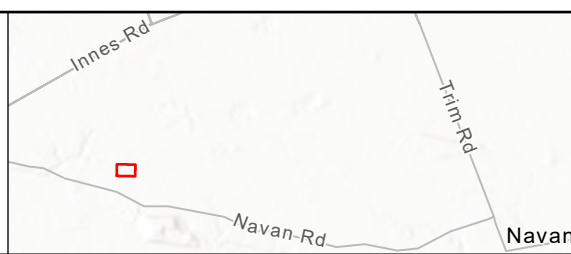
Figure 3. Proposed Development

One Black Ash tree measuring 9 DBH was observed adjacent to the northern Site boundary during the tree inventory that took place on March 6, 2025. If it is confirmed to be healthy through a formal Black Ash Assessment, to take place in June 2025, Black Ash protections will apply to this tree and its root protection zone (i.e. 30 cm radial distance around the tree), per O.Reg. 6/24 and O.Reg. 7/24. If the individual is confirmed to be unhealthy, that data will be submitted to MECP and no protections under the ESA will apply, per O.Reg. 6/24 and O.Reg. 7/24.

MECP guidelines state that Black Ash Assessments must take place during the leaf-on season, between June 1 and October 1 (MECP, 2021, 2024). Accordingly, a Black Ash assessment will take place on or after June 1, 2025 and will be submitted to MECP upon completion. The individual tree and its root protection zone will not be harmed prior to retaining the appropriate permits and approvals. Minor landscaping works may take place within the root protection zone to improve the current condition (e.g., improving landscaping with native vegetation); however, no grading/excavation work and no hard infrastructure is permitted within the root protection zone to remain compliant with the ESA. Development work within the root protection zone may only proceed following the issuance of a “net benefit” permit by the MECP and the implementation of any relevant obligations under that permit.
