# **Phase I Environmental Site Assessment**

4405 & 4409 Innes Road  
Ottawa, Ontario

Prepared for 1000772034 Ontario Inc.

Report: PE6827-1  
November 14, 2024

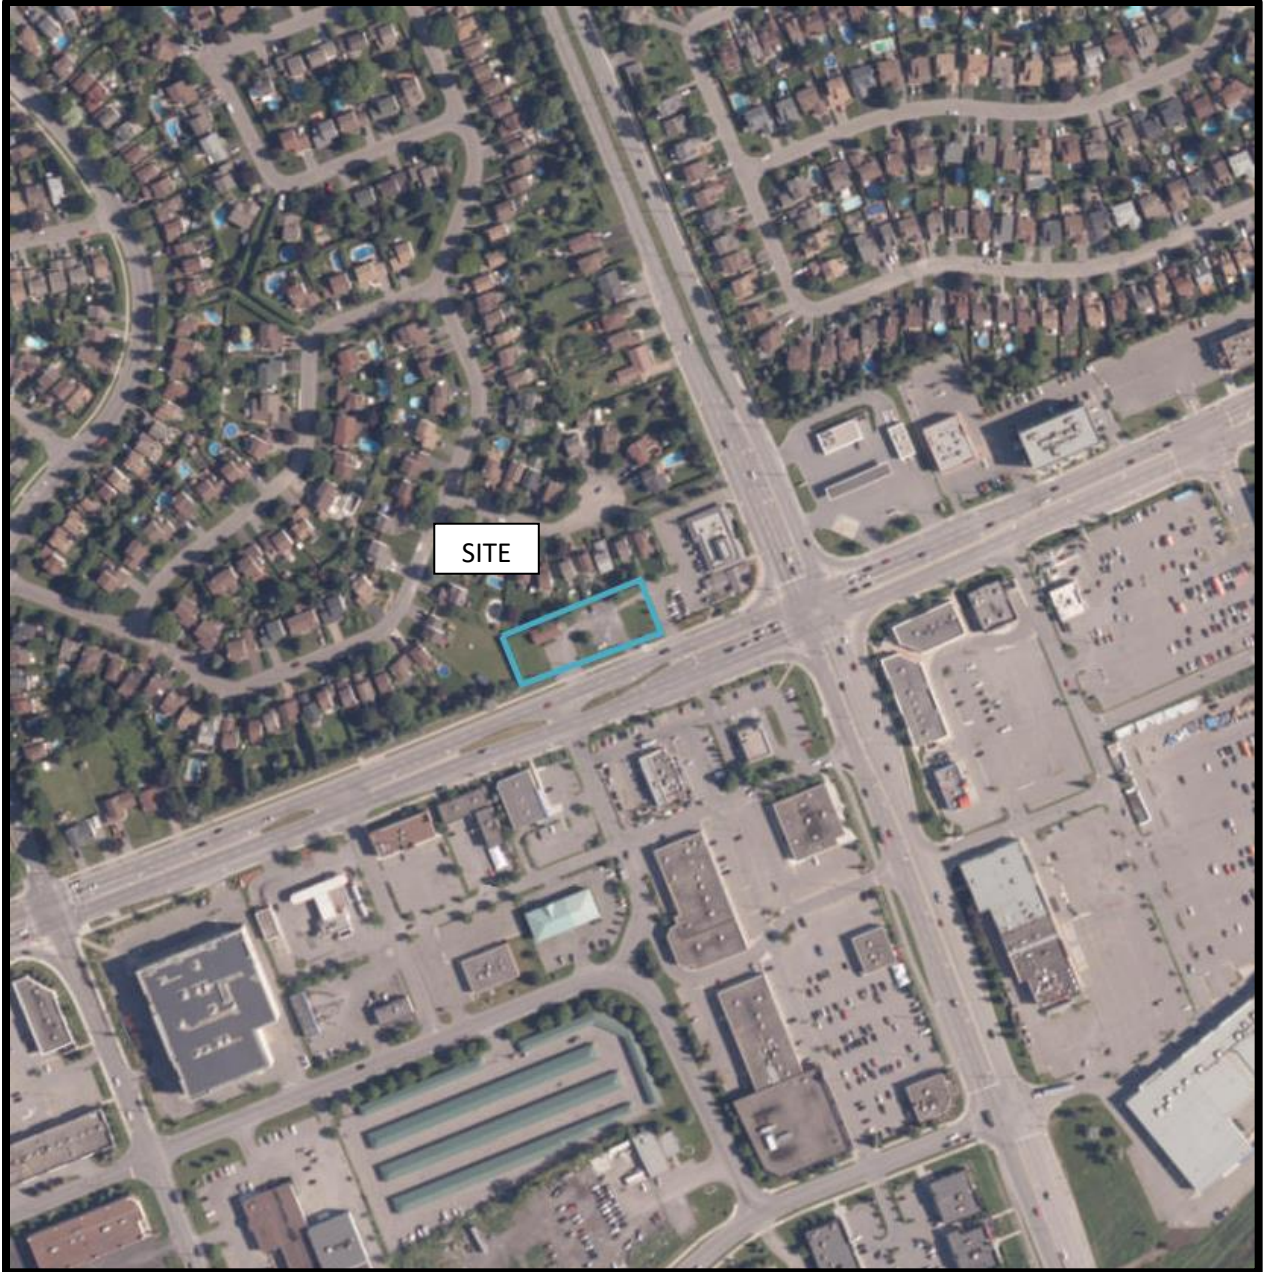
AERIAL PHOTOGRAPH  
2022

- 2011 The subject property is unchanged since the previous aerial photograph. Additional commercial buildings were constructed to the south of the site. No other changes have been made to the surrounding area since the previous aerial image.
- 2022 The residential dwelling on 4409 Innes Road was demolished. The gravel pad at 4405 Innes Road was replaced with a paved parking lot. Three buildings directly to the east of the site were demolished and replaced with the present-day veterinary hospital, pet groomers and associated paved parking lot. No other significant changes have been made to the site or neighbouring properties since the previous aerial photograph.
