TREE CONSERVATION REPORT

1058-1066 Silver Street
and 1291-1305 Summerville Avenue

Tree Conservation Report submitted as Partial
Requirements for a Site Plan Control Application.

Dendron Forestry Services

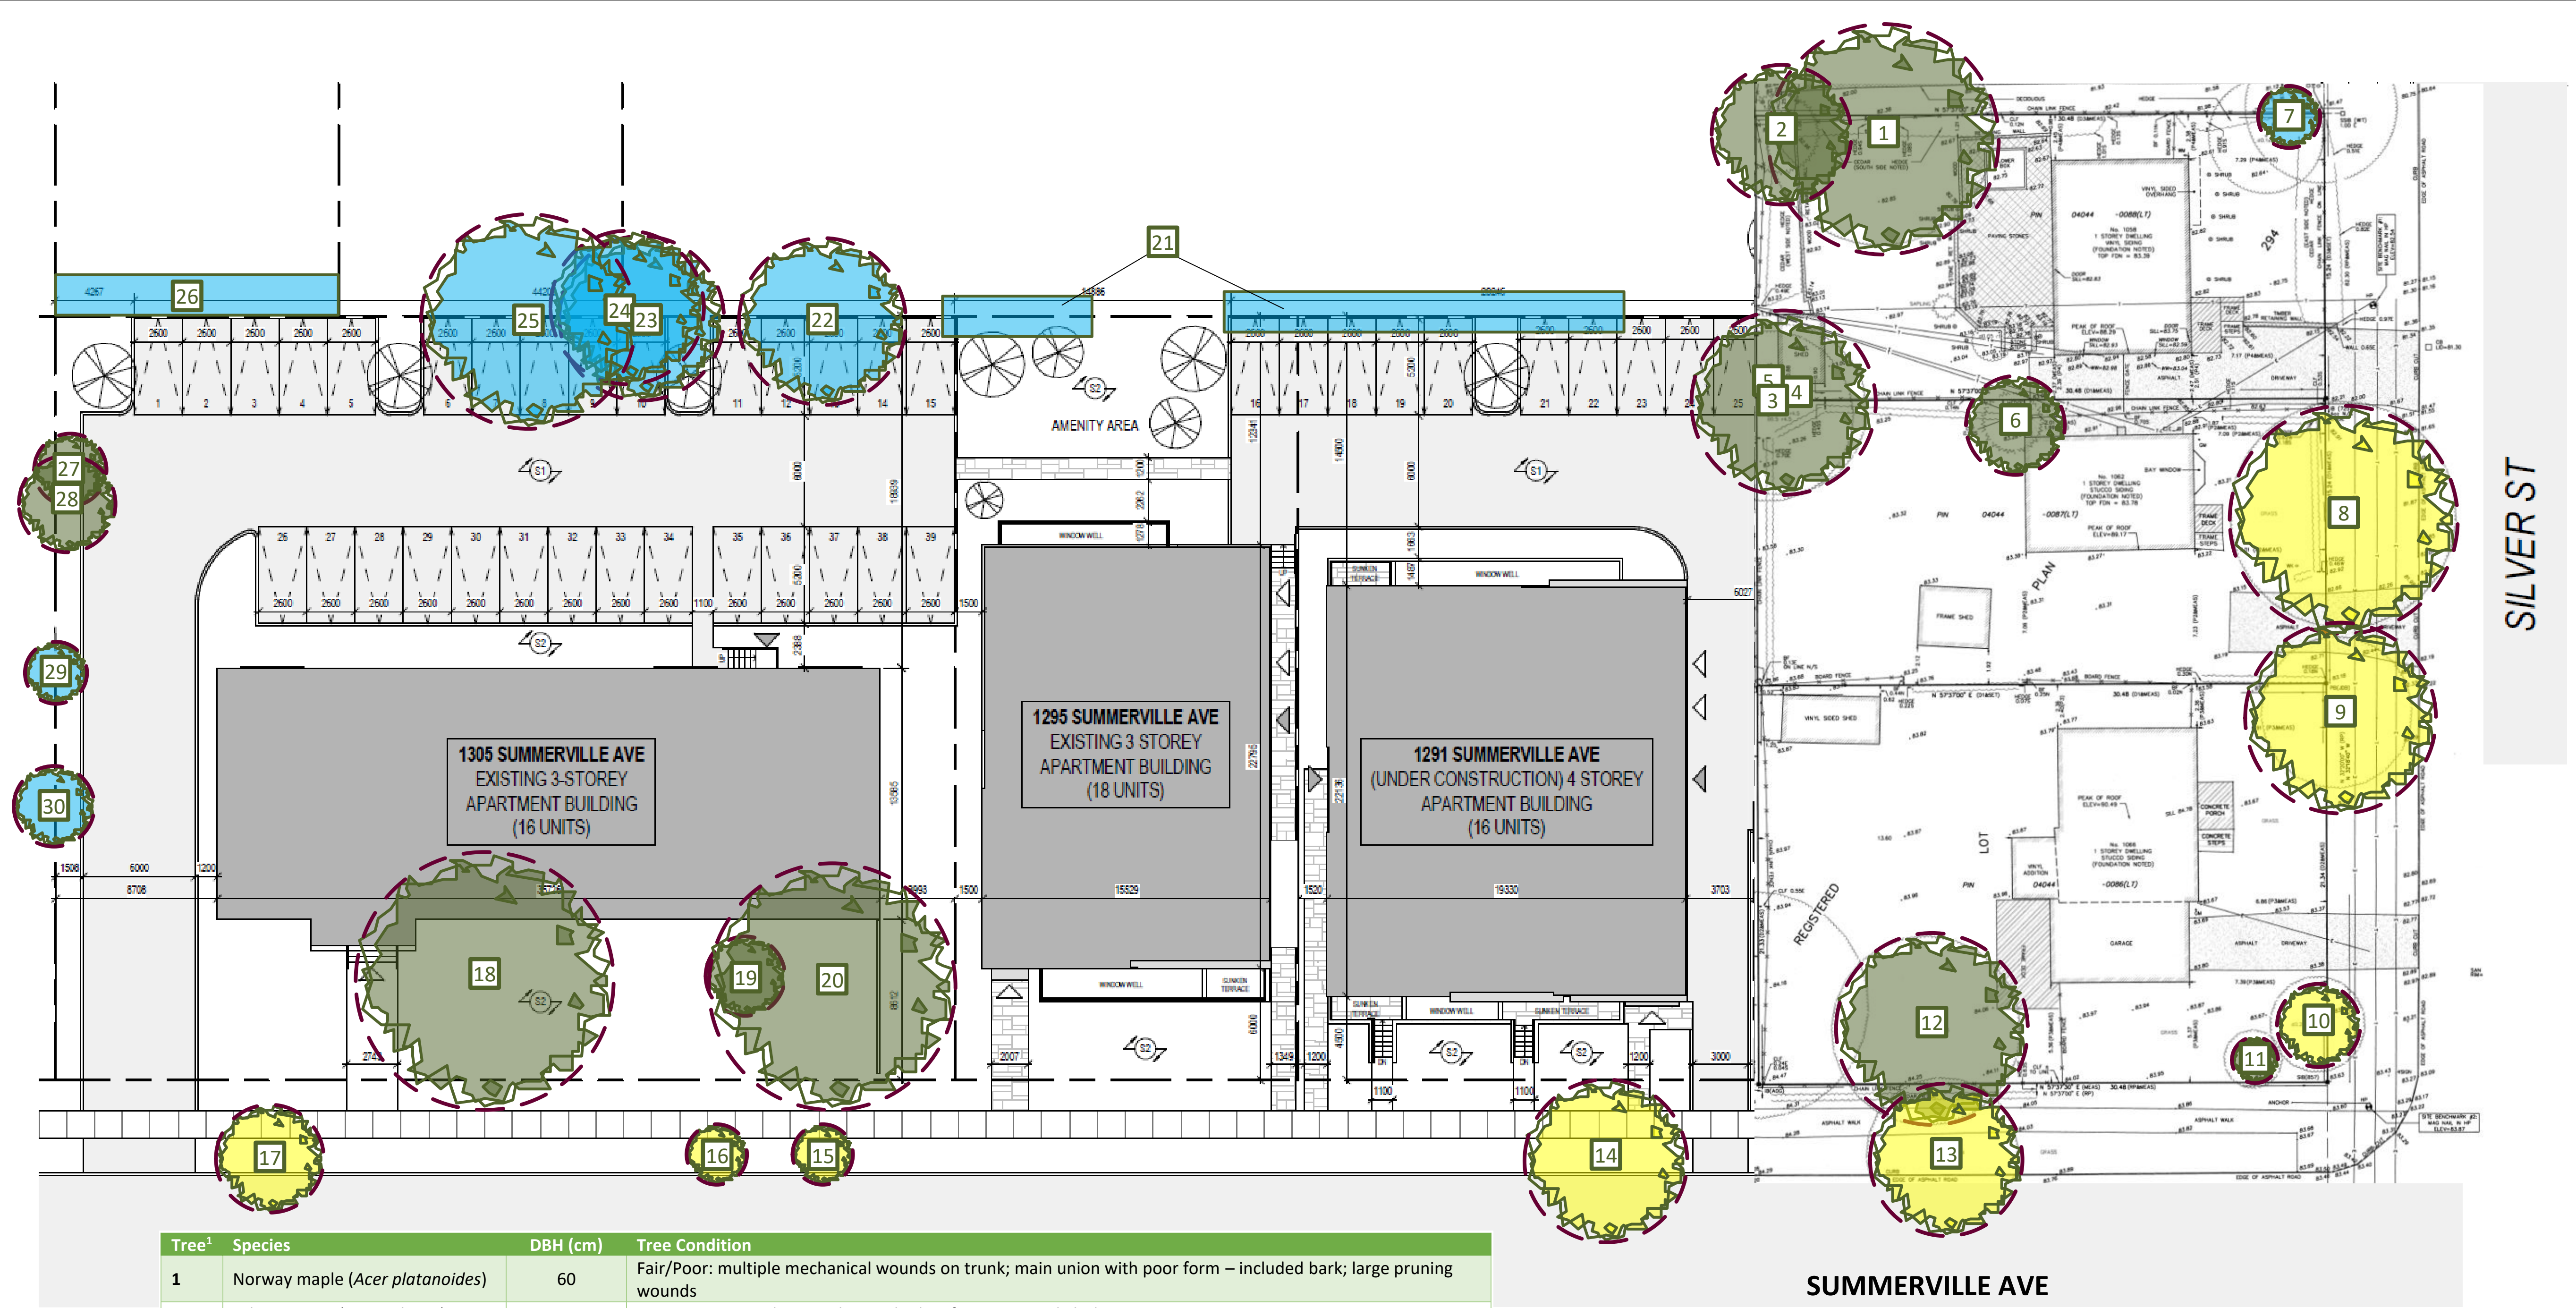
Tree ¹	Species	DBH (cm)	Tree Condition
1	Norway maple (<i>Acer platanoides</i>)	60	Fair/Poor: multiple mechanical wounds on trunk; main union with poor form – included bark; large pruning wounds
2	White spruce (<i>Picea glauca</i>)	36	Fair: asymmetrical crown due to shading from Tree 1; slight lean W
3	Norway maple (<i>Acer platanoides</i>)	47	Fair/Poor: large branch attachment wound; asymmetrical crown
4	Norway maple (<i>Acer platanoides</i>)	43	Fair: asymmetrical crown; lean to S (approx. 10°)
5	Norway maple (<i>Acer platanoides</i>)	18	Poor: suppressed
6	Eastern white cedar (<i>Thuja occidentalis</i>)	25	Fair: codominant leaders
7 ⁴	Norway maple (<i>Acer platanoides</i>)	12	Poor: growing on fence – current growth is sprout from cut base
8	Sugar maple (<i>Acer saccharum</i>)	59	Fair: pruned around wires; two leaders are dead
9	Norway maple (<i>Acer platanoides</i>)	49	Fair/Poor: three large seams on trunk; girdling roots probable; asymmetrical crown due to pruning around wires

10	Cherry (<i>Prunus spp.</i>)	7, 8, 11, 14	Poor/Fair: fungal bodies present 1m from ground; pruning wounds with decay beginning
11	Tree lilac (<i>Syringa reticulata</i>)	12	Good/Fair: tridominant stems
12	Norway maple (<i>Acer platanoides</i>)	50 (estimate)	Good: small cavity in central leader
13	Norway maple (<i>Acer platanoides</i>)	39	Fair: mechanical wound at base; poor unions between tridominant leaders
14 ⁴	Norway maple (<i>Acer platanoides</i>)	42	Poor: girdling roots >1/3 circumference; included bark at main union – fungal bodies present
15 ⁴	Hackberry (<i>Celtis occidentalis</i>)	13	Fair: large seam (likely sun scald) almost sealed; girdling root possible
16 ⁴	Hackberry (<i>Celtis occidentalis</i>)	12	Poor: moderate lean and asymmetrical crown towards road; sun scald wound sealing but still 80% open; girdling roots possible
17 ⁴	Norway maple (<i>Acer platanoides</i>)	28	Fair: seam with crack along entire stem; decay in small pruning wounds; girdling roots ~1/4 circumference
