# TREE CONSERVATION REPORT

85 Gemini Way

Tree Conservation Report submitted as Partial  
Requirements for a Site Plan Control Application,  
November 28, 2024

**Date of Report:** November 28, 2024

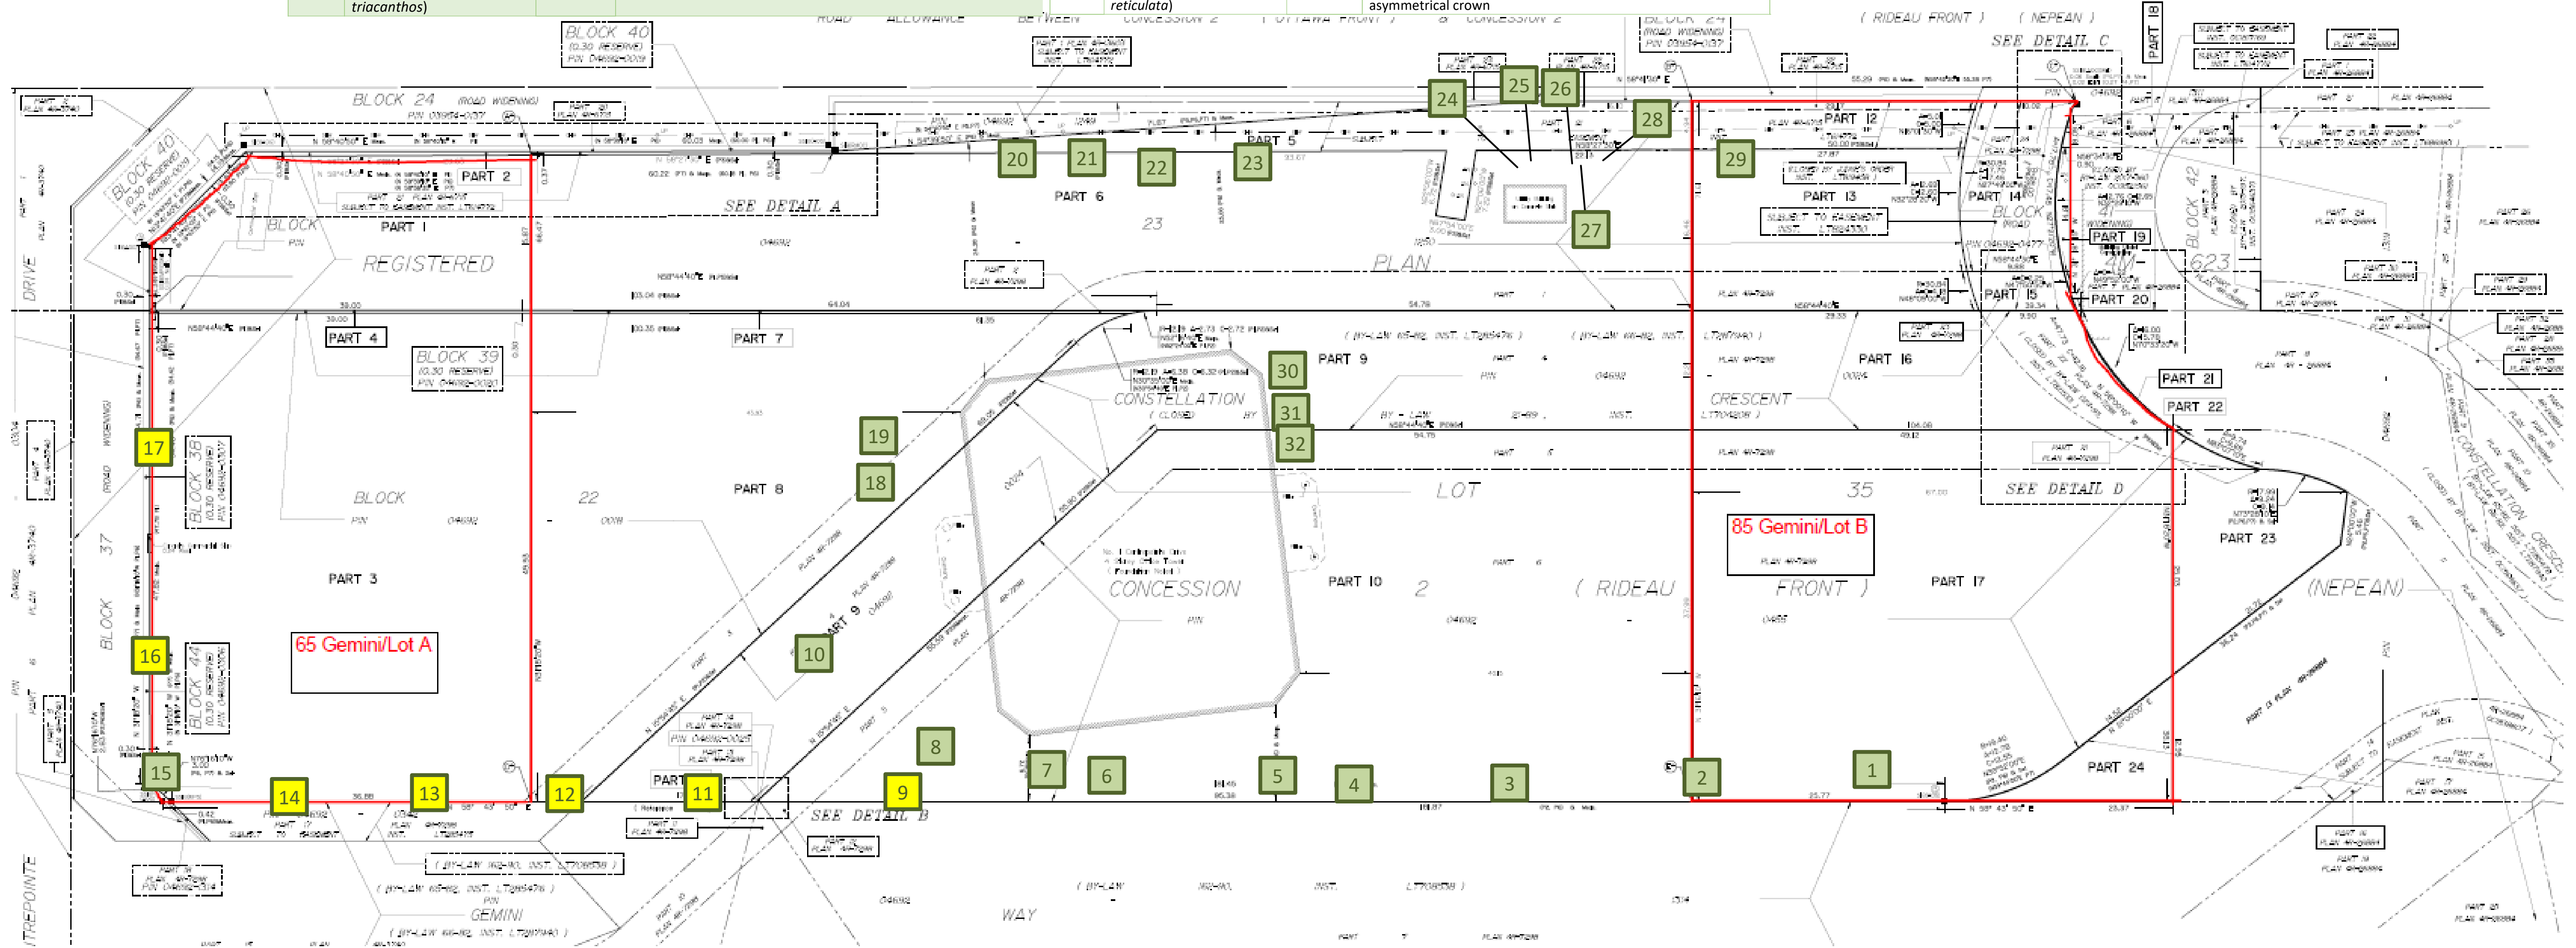
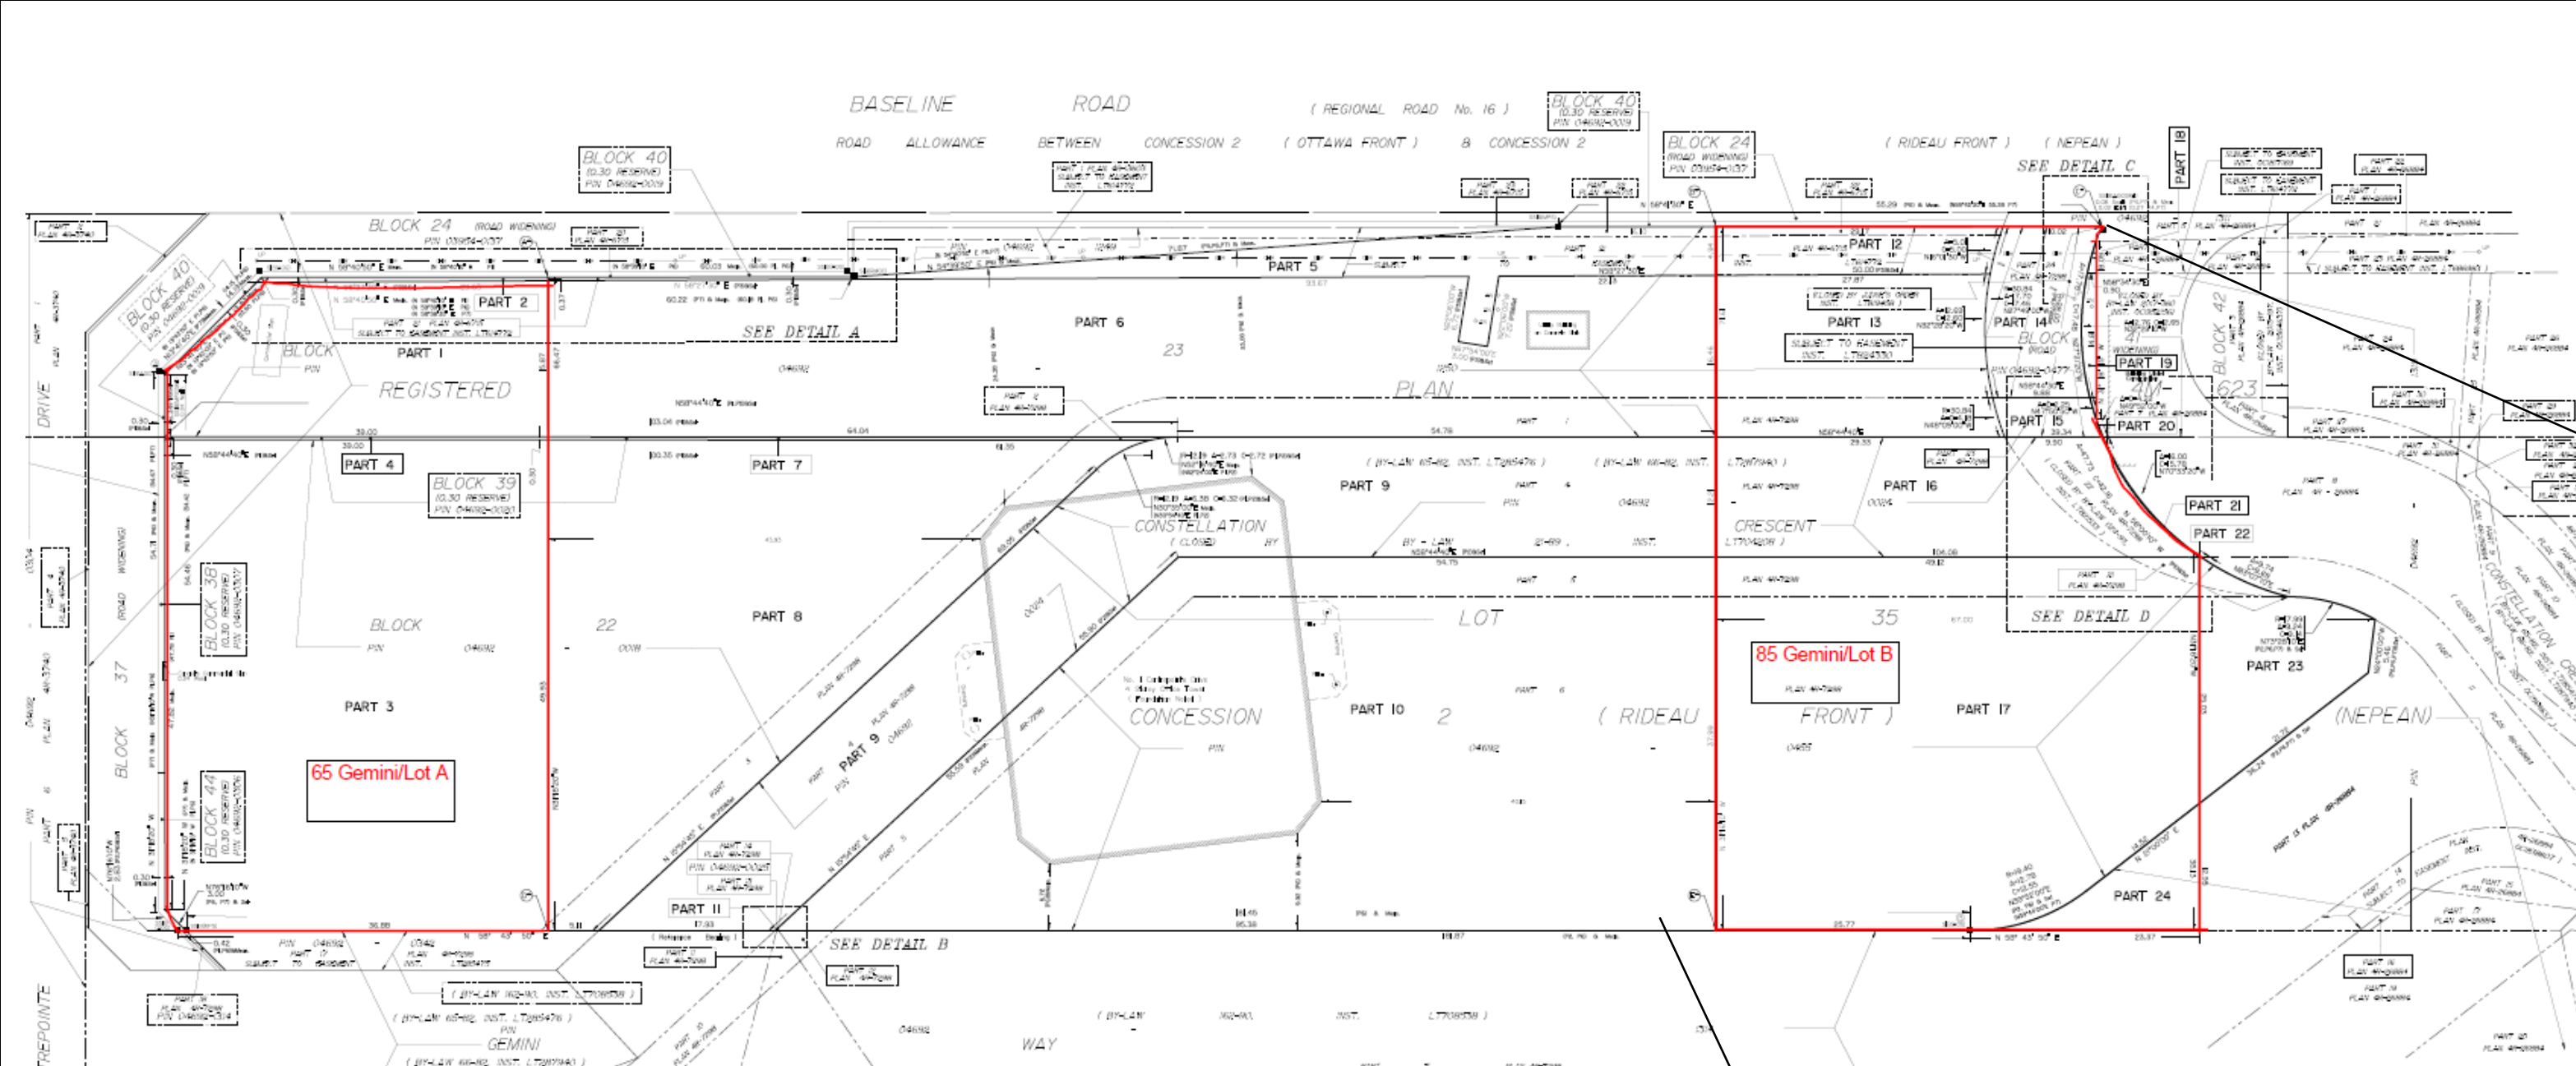
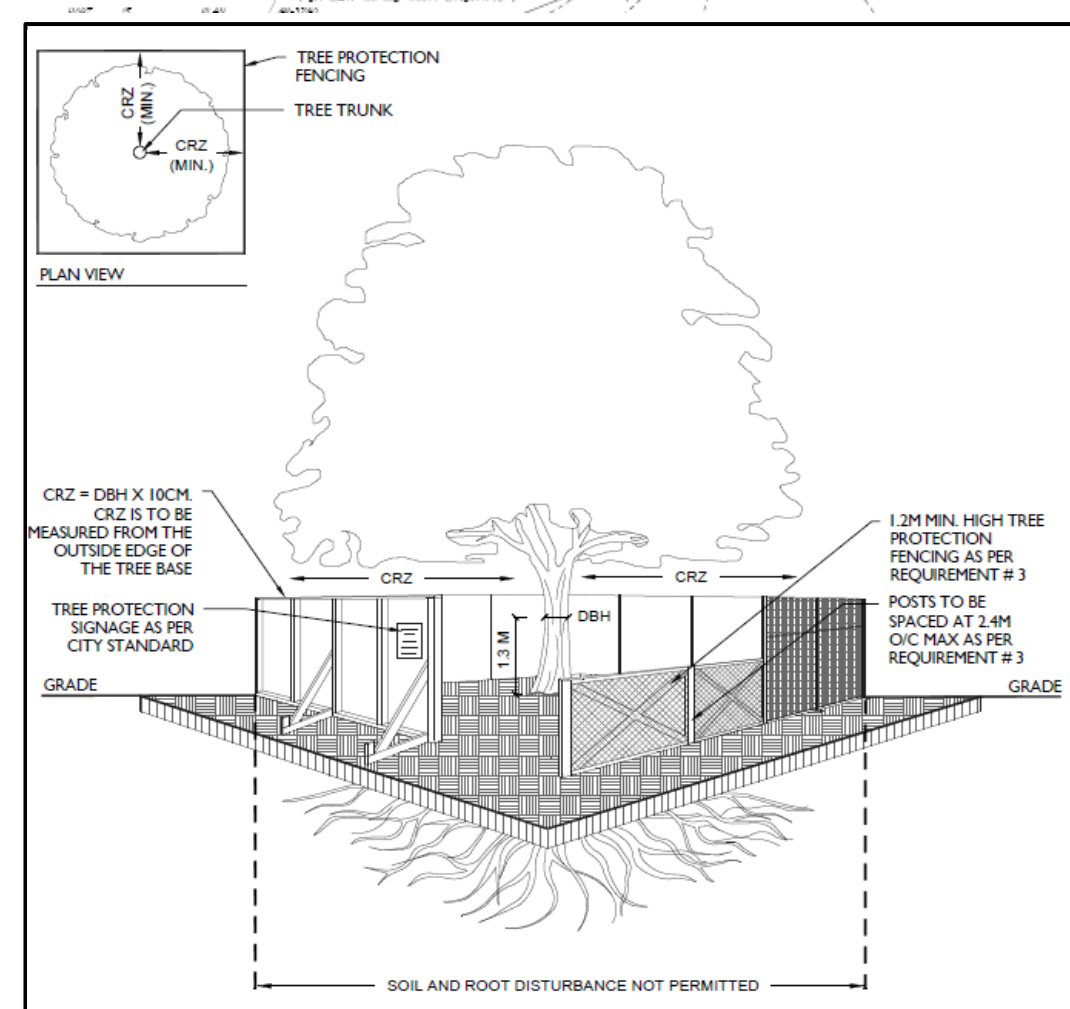
Tree Conservation Replot – 85 Gemini Way  
Map #2 – Proposed Development  
Version 1.0, November 28, 2024  
For more information, please contact [info@dendronforestry.ca](mailto:info@dendronforestry.ca)

The proposed building will include underground parking. The three protected trees in this area of the 1 Centrepointhe property are recommended for removal based on the intensity of excavation required to install the parking and build the tower.

**Tree 3** is an oak in good condition. A Tree Protection Area should be installed to ensure that the tree's rooting space is protected to the greatest extent possible.

1. PRIOR TO ANY WORK ACTIVITY WITHIN THE CRITICAL ROOT ZONE (CRZ = 10 X DIAMETER) OF A TREE, TREE PROTECTION FENCING MUST BE INSTALLED SURROUNDING THE CRITICAL ROOT ZONE, AND REMAIN IN PLACE UNTIL THE WORK IS COMPLETE.
