Report

Trail Road Battery Energy Storage System (BESS)
Fluvial Geomorphology Assessment

H375035-0000-2B0-066-0001

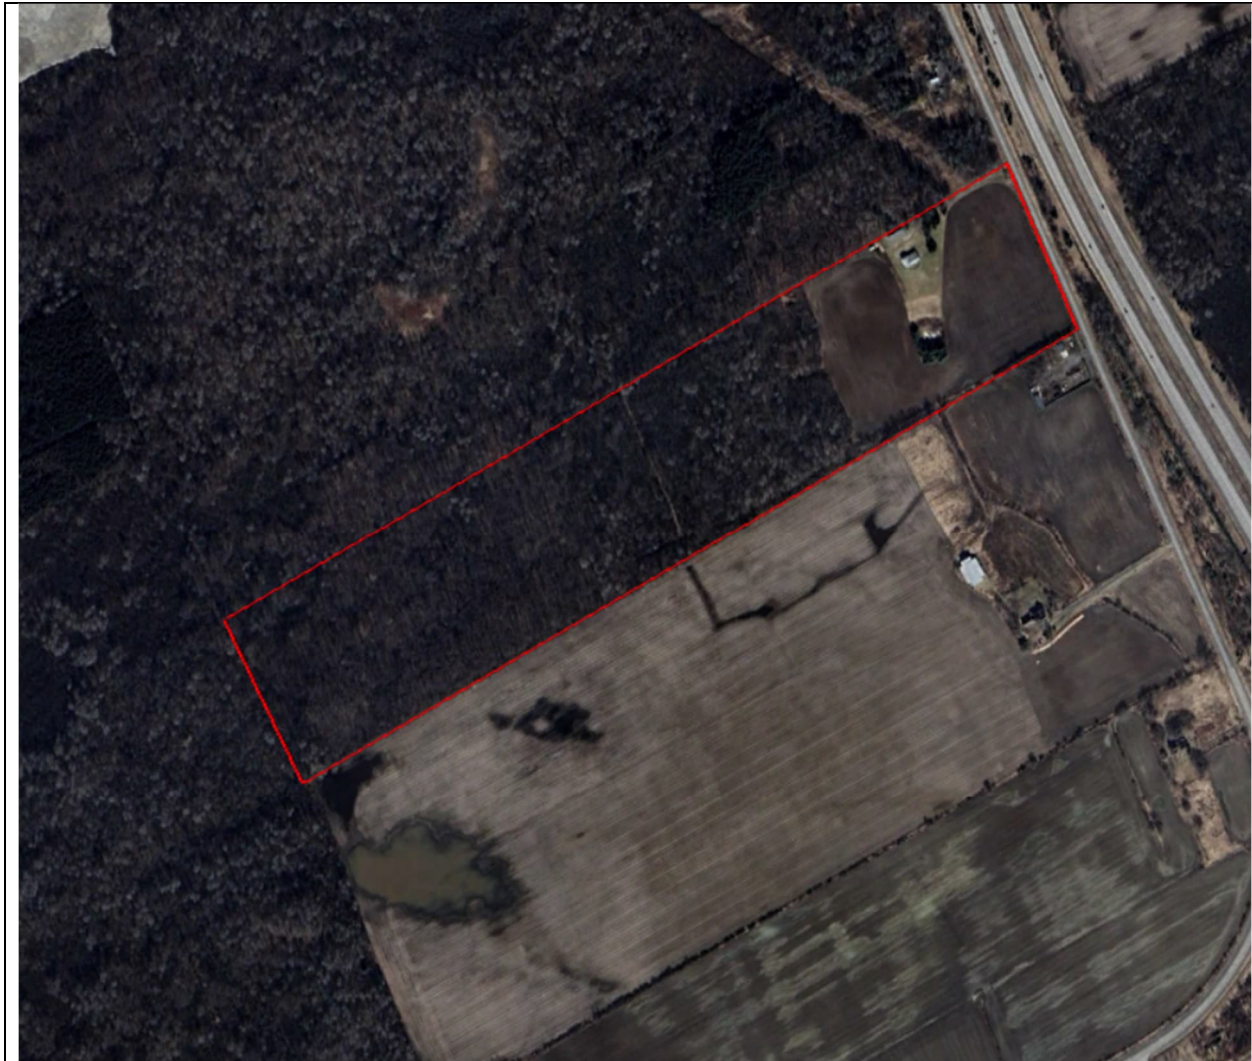
Location: Ottawa, ON
Year: 2024
Scale: 1:14,000
Source: Google Earth Pro
Red Boundary: Site Limits

By 2020, the constructed banks are no longer visible, and the condition of the Creek continues to degrade through to 2024. In general, the Creek within the Project site follows a straight alignment; however, no visible changes to the planform of the tributary are observable in all aerial imagery due to tree cover.

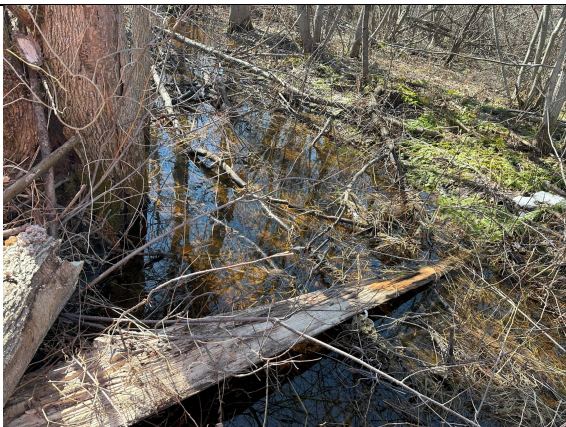
Photo 3: View looking southeast (downstream) at location S1 (Figure 3-1) on April 7, 2025.

At the north boundary of the Project site, along the property line shared with the adjacent parcel, stagnant water was observed accumulating in a depressed corridor perpendicular to the main Creek alignment as shown in Photo 2 (Appendix B) from location S1. The presence of standing water outside the defined channel zone may also suggest the existence of secondary flow paths or backwater effects during wet periods, although no defined channel is visible in this area.
