STAGE II CULTURAL HERITAGE IMPACT STATEMENT & CONSERVATION PLAN

145 Loretta Avenue & 951 Gladstone Avenue,
Ottawa, Ontario

PREPARED BY: COMMONWEALTH HISTORIC RESOURCE MANAGEMENT

Revision V5 October 2022

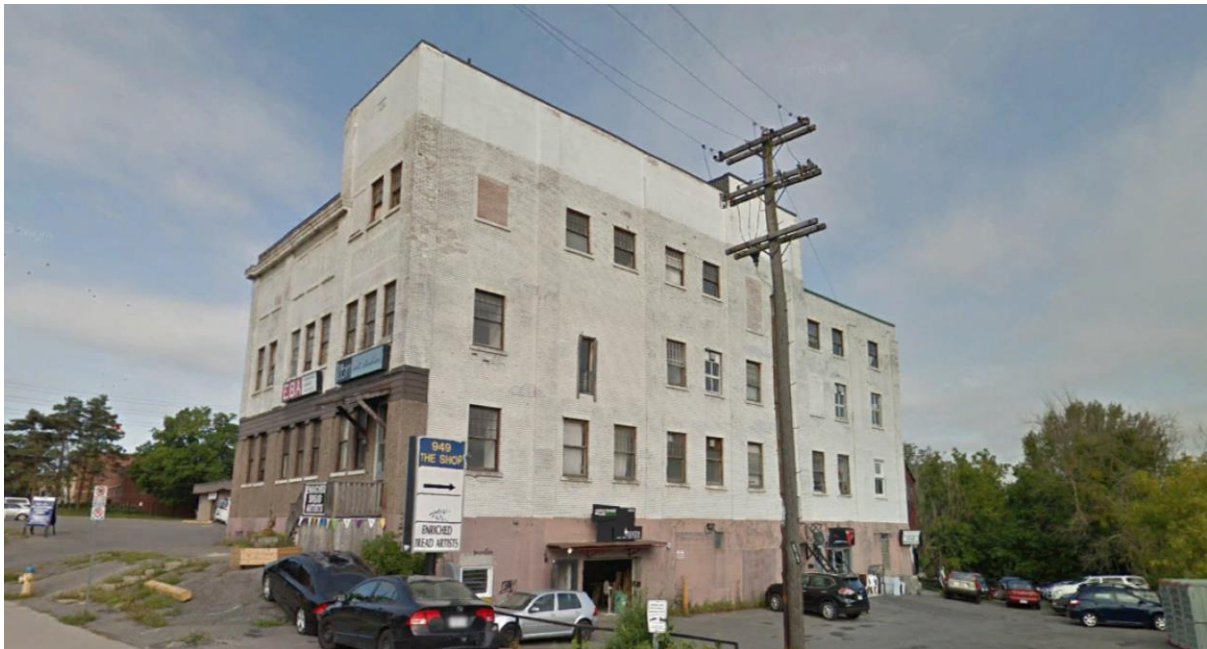
Figure 3: View looking west along Gladstone to the development site. Note the fenestration pattern on the east elevation (left) which characterizes its light industrial use with doors occurring on the second and third-floor levels and the location of an internal hoist to move material between floor levels. Source: Google Earth.

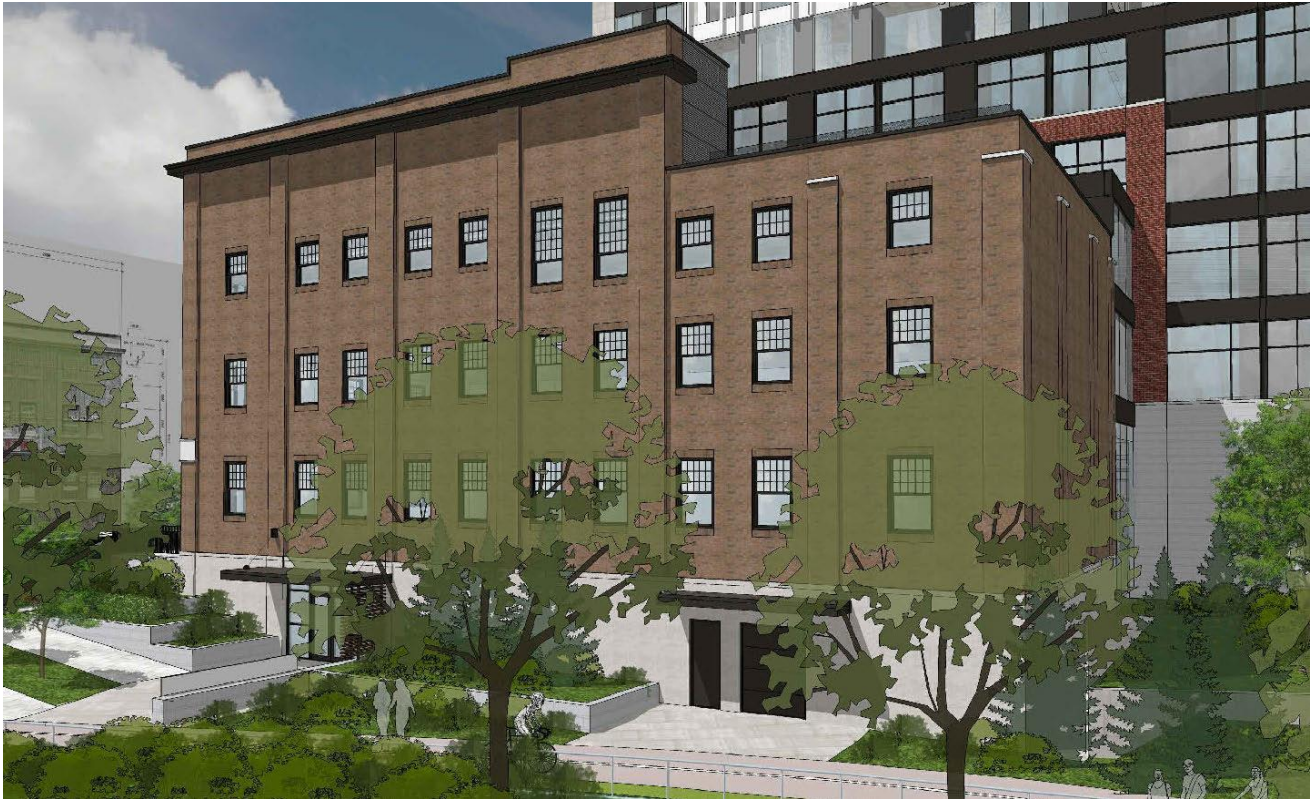
Figure 19: Rendered perspective view of the east elevation of the Standard Bread Building with the multi-use path system in the foreground. The fenestration pattern provides reference to the original openings, a number of which have been bricked in and will be opened up. The documented fenestration pattern will be retained. Source: Hobin Architecture 2022.

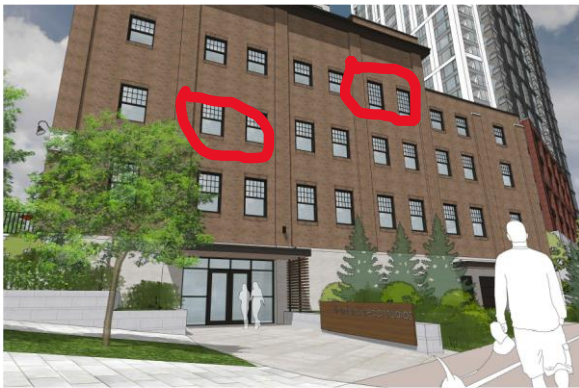
Figure 24 and 25: The fenestration along the east facade follows the profile of the original building as the as-found drawing below illustrates. Highlighted in red are proposed windows replacing doors and the introduction of new windows that were not originally part of the façade.

The large industrial openings have been retained with the stucco treatment on the lower level.

Because of the type of brick and the difficulty in removing paint the brick will be painted again. The red-brown colour of the original brick will replace the white.

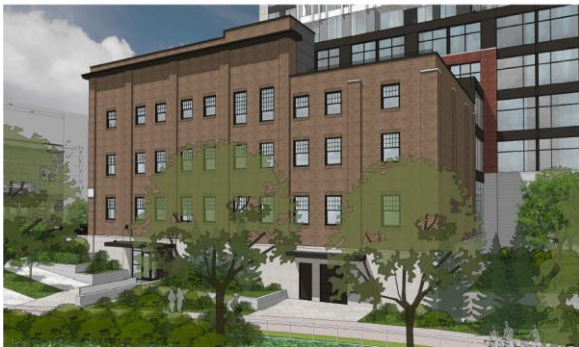
Figure 26: As-Found recording of the east and west elevation illustrating the configuration of windows and openings will provide a guide to the rehabilitation. The two areas highlighted in red are areas that the window configuration is proposed to be changed. Source: Hobin Architecture 2021.

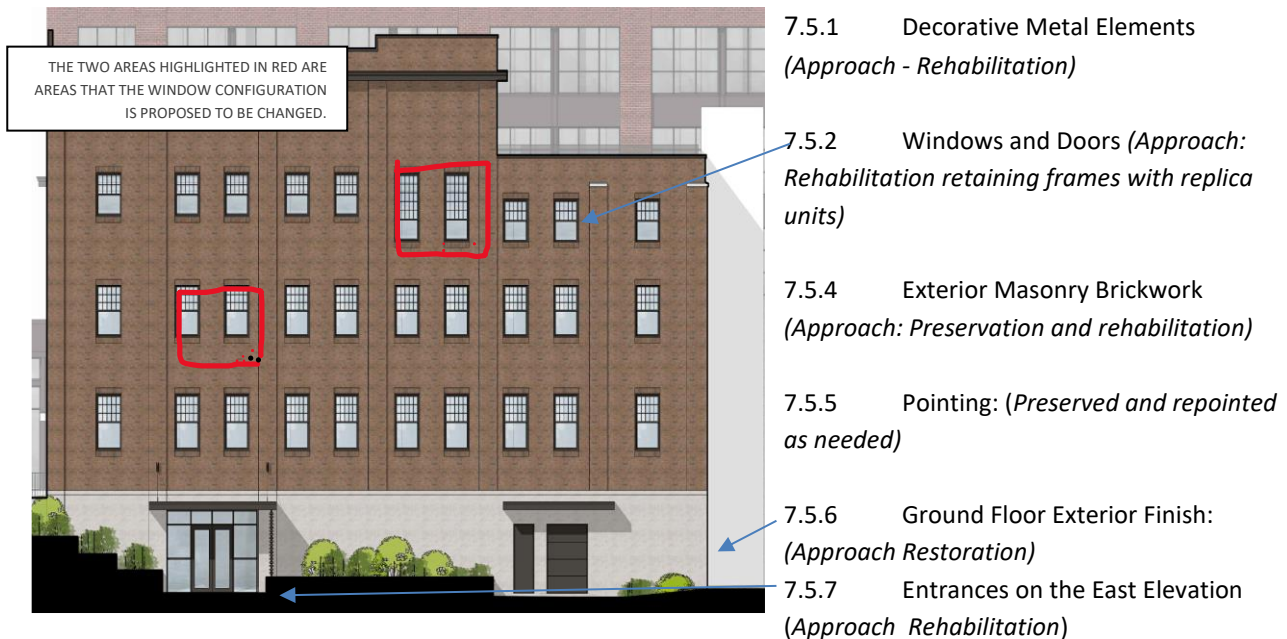
East Elevation

The fenestration pattern on the east elevation overlooking the rail corridor is noted to be a character-defining feature reflecting its industrial use adjacent to a railway siding when constructed in 1924. The existing fenestration pattern will be retained including doors, and windows. At present the drawings illustrate the replacement of doors on the third floor with windows and the introduction of windows that are not original. These are noted on Figure 26.

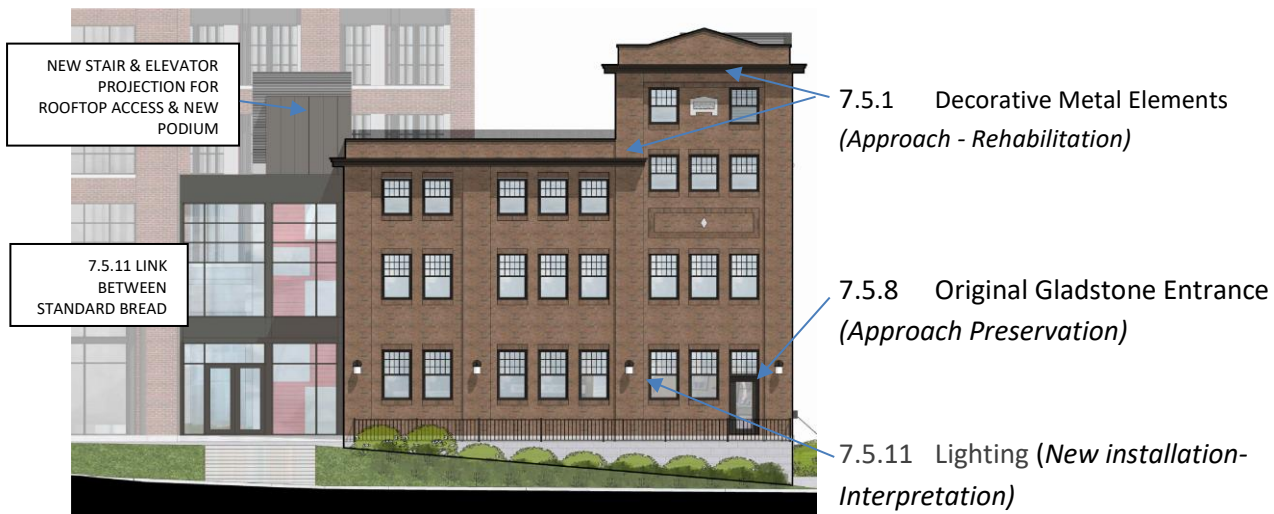
Commonwealth undertook an inspection of the exterior masonry in December 2020 to document the condition of the exterior walls including the windows, decorative metal elements, brickwork, concrete, pointing, and to determine the materials applied to the ground floor of the main façade. The information supplements the condition report prepared by John Cooke (see Appendix A). The inspection was limited to the ground floor and second floor walls on the north and west facades of the building which were accessed from a fire exit to the roof of the single storey wing. Specific attributes are referenced on the East and South Elevations and described below.

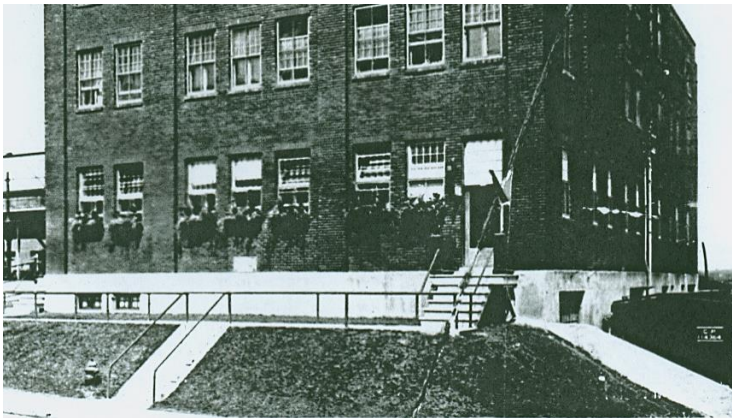
Figure 33: The 1930 view of the front entrance with a stairway leading from Gladstone and an entrance on the right-hand side of the building are defining features.

The design of the landscaping / streetscape in front of the Standard Bread building on Gladstone Street and its interface with the building has been developed based on historic photographs that document the location of the main entrance to the building as a character-defining feature. The historic entrance is interpreted from the street with stairs leading to the linked entrance from the public sidewalk.

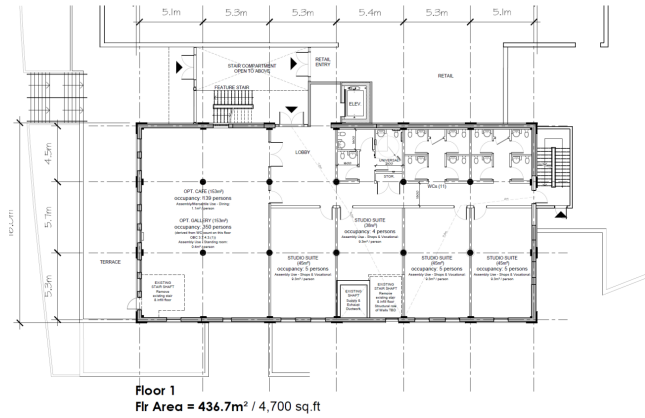
Figure 36: Ground floor plan illustrating the mushroom columns establishing the grid pattern.

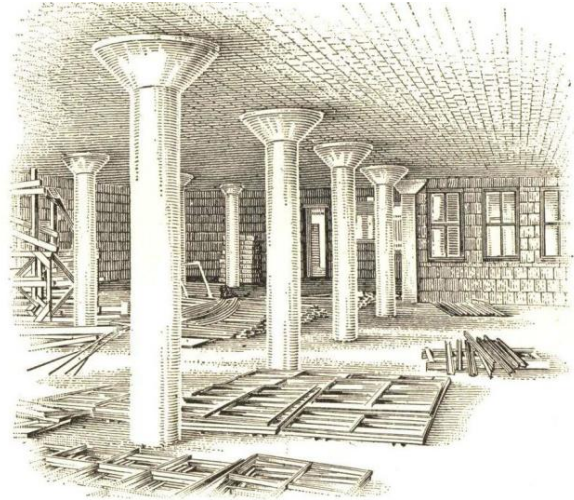
FIG. 63

Figure 37: Concrete Mushroom Columns are a character defining feature. Source: Fig. 63 illustration from *Plain and Reinforced Concrete Construction*.

The Standard Bread Building is being retained in-situ except for the one- storey wing on the north side of the building where the ovens were located. The existing reinforced concrete frame, including columns, beams, floor, and roof structures on the 3 and 4 storey portions of the building will be retained; the interior columns are one of the building’s character- defining features as well as the exterior wall assemblies, including terra cotta back-up walls and the brick veneer all of which are being conserved.
