VIDEO CAMERA INSPECTION REPORTS

REDLINE ARCHITECTURE INC.

**116 – 118 CARRUTHERS AVENUE
LYNDALE - STONEHURST
OTTAWA**

**SANITARY
APRIL 6, 2026
AQ-4841A**

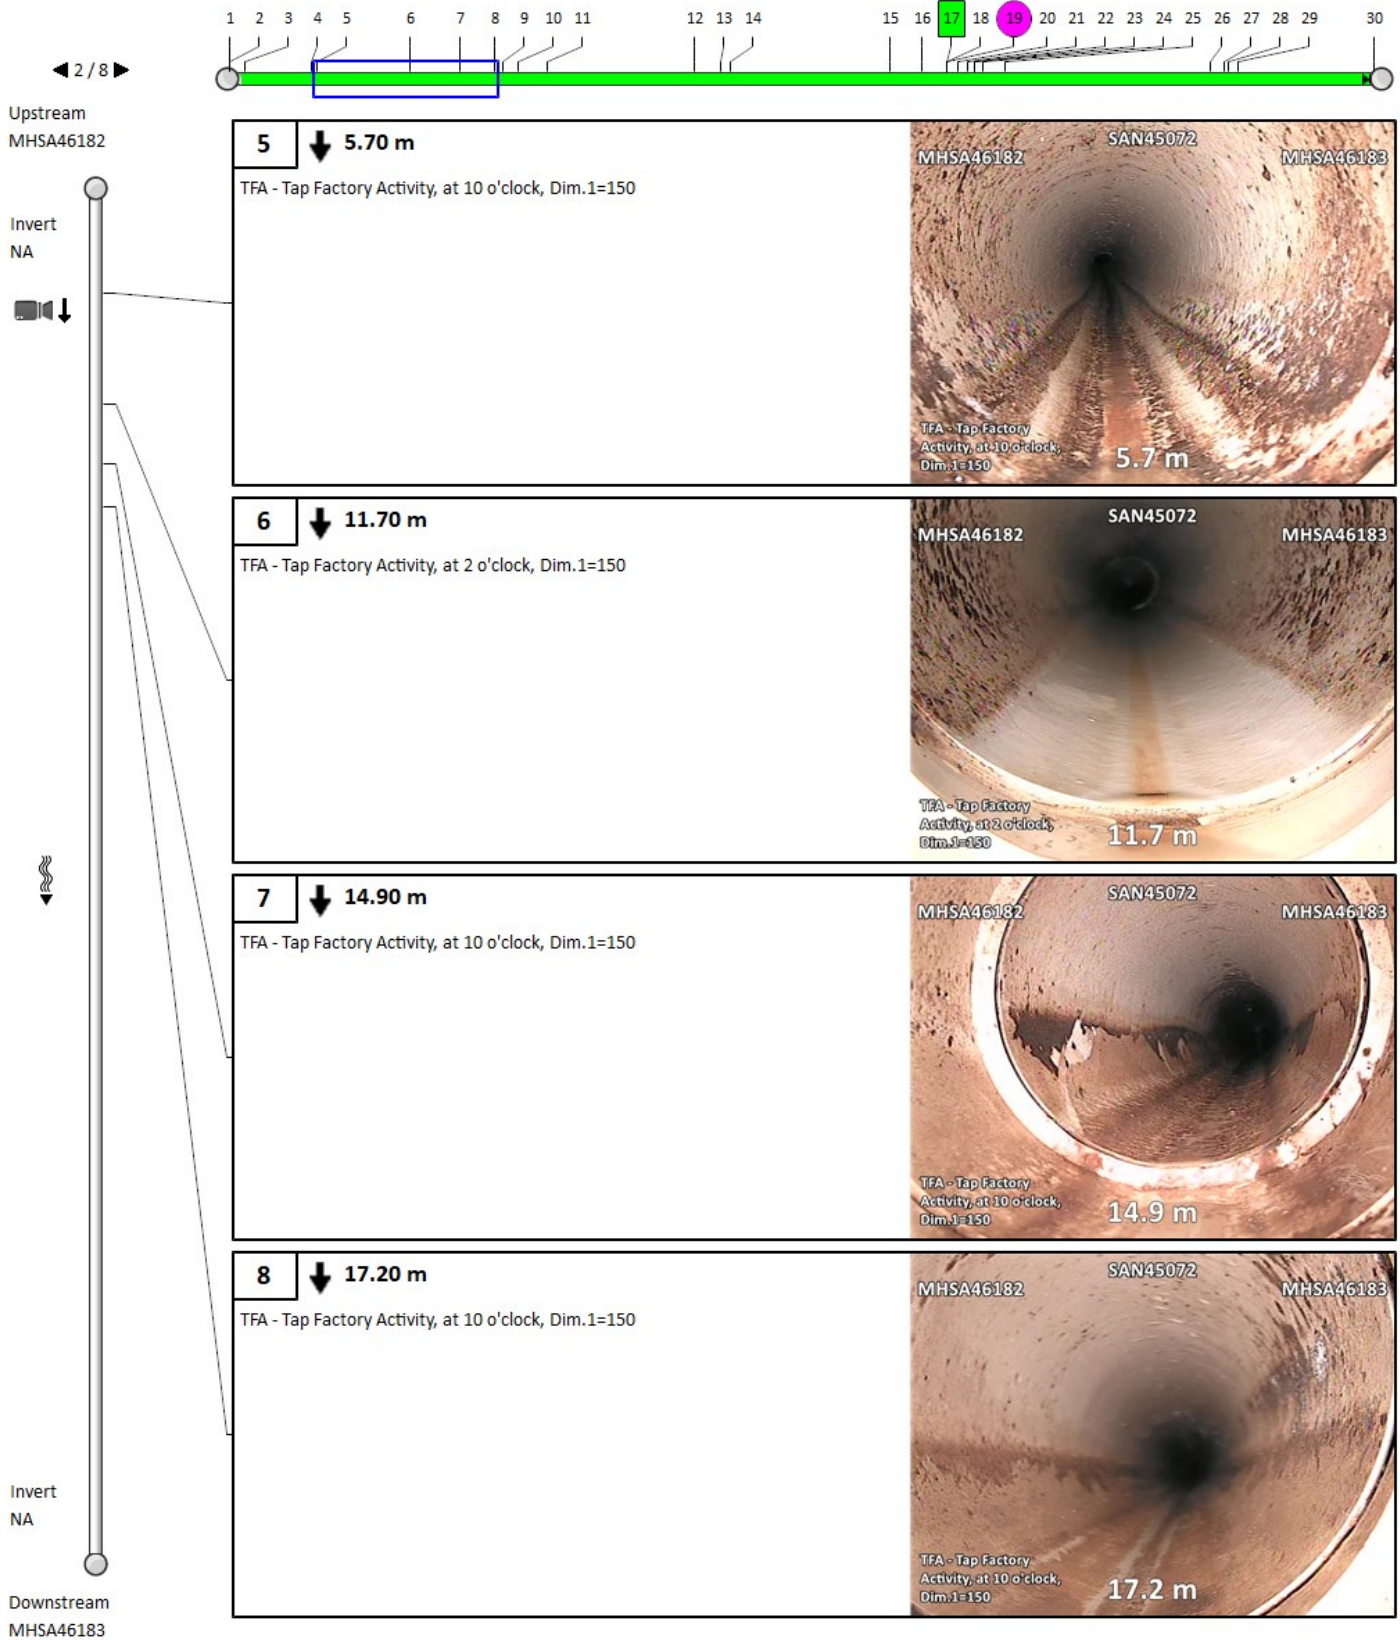
5 ↓ **5.70 m**

TFA - Tap Factory Activity, at 10 o'clock, Dim.1=150

6 ↓ **11.70 m**

TFA - Tap Factory Activity, at 2 o'clock, Dim.1=150

7 ↓ **14.90 m**

8 ↓ **17.20 m**
