VIDEO CAMERA INSPECTION REPORTS

**116 – 118 CARRUTHERS AVENUE
LYNDALE - STONEHURST
OTTAWA**

PRE CONSTRUCTION

**STORM
APRIL 6, 2026
AQ-4841B**

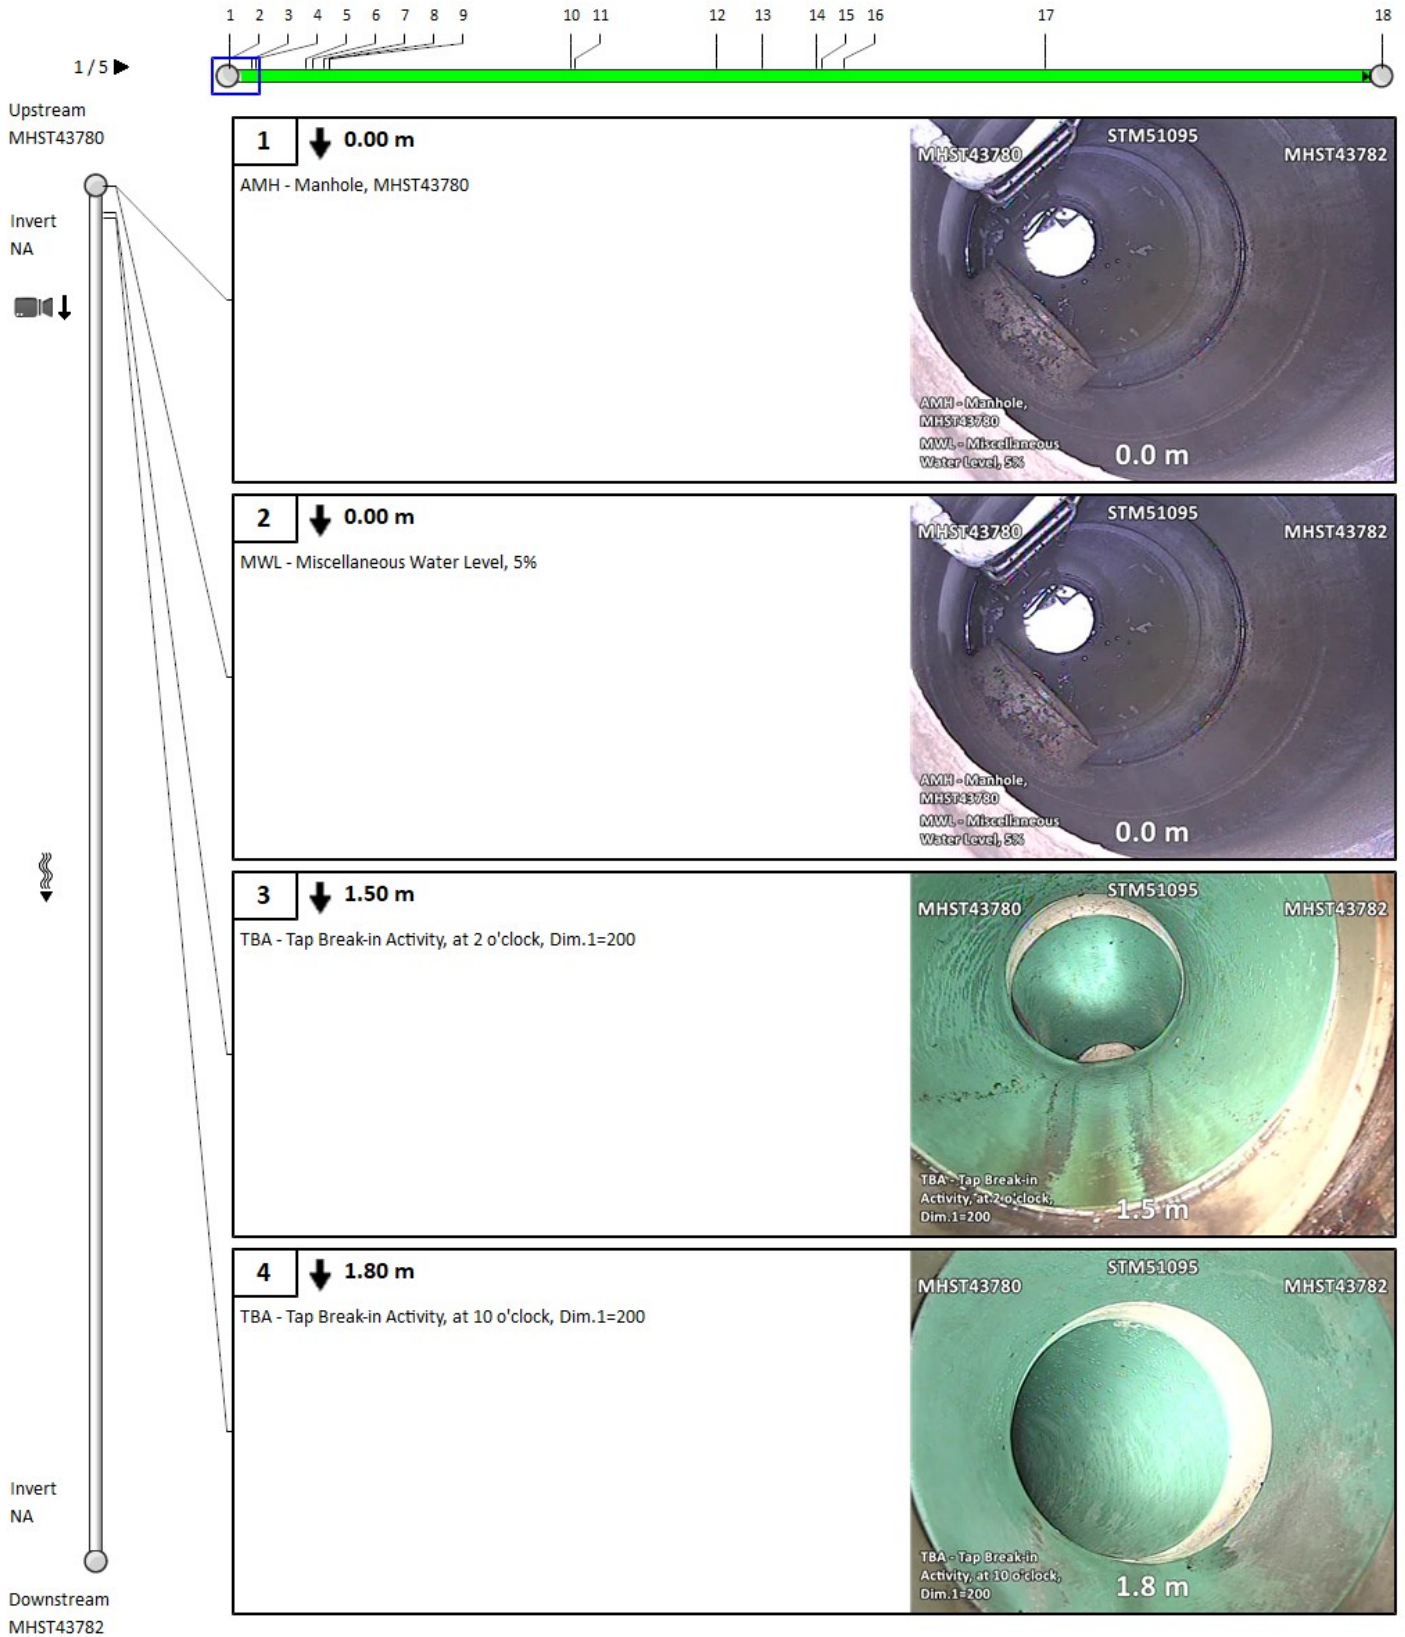
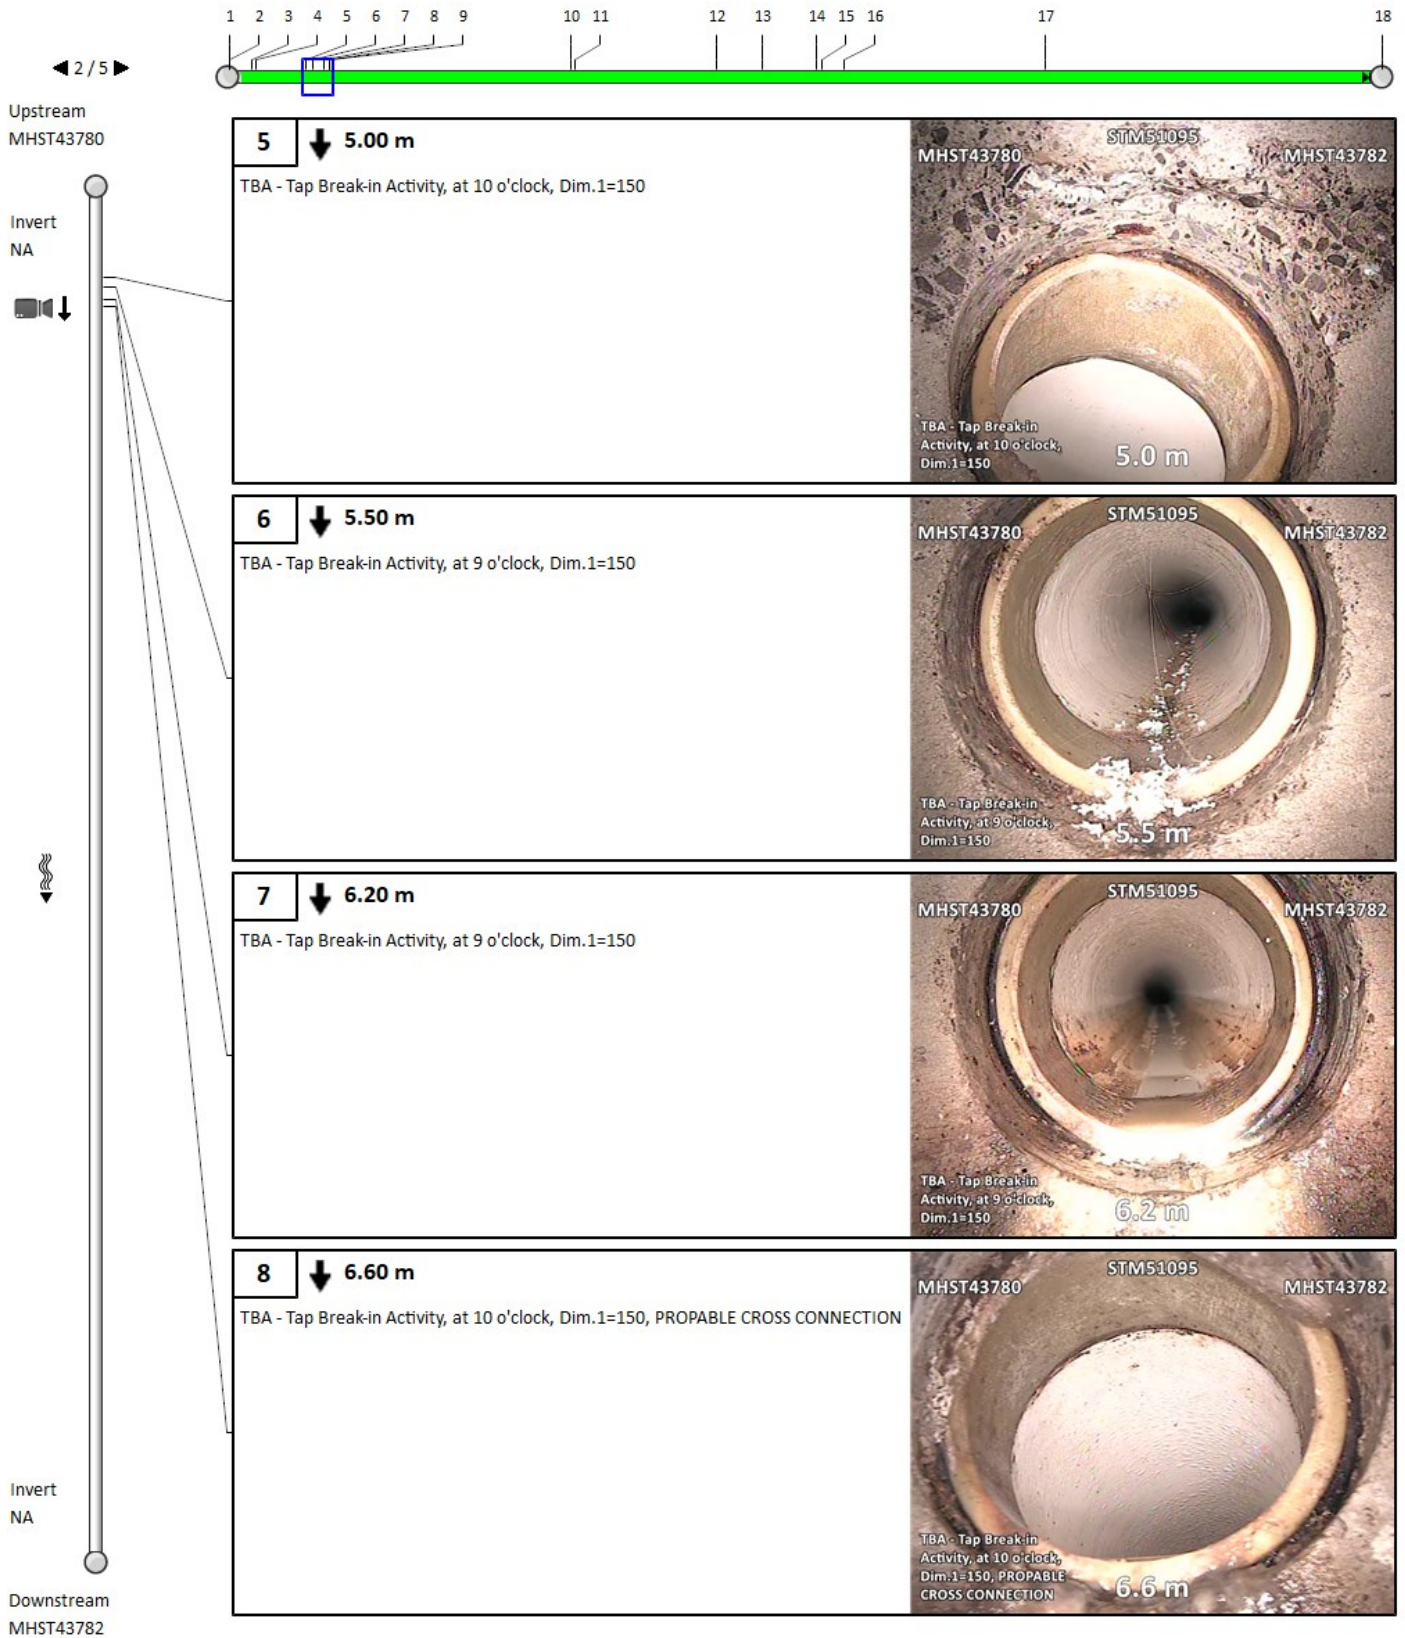
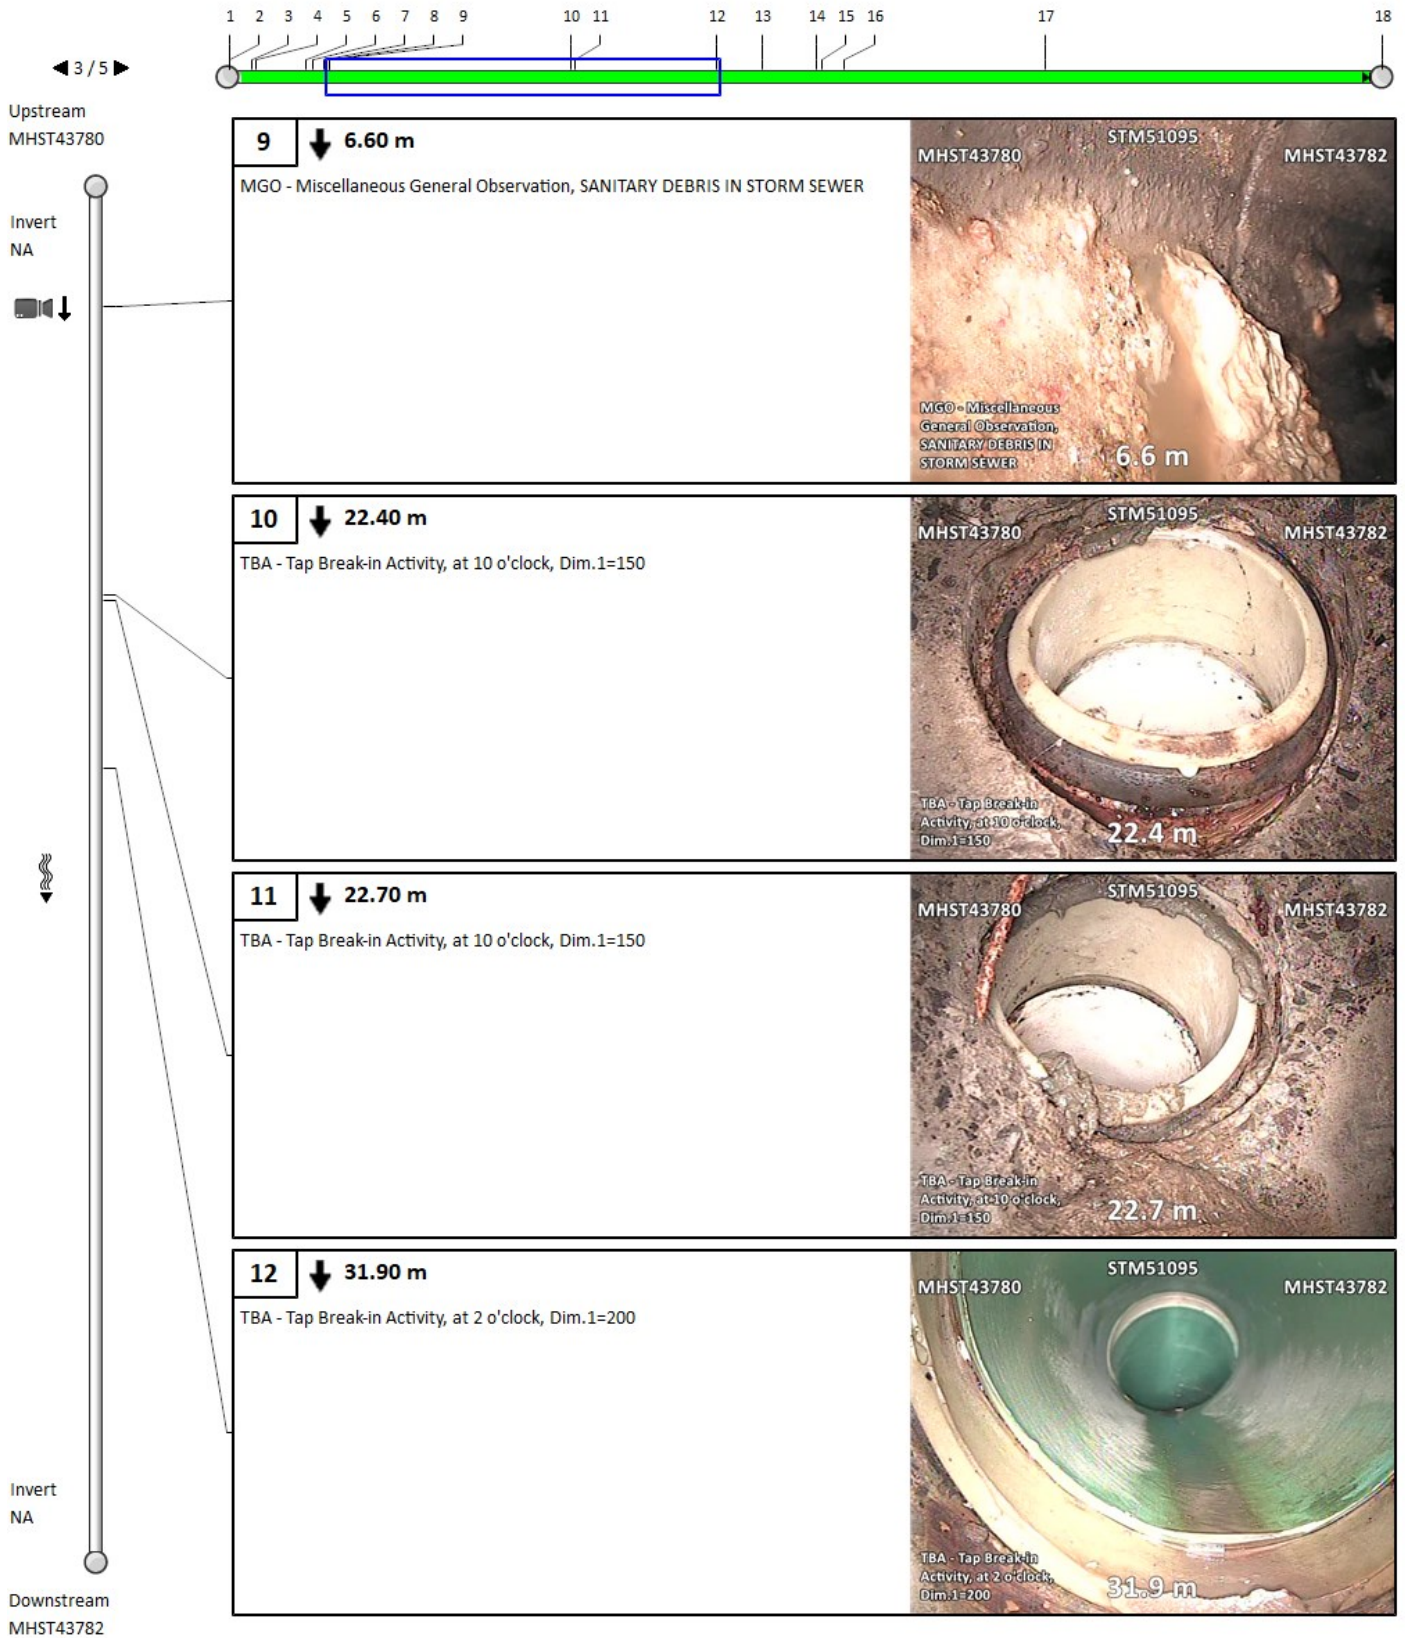
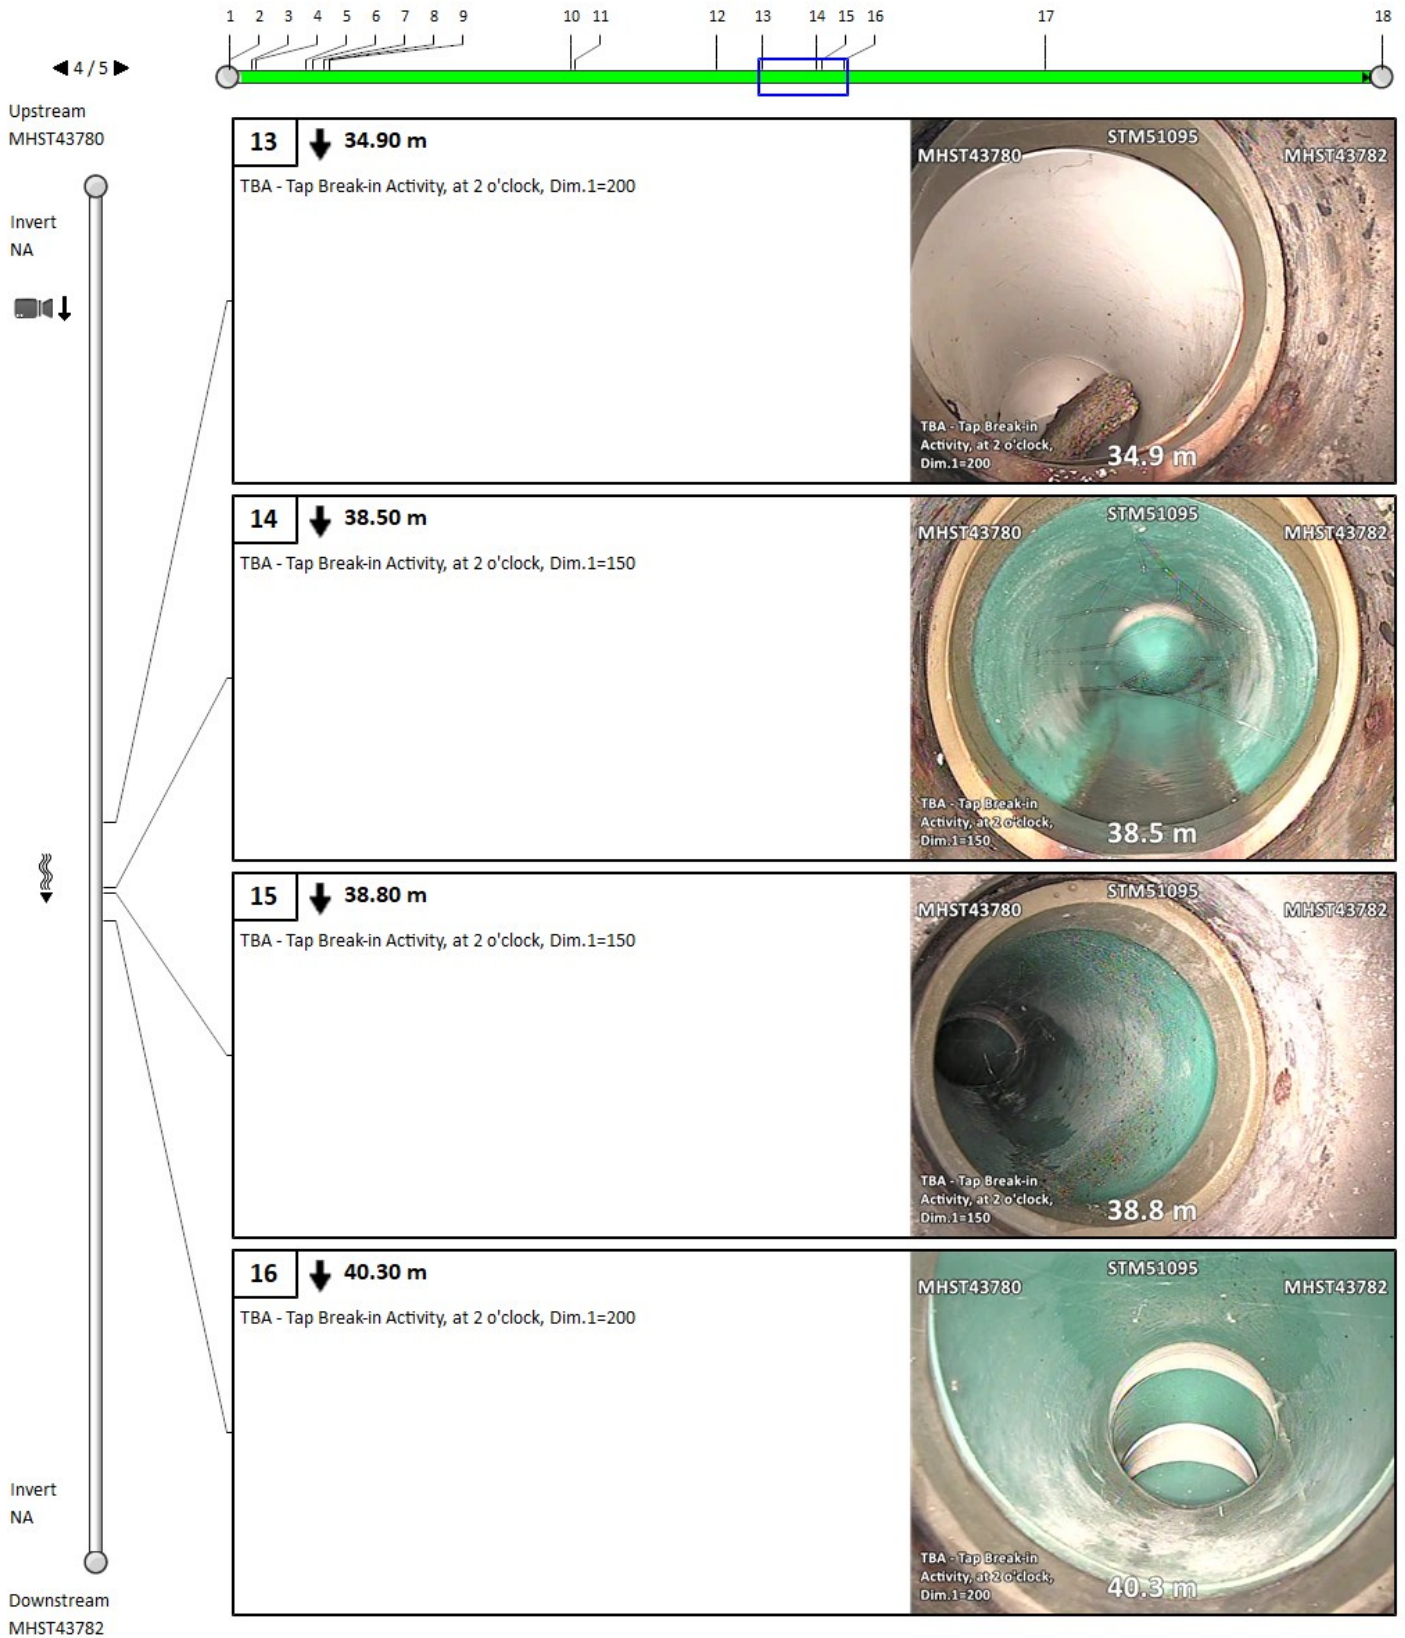
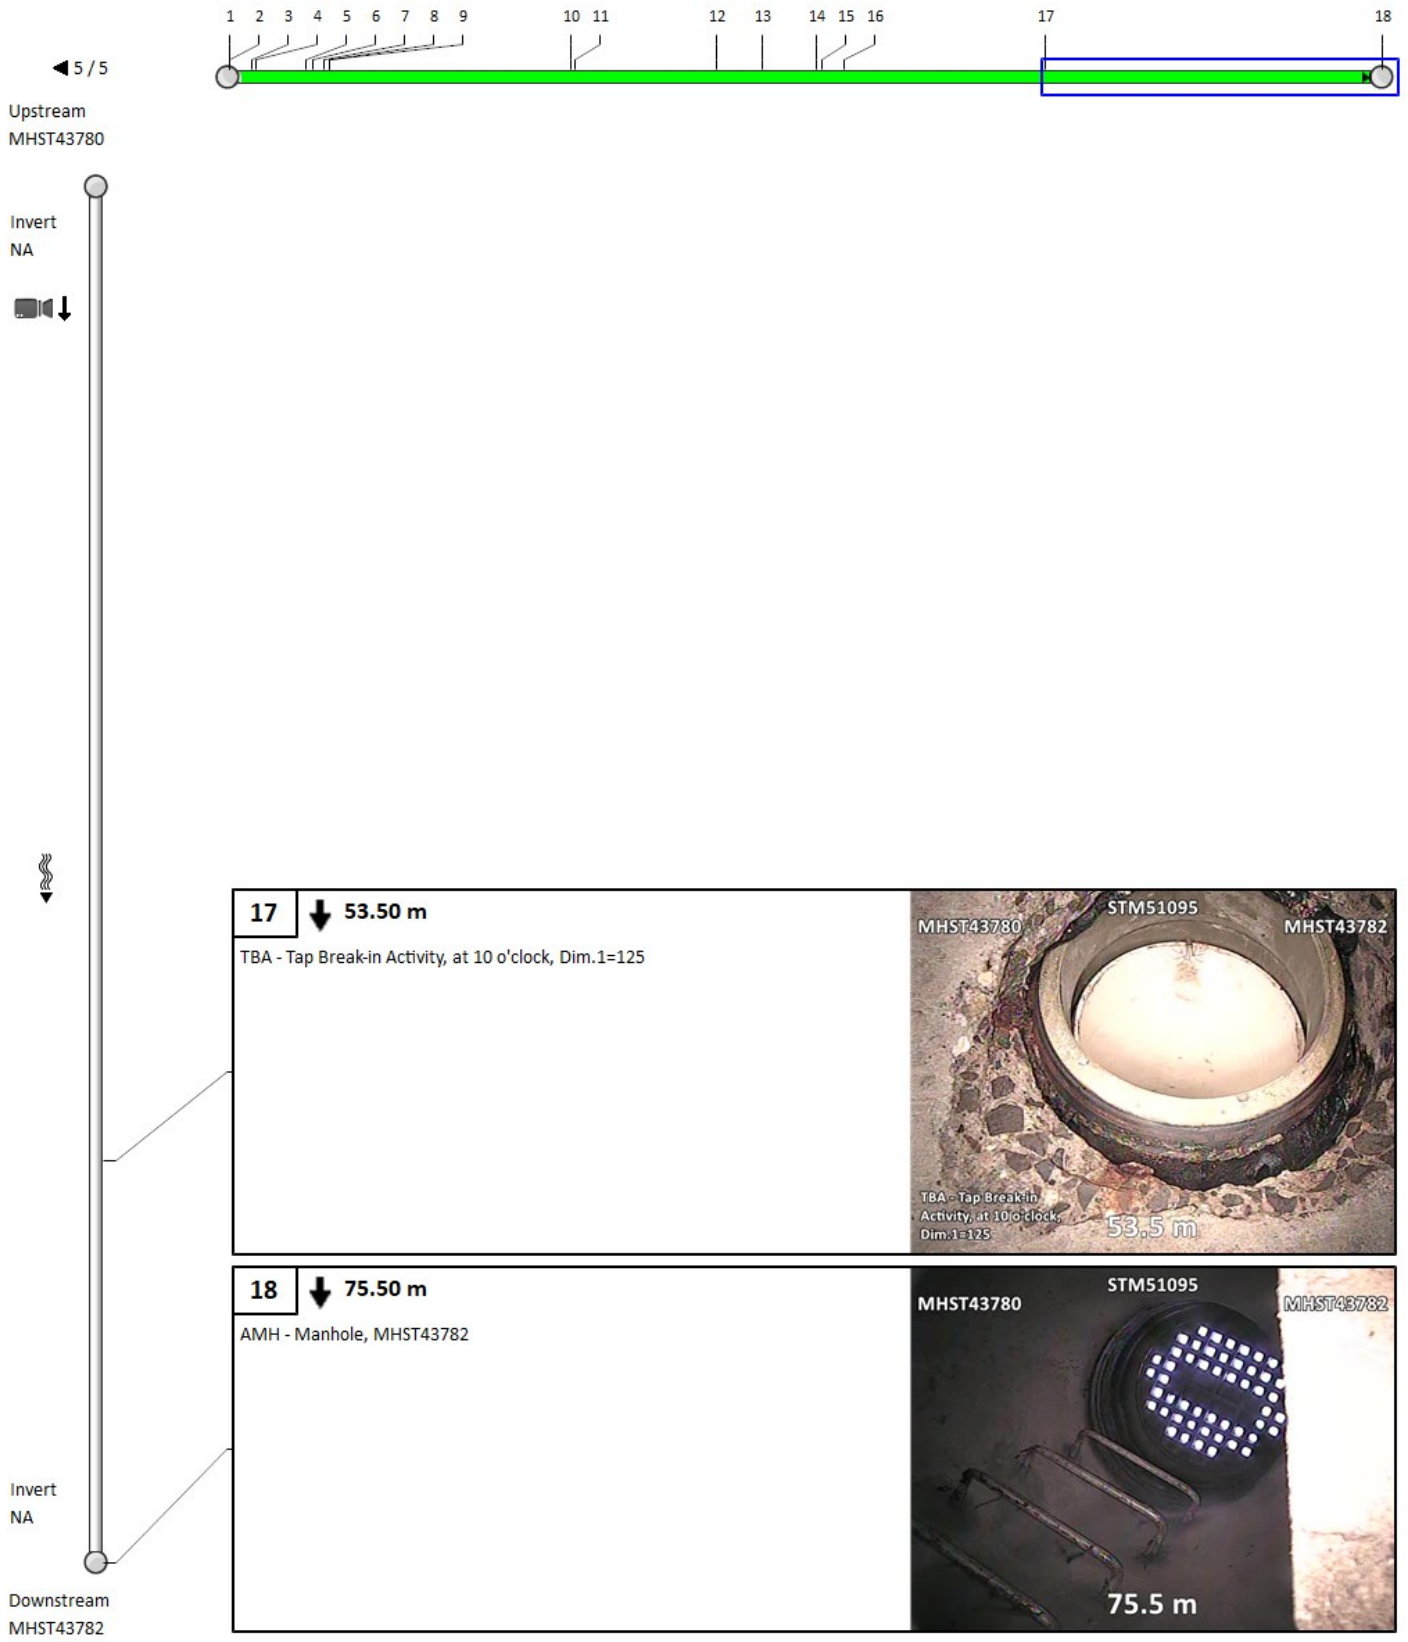
Pipe: STM51095
Direction of flow: MHST43780 --> MHST43782
Direction of inspection: Downstream

Structural rating		O&M rating		Overall rating		Failure	
Peak:	0	Peak:	0	Peak:	0	Consequence:	
Quick rating:	0000	Quick rating:	0000	Quick rating:	0000	Likelihood:	1.000
Score:	0	Score:	0	Score:	0	Risk:	
Index:	0.000	Index:	0.000	Index:	0.000
