## **Geotechnical Investigation and Slope Stability Assessment**

Final (3rd Revision)

Proposed Humanics Sanctuary and Sculpture Park  
3400 Old Montreal Road  
Part of Lot 7, Concession 1, Old Survey  
Ottawa (Formerly Township of Cumberland), Ontario

OTT-00229886-A0

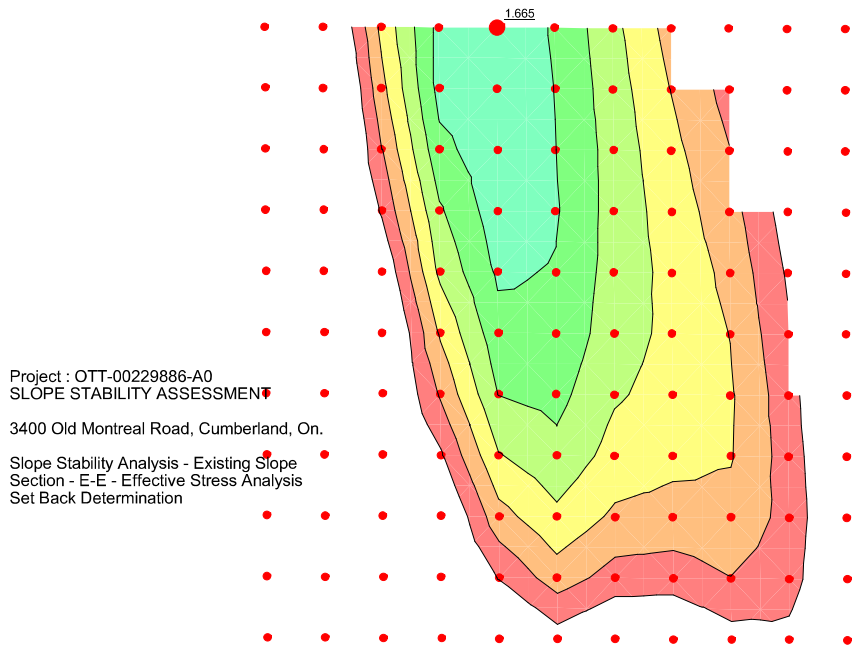
Figure 28

Project : OTT-00229886-A0  
 SLOPE STABILITY ASSESSMENT  
 3400 Old Montreal Road, Cumberland, On.  
 Slope Stability Analysis - Existing Slope  
 Section - E-E - Effective Stress Analysis  
 Set Back Determination

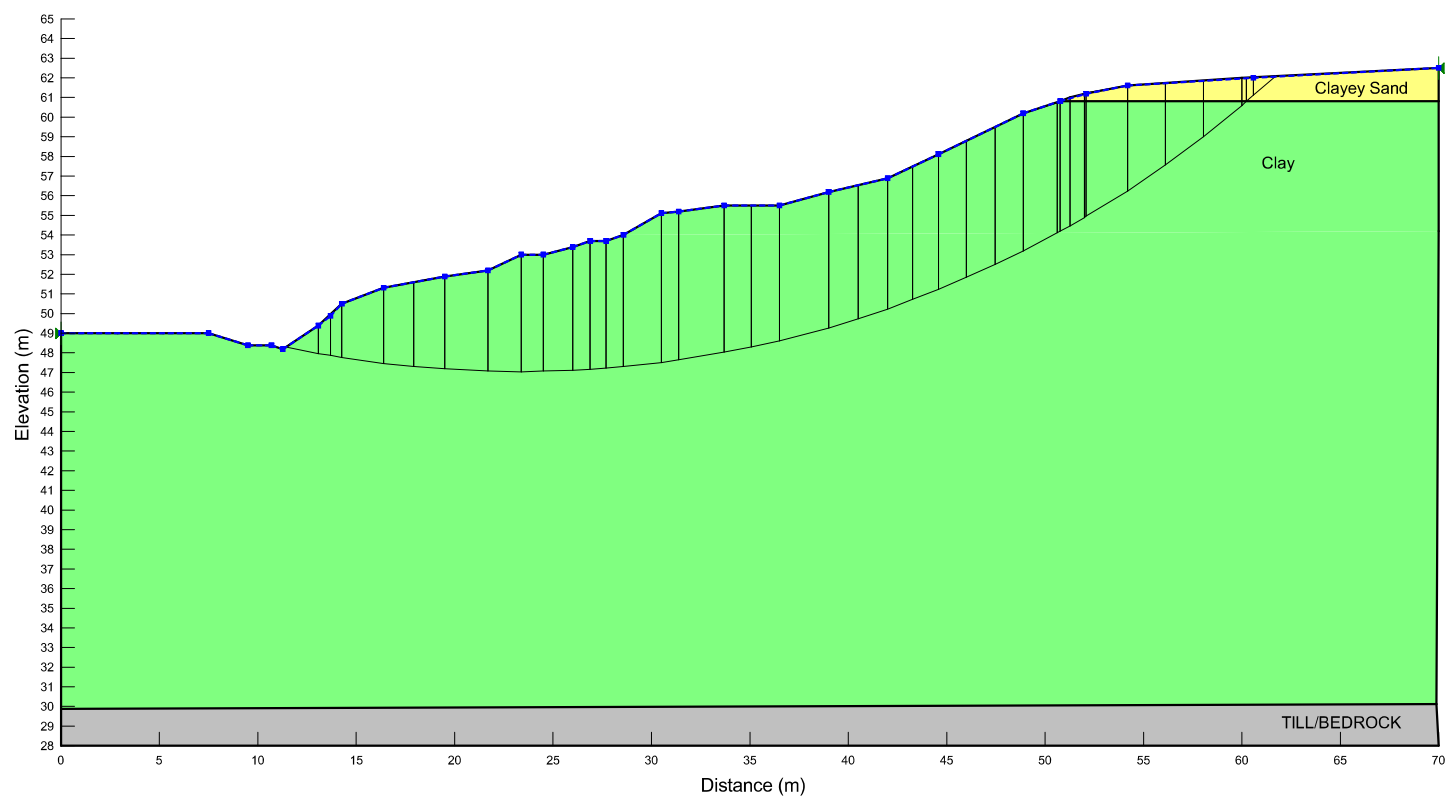
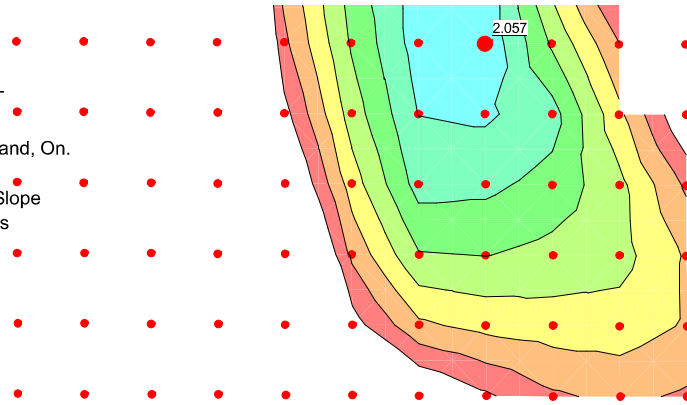
Figure 29

Slope Stability Analysis - Existing Slope  
 Section -E-E - Total Stress Analysis

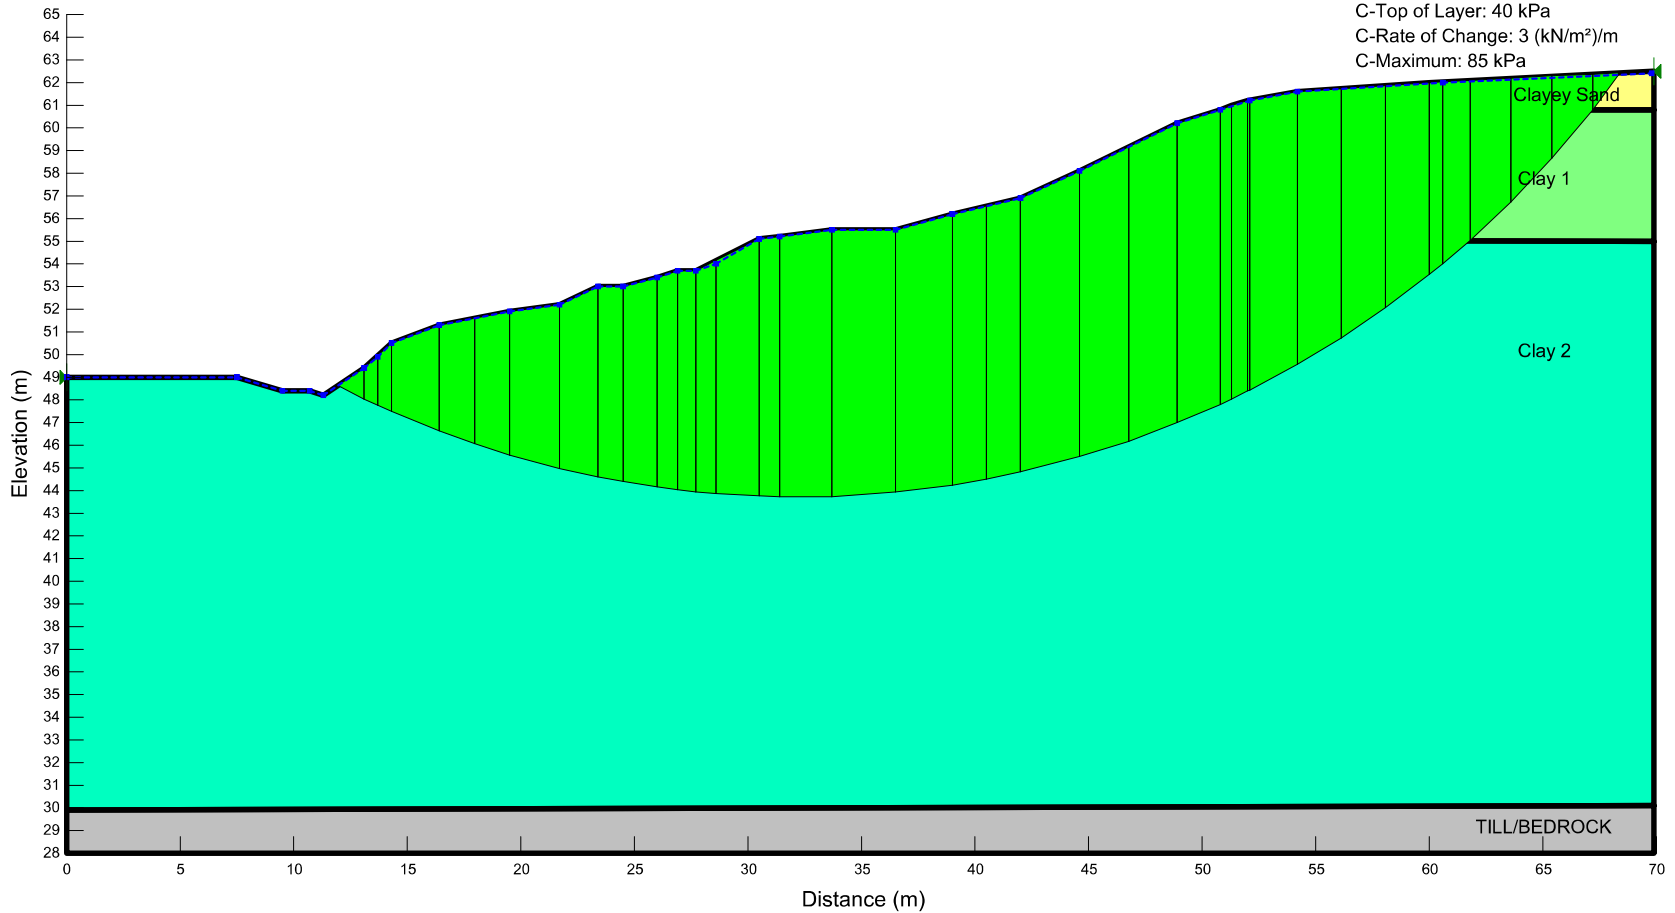
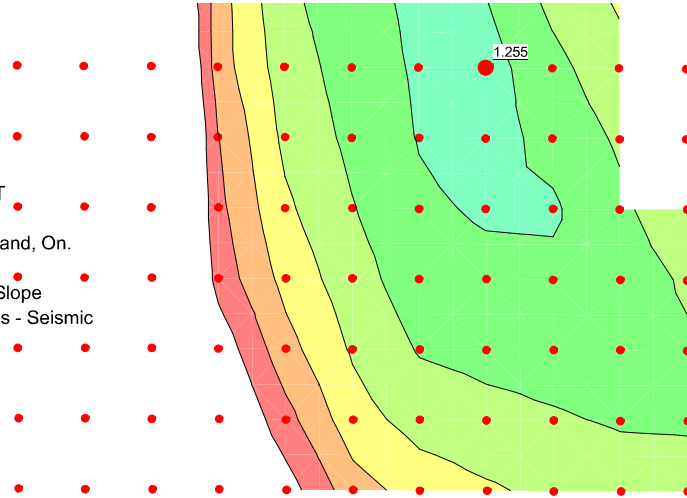
Figure 30

Slope Stability Analysis - Existing Slope  
 Section -E-E - Total Stress Analysis - Seismic

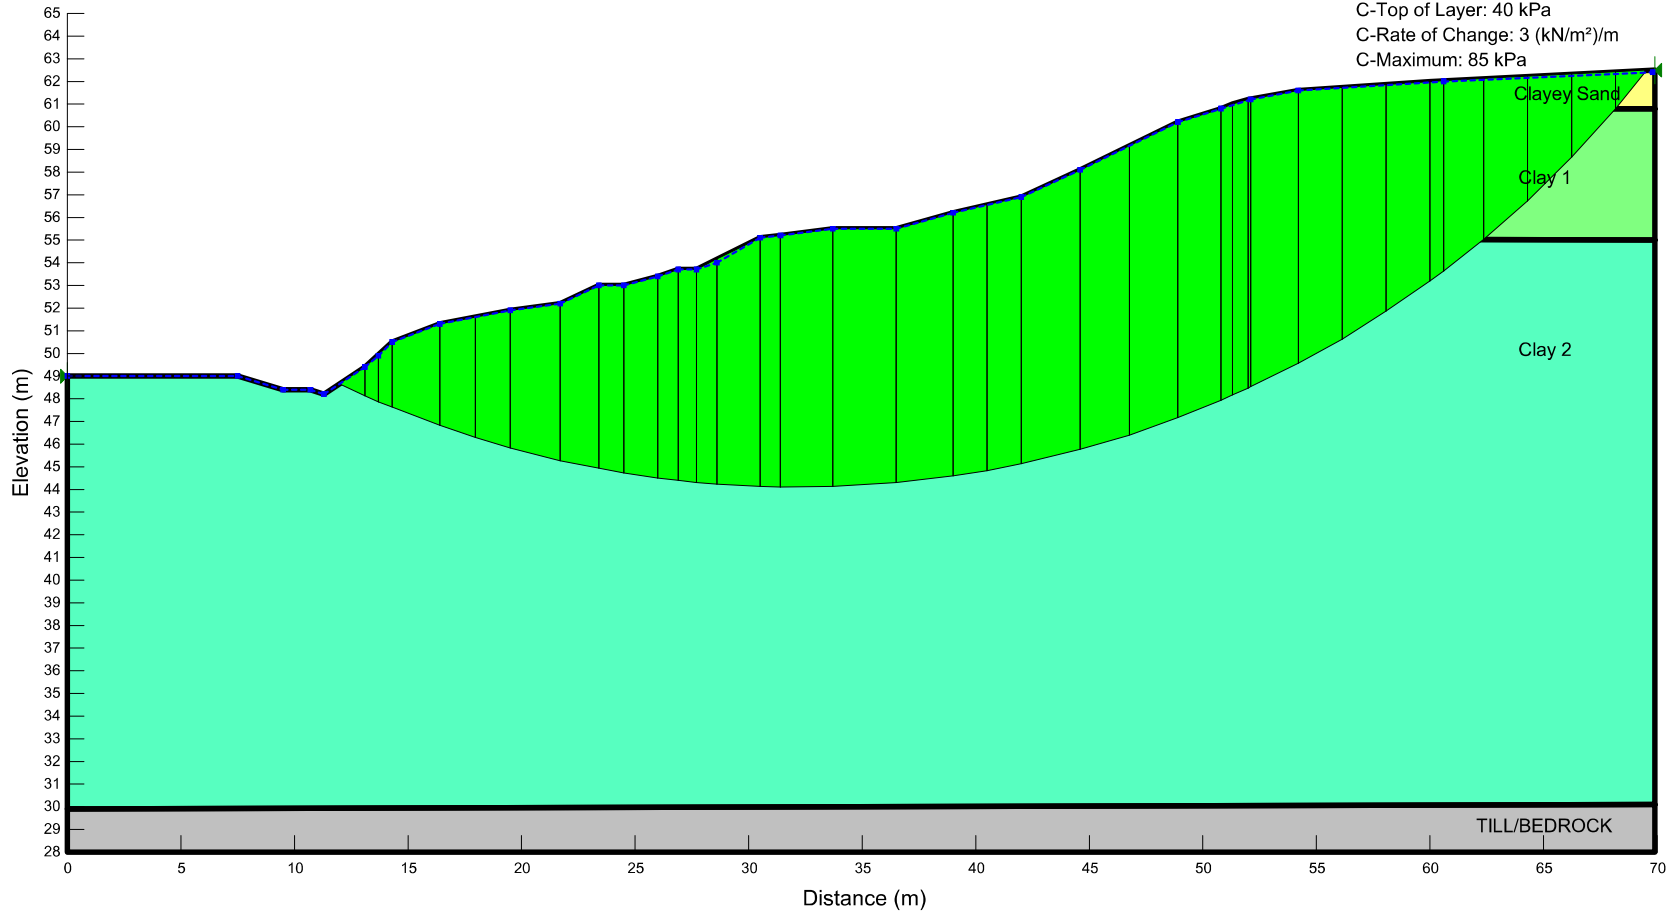
Figure 31

Project : OTT-00229886-A0  
SLOPE STABILITY ASSESSMENT  
3400 Old Montreal Road, Cumberland, On.  
Slope Stability Analysis - Existing Slope  
Section - F-F - Effective Stress Analysis  
Set Back Determination

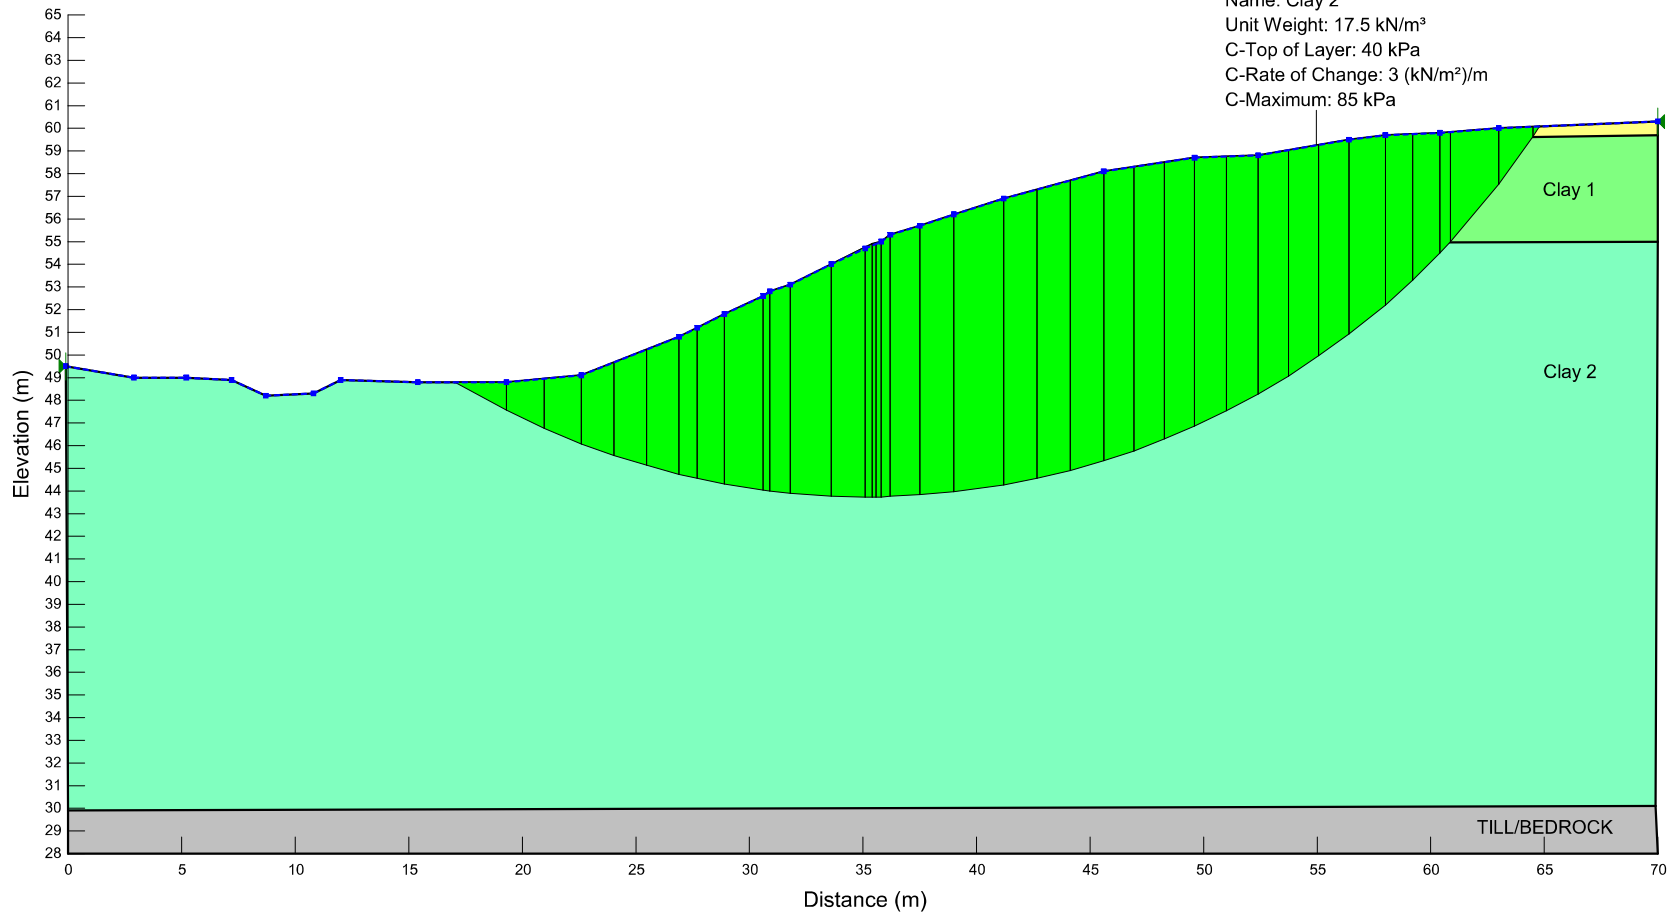
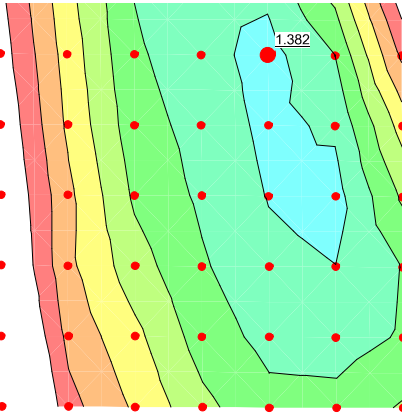
Figure 33

Project : OTT-00229886-A0  
 SLOPE STABILITY ASSESSMENT  
 3400 Old Montreal Road, Cumberland, On.  
 Slope Stability Analysis - Existing Slope  
 Section -F-F - Total Stress Analysis - Seismic

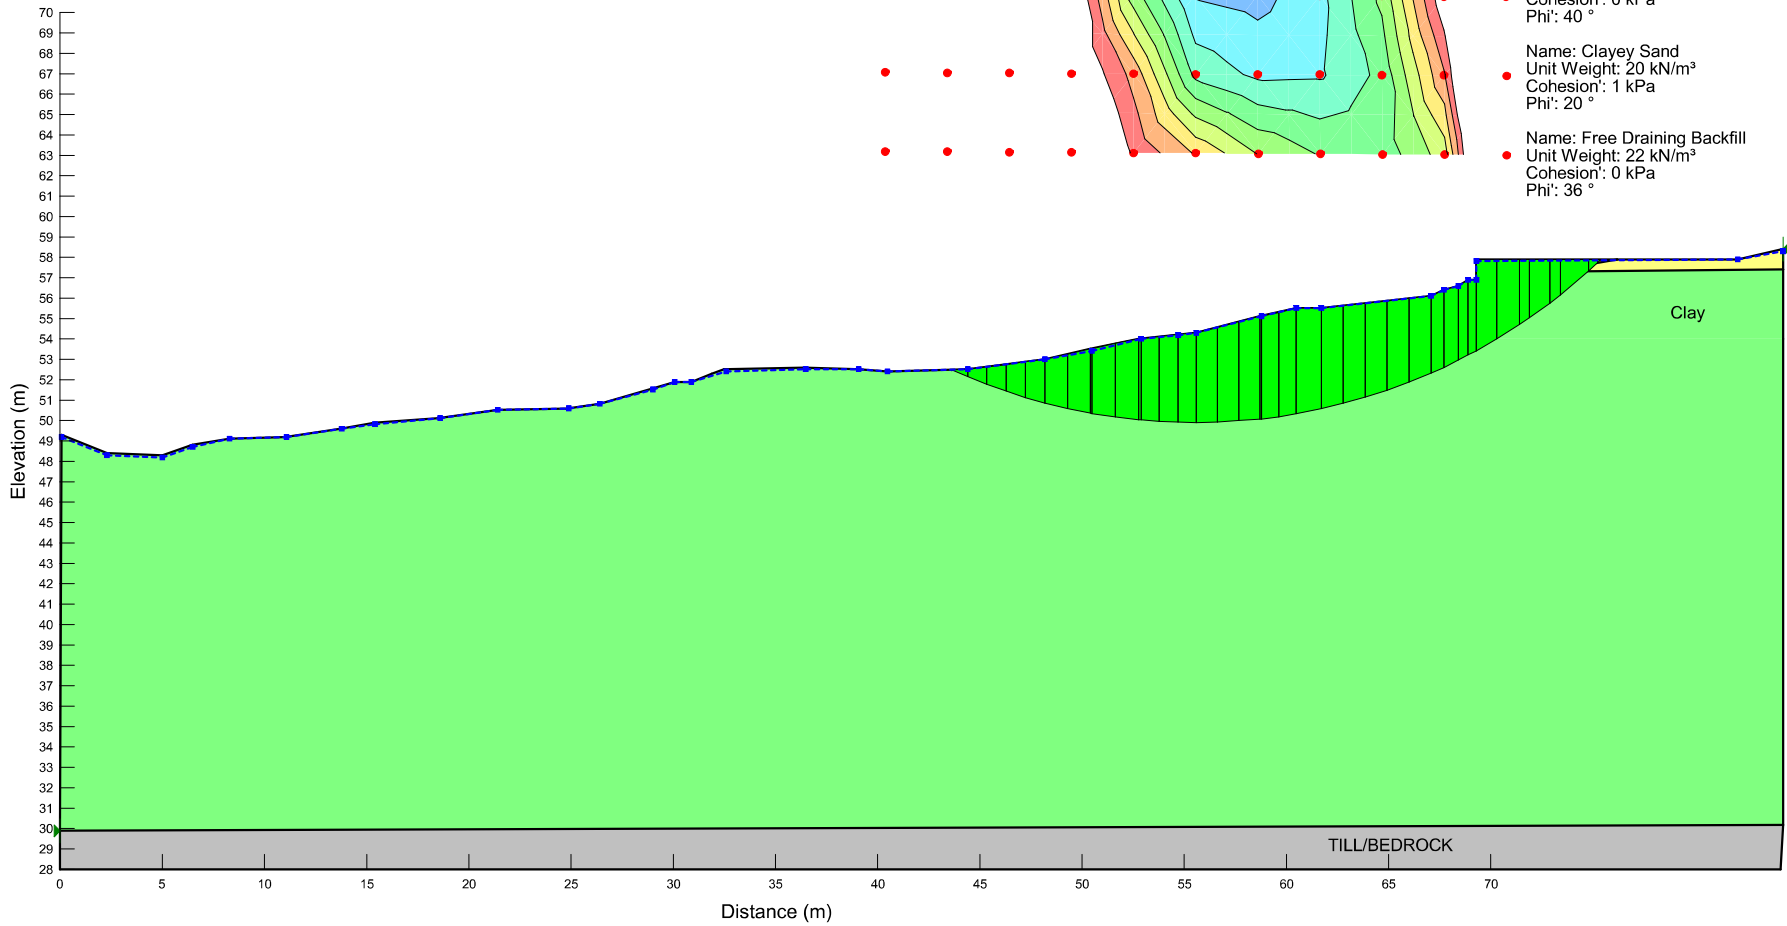
Figure 35

Slope Stability Analysis - Existing Slope & Proposed Retaining Wall  
Section - G-G - Total Stress Analysis

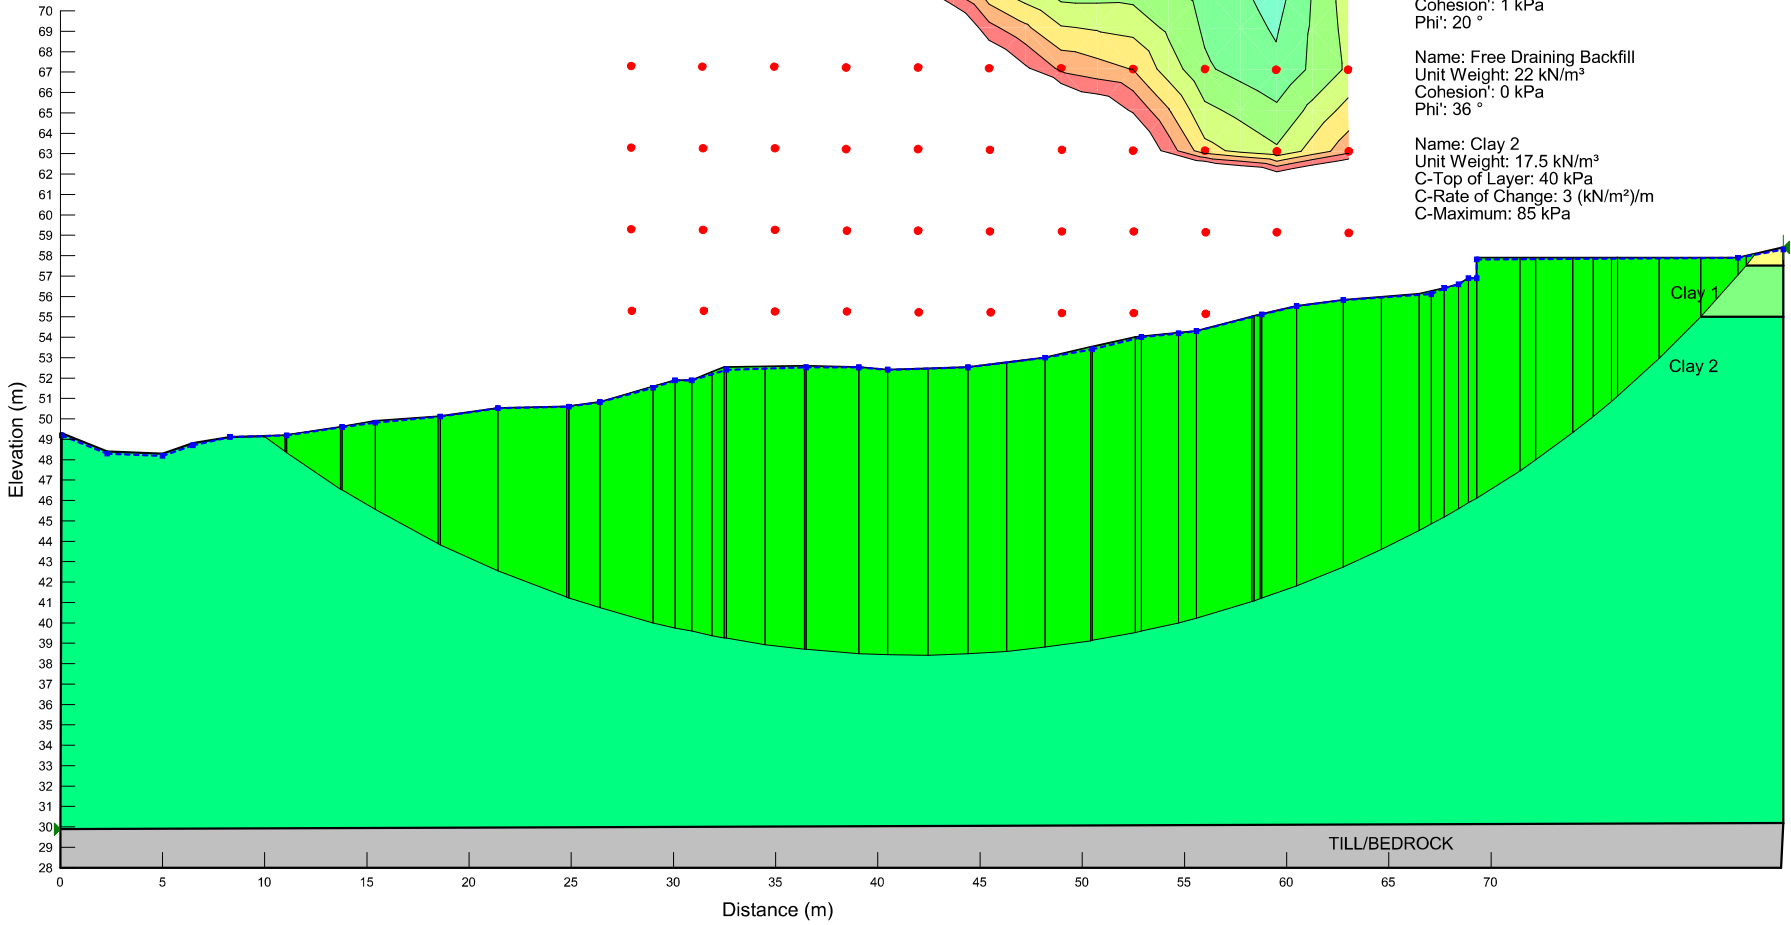
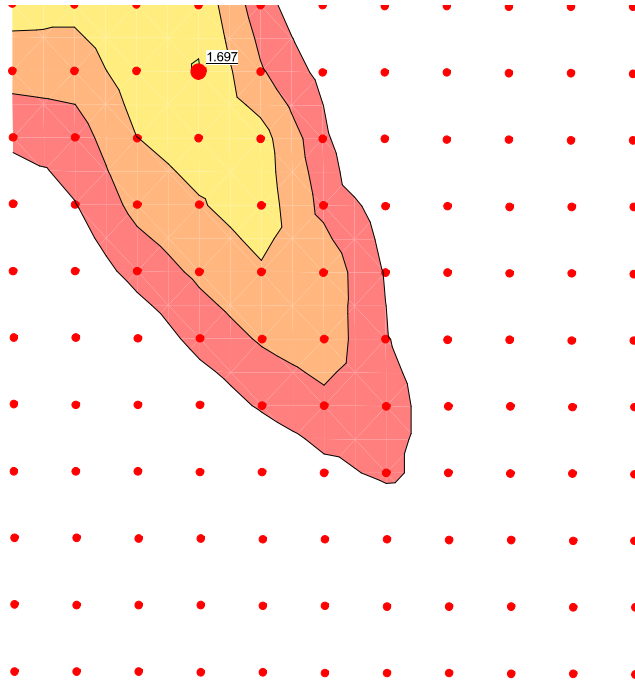
Figure 36

Slope Stability Analysis - Existing Slope & Proposed Retaining Wall  
Section - G-G - Total Stress Analysis - Seismic

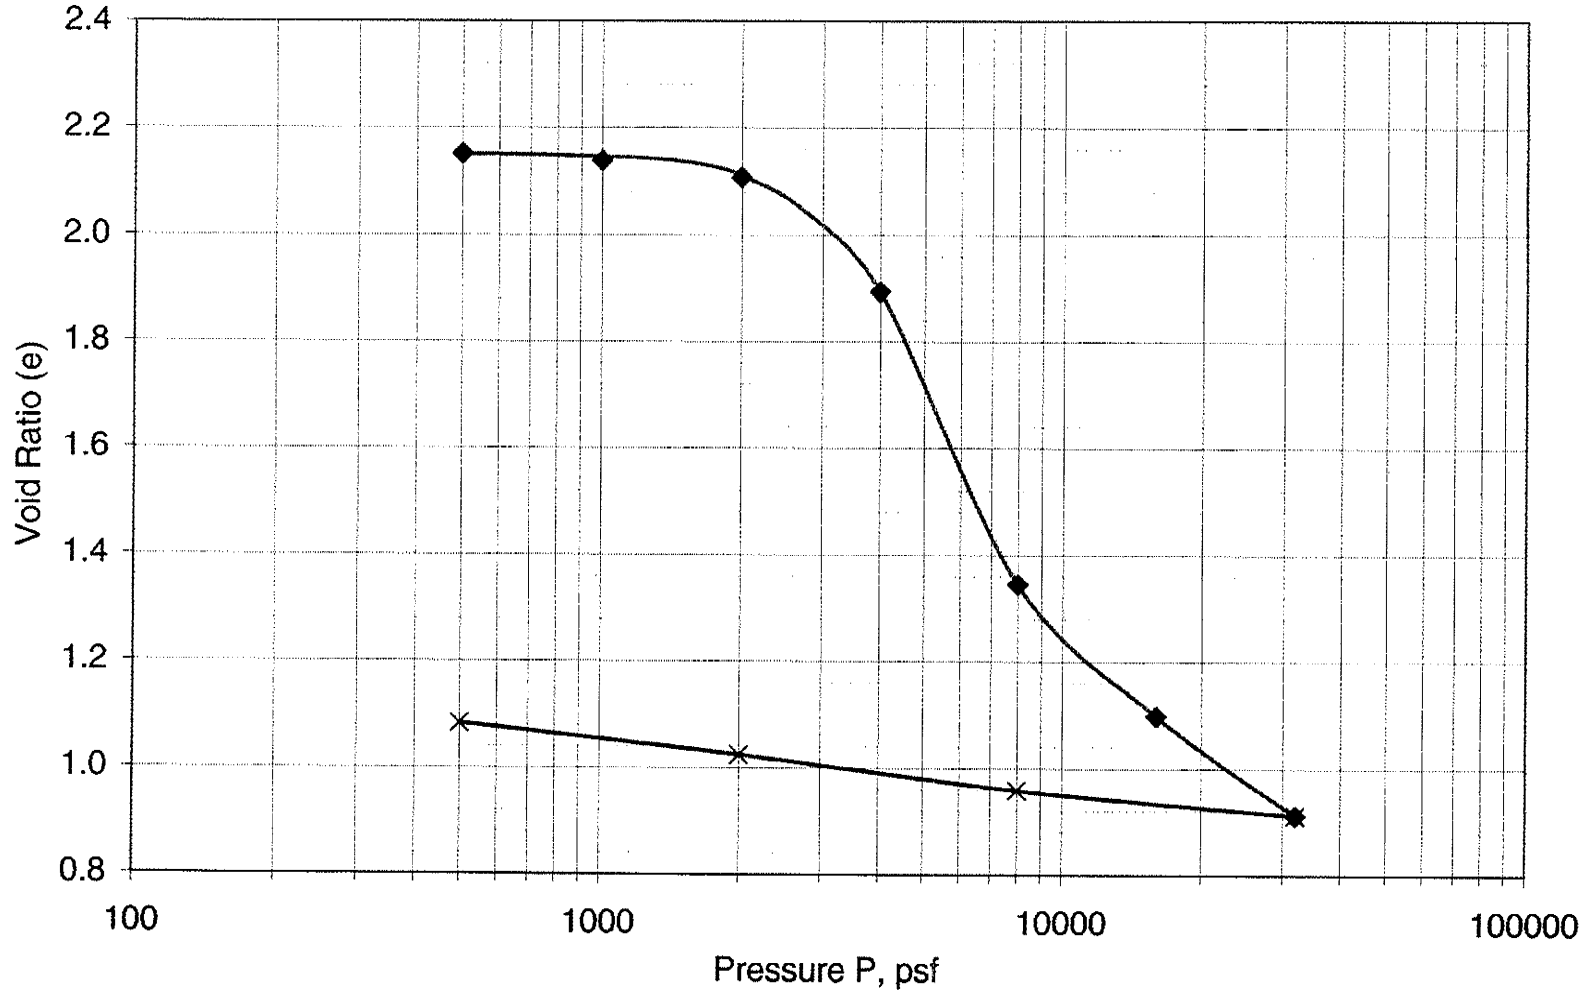
One Dimensional Consolidation Test Results  
Borehole 6 - 3.0 m to 3.6 m Depth

$P'_c$  = 175 kPa  
 $P'_o$  = 45 kPa  
 $C_{cr}$  = 0.086  
 $C_c$  = 0.957

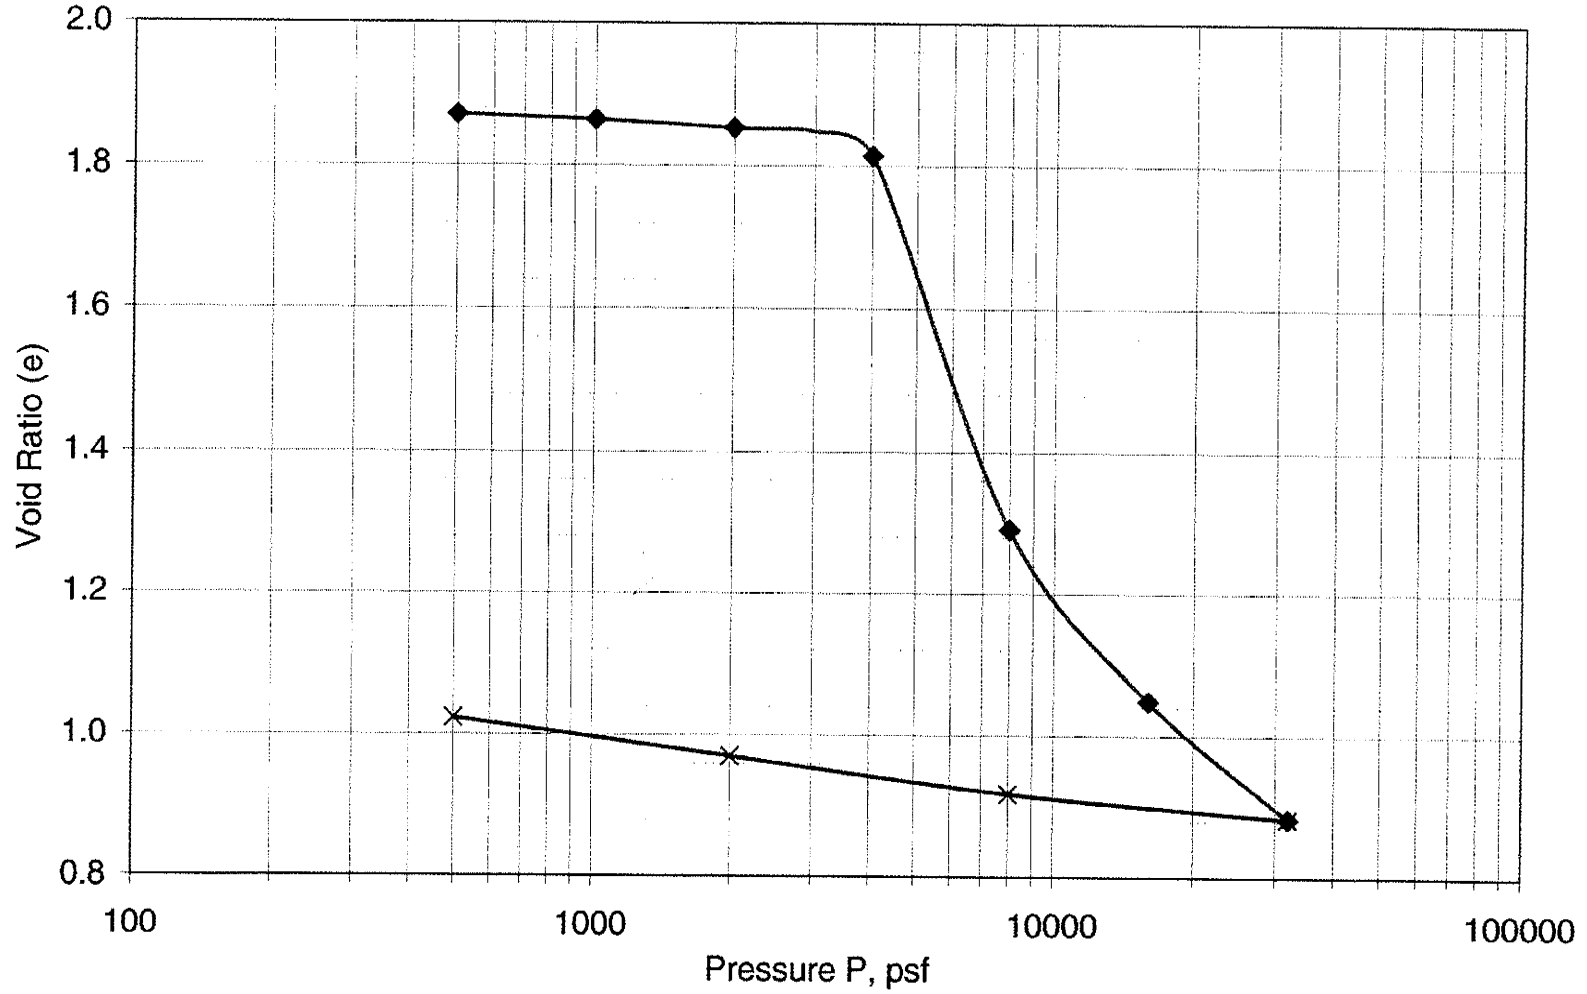
One Dimensional Consolidation Test Results  
Borehole 1 - 4.6 m to 5.2 m Depth

$P'_c$  = 190 kPa  
 $P'_o$  = 55 kPa  
 $C_{cr}$  = 0.0864  
 $C_c$  = 1.014

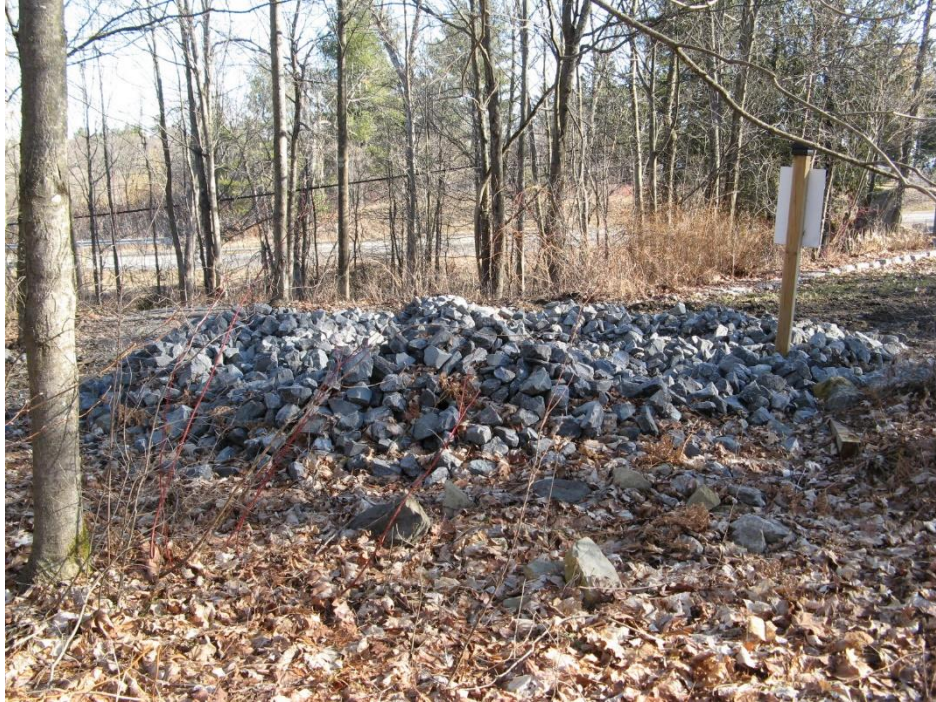
*Photo 1 – Proposed location of the Islamic gazebo (north gazebo).  
View looking north towards Old Montreal Road*

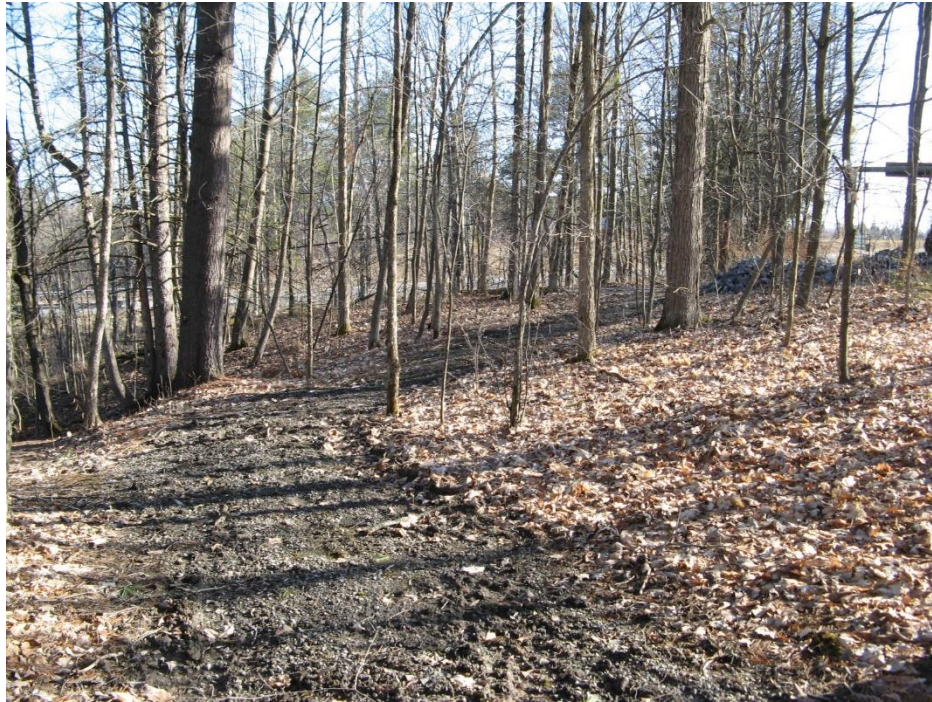
The gazebos will be located a minimum of 10 metres from the crest of slope. The crest of slope is well treed as are the portions of the valley leading to the tributary of Beckett's Creek. The tableland setback from the crest of slope is forested closer to the crest save for the permeable pathways, with intermittent tree cover in the outer portions of the setback.

*Photo 3 – Typical condition of setback between the proposed gazebo locations and the crest of slope (to left) with a permeable pathway. View looking north towards Old Montreal Road*
