#### **FINAL REPORT**

# Phase One Environmental Site Assessment

6409, 6363 and 6295 Perth Street, Ottawa, Ontario

## Golder Associates Ltd.

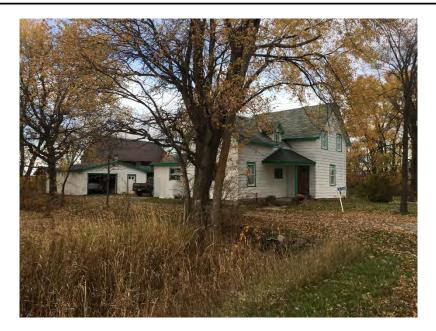
Photo 1 – Looking northeast at the farm property on the 6409 Perth Street portion of the Site with a residential house, parking garage, barn and storage shed.

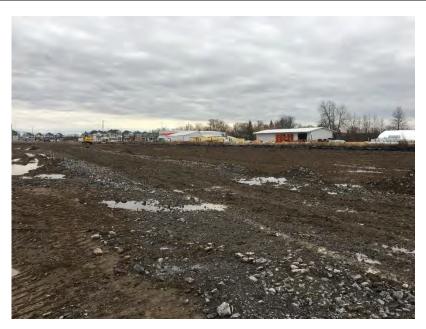
Photo 7 – Looking south at the southern portion of 6363 Perth Street that had been stripped and the adjacent Home Depot property to the west of this property.

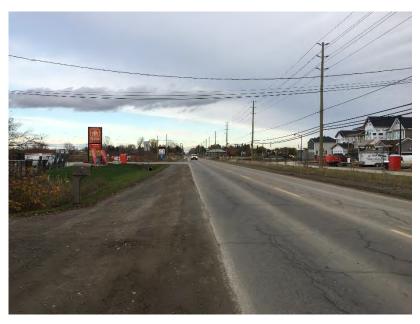
Photo 9 – Looking east at Perth Street located south of the Site along with the Home Deport on the north side of Perth Street. Ongoing residential development and a fire hall to the south and southeast of the Site are also visible.

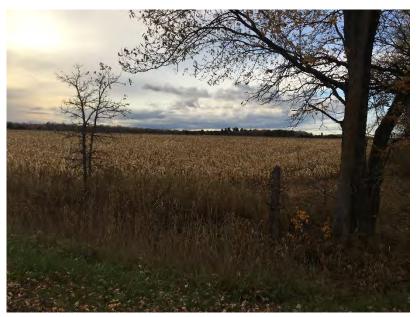
Photo 10 - Photo of the agricultural field on the 6363 Perth Street portion of the Site.

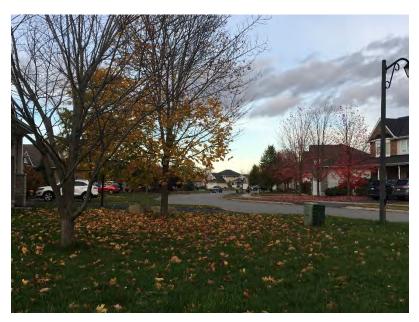
Photo 11 – Residential development on the surrounding lands east of the Site along Rochelle Drive, looking east.

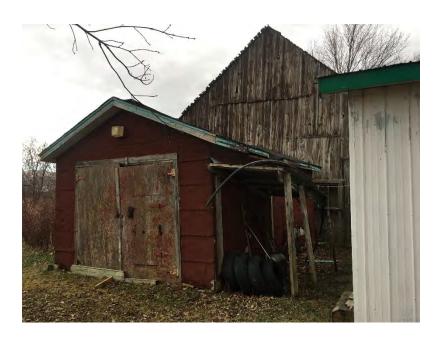
Photo 12 – Looking east at the storage shed on behind the house and parking garage on the 6409 Perth Street portion of the Site.
