Kizell Drain Downstream of 7000 Campeau Drive Geomorphological and Erosion Threshold Assessment

**Kizell Drain
Kanata, Ontario**

July 7, 2020
PN20053

Report Prepared by: GEO Morphix Ltd.
PO Box 205, 36 Main St. N.
Campbellville, ON L0P 1B0

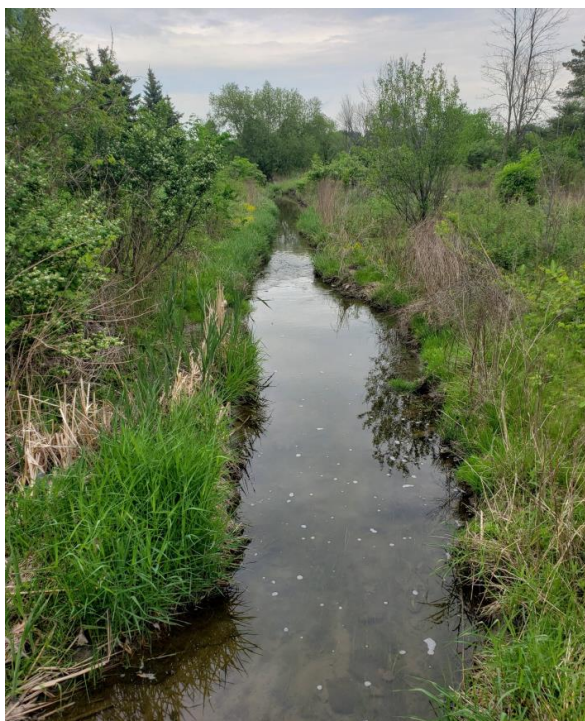
Detailed assessment Site KDR-3 is a channelized watercourse conveying flows through a commercial business park with large parking lots. The channel is unconfined, and at the time of the assessment was backwatered by a beaver dam which exceeded 1 m in height near Legett Drive. The channel had a fragmented, narrow riparian buffer composed of grasses and herbaceous vegetation which occasionally encroached the watercourse, with sparse shade provided from trees. The channel bed was composed of a cohesive clay material, while channel banks were composed of a loamy clay.

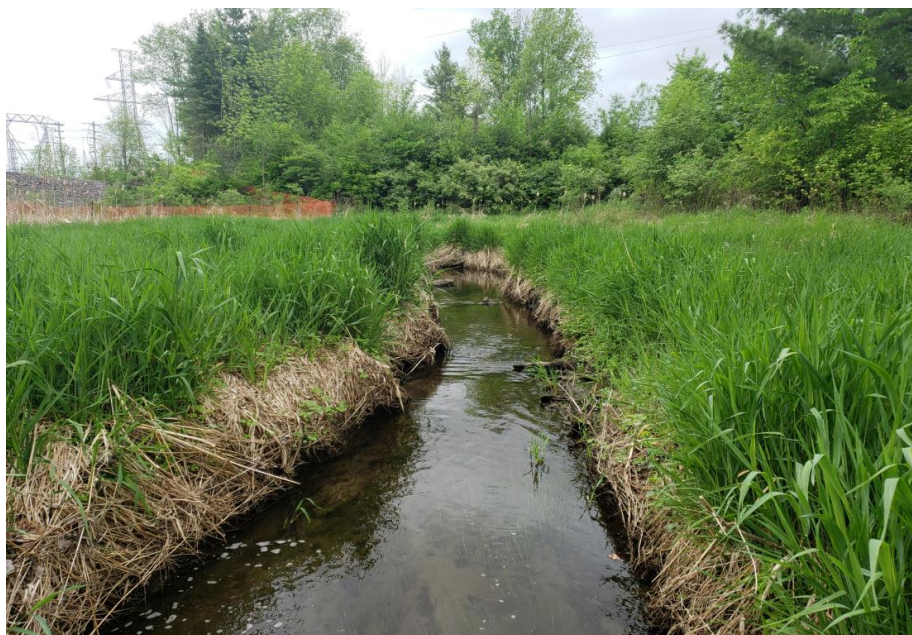
Detailed Assessment Site KDR-4 conveys flows through an unconfined valley, and is surrounded predominantly by residential development. The site has a continuous riparian buffer consisting of a forest in the upstream section of the site, and a meadow in the downstream section. Channel bed materials are composed of dense clay, with overlying sand, gravels and small cobbles. Banks are composed of a loamy clay. The channel has a natural sinuous planform, and the specific detailed site is delimited at the upstream extent by a bedrock outcrop and the downstream extent by a wet meadow with poor bank definition.
