**Headwater Drainage Feature Assessment
Phoenix Homes -
Old Montreal Road**

July 31, 2021

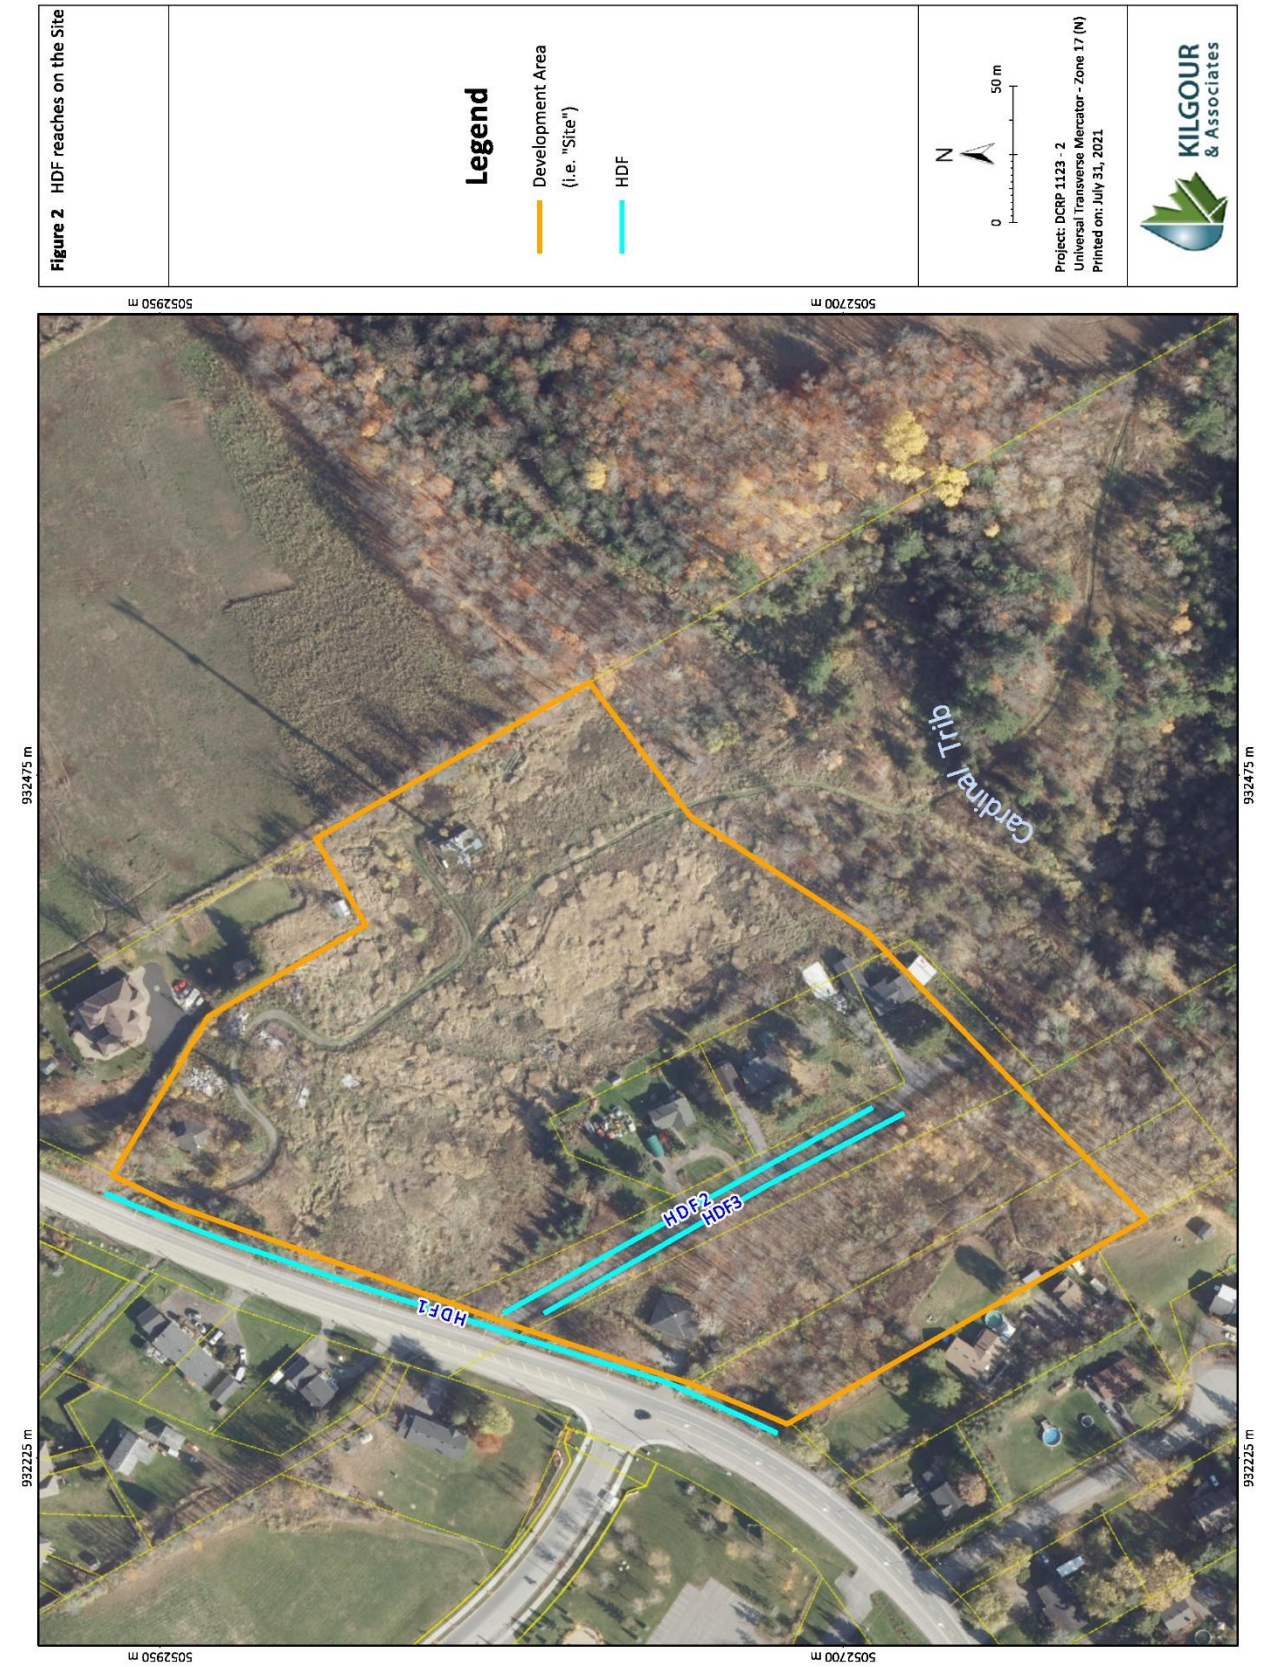
HDFs were reviewed on the Site initially in 2018, then again in 2021. A total of three HDFs were identified and are described in this report (Figure 2). All three features are/were located at the north end of the Site. The southern edge of the Site corresponds with the top of a ravine crossing the Site properties that conveys a tributary to Cardinal creek to the west. The tributary, as a permanent stream, does not meet the definition of an HDF under the HDFA Guidelines. Moreover, it is located outside of the Site area and no HDFs conveyed flows from the rear of the Site flows to that stream. Proposed future development on the Site will adhere to setback requirements as required based on floodplain limits, buffer distances from top-of-bank and/or normal high water mark, and hazard limits. The Cardinal Creek tributary is therefore not addressed further within this report.
