Landslide Hazard and Risk Assessment

Final Report

December 13, 2021
File: 121624058

DCR/Phoenix Group of Companies
Ottawa, ON

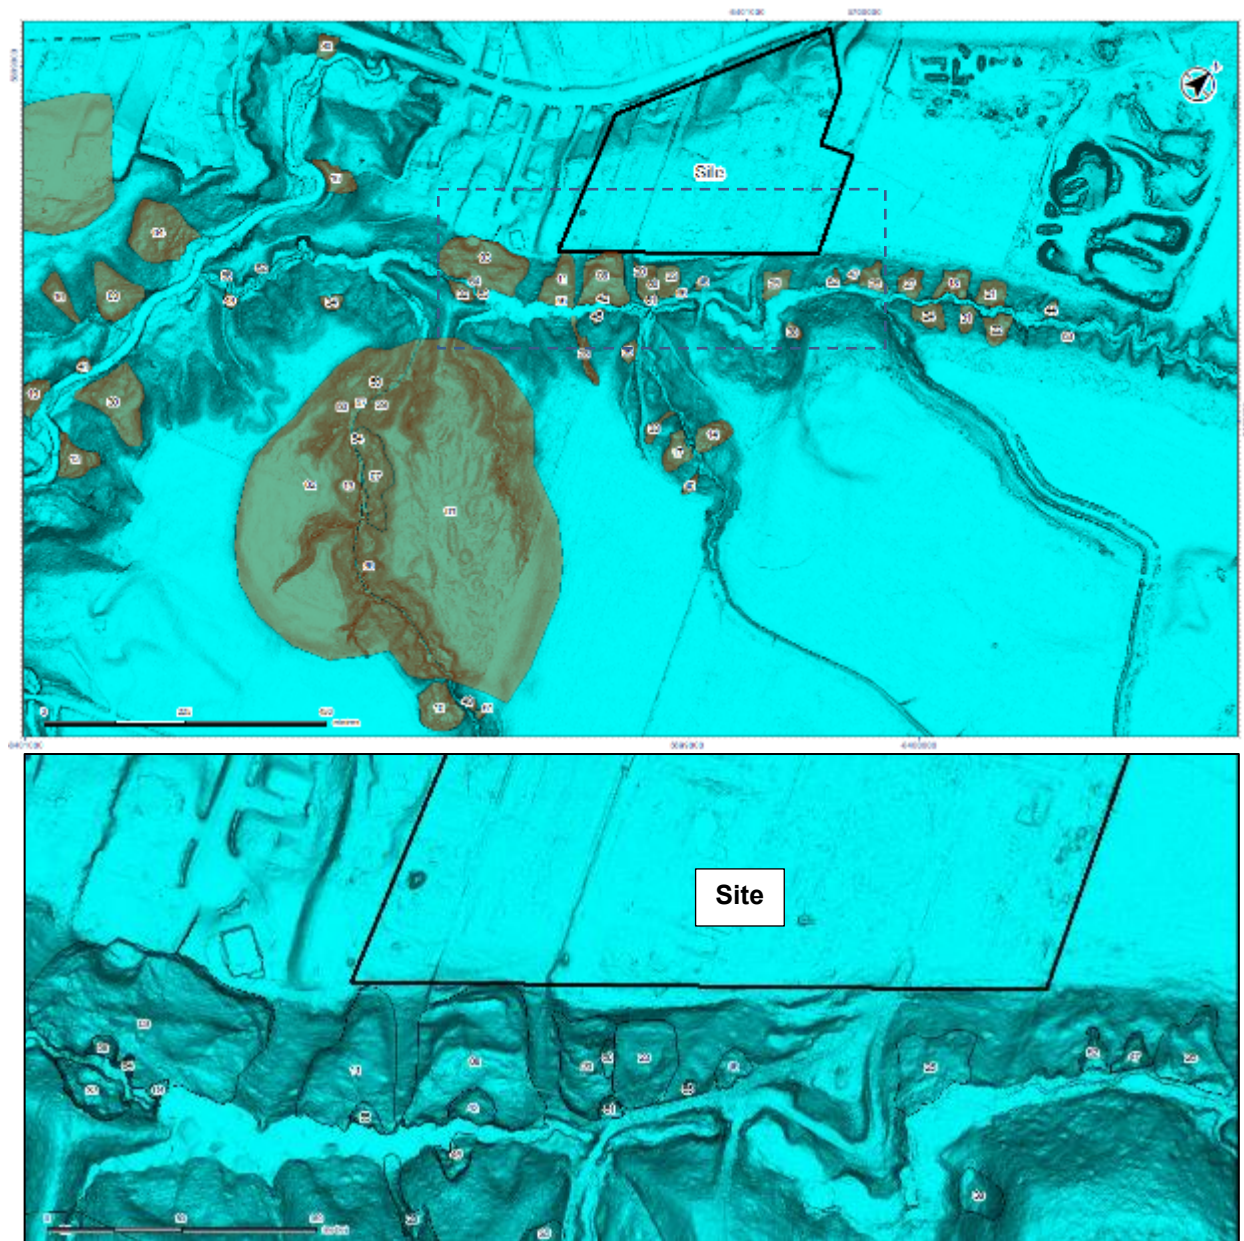
Figure 3-1 Old Montreal Road Landslide Inventory

Reviewing available data suggest the gully system located south of the Site has developed by basal incision and headward erosion, with contribution of relatively small landslides features (generally under 5,000 m² in size) that have developed in gully headwalls, side slopes and/or along the edges of the creek and tributary gullies over time.

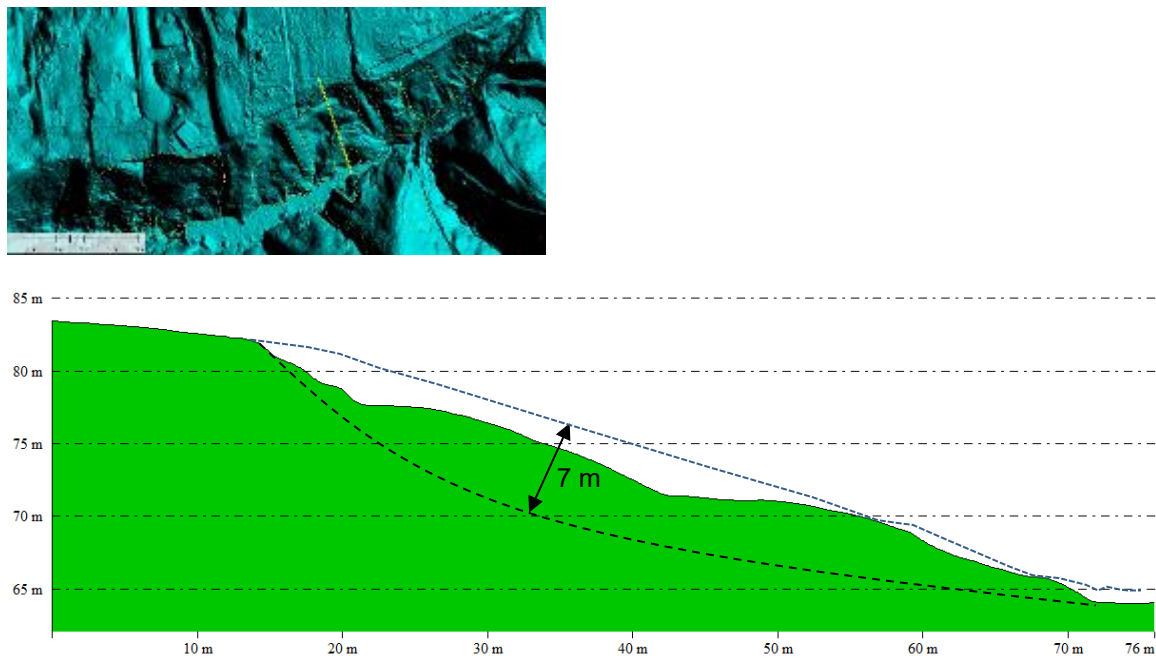
- Longitudinal cross sections through mapped landslides units (i.e., from the head scarp to the toe bulge position) suggest overall displacement depth in the order of 1 to 5 m (example on Figure 3-2). Cross sections across the retrogressive landslides south of the Site (example on Figure 3-3) suggest spread-type failures may have reached a minimum depth of approximately 10 m.

Figure 3-2 Topographic cross section across rotational landslide south of the Site

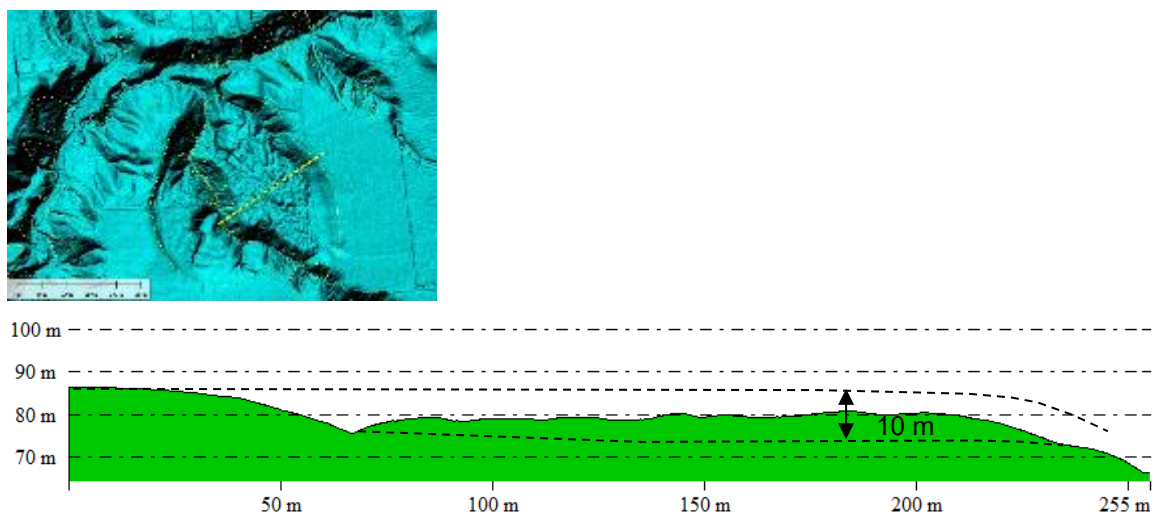
Figure 3-3 Topographic cross section across retrogressive landslide 400m south of the Site

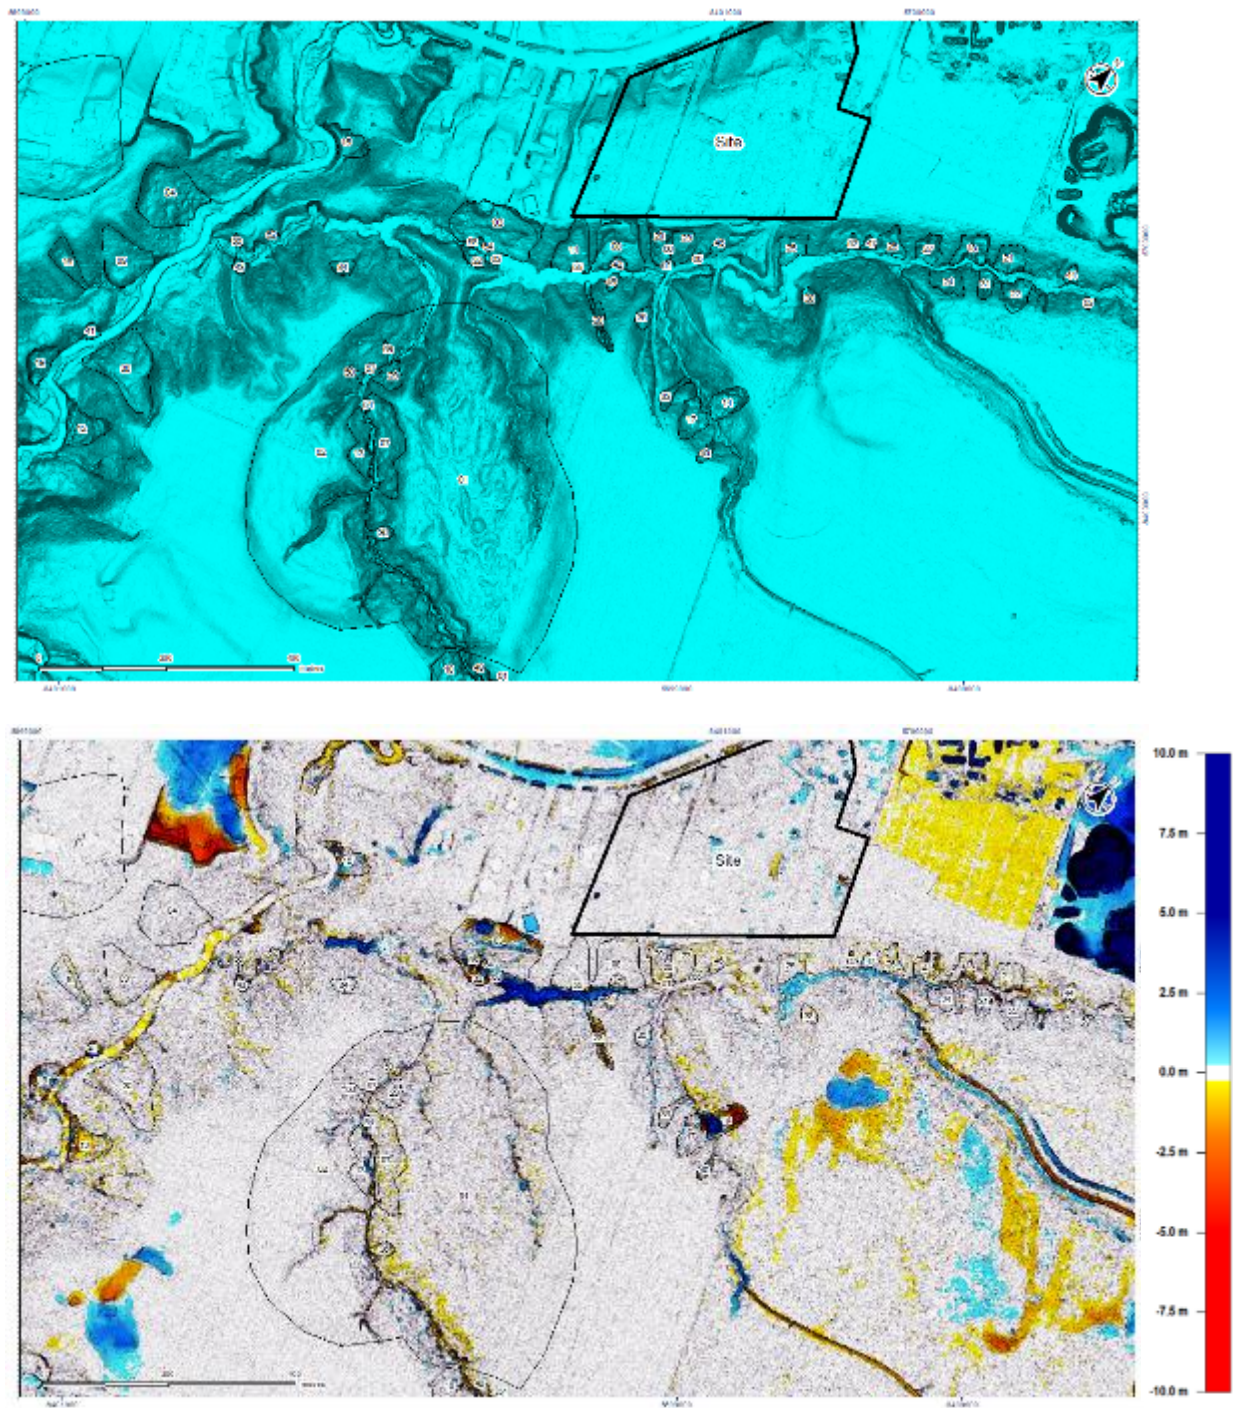
The availability of three distinct LiDAR dataset allowed for the identification of topographic changes within the Project Area. Visual representations of the DoD produced from comparing the 2006, 2014 and 2019 LiDAR DEMs are presented in Figure 3-4 to 3-6. On these figures, areas of positive elevation changes are shown in shades of blue, and areas of negative elevation changes are shown in shades of red and yellow.

Figure 3-4 Overview of 2006-2019 LiDAR Change Detection

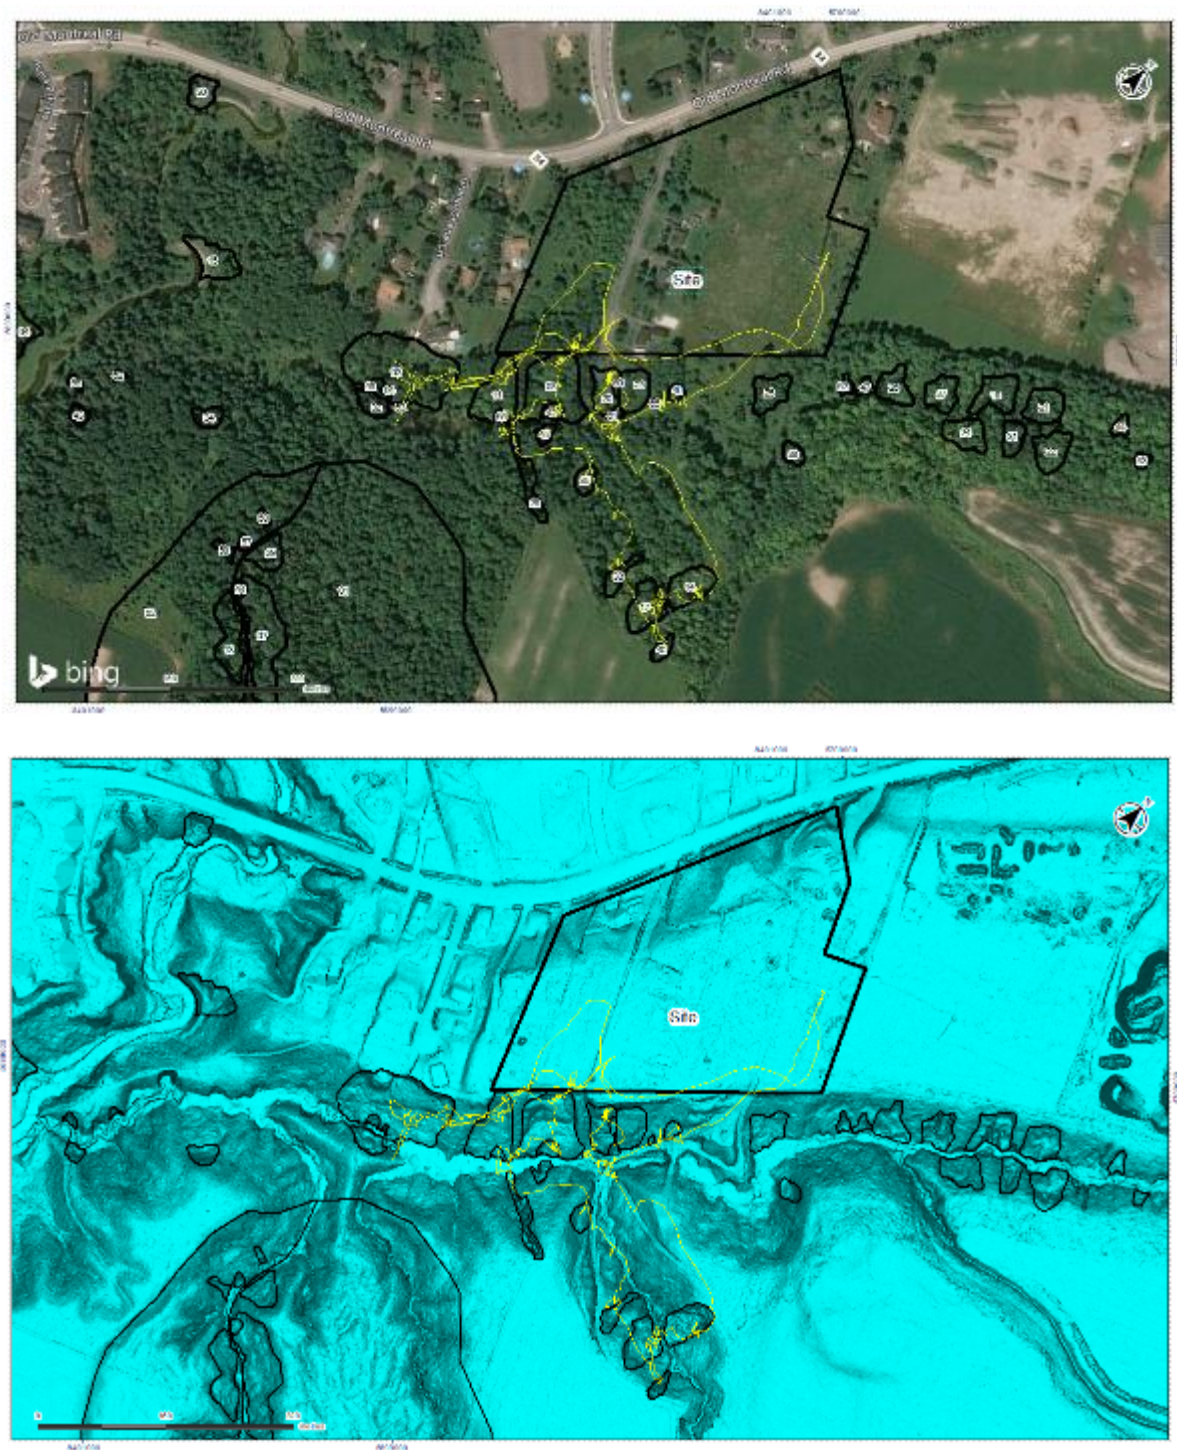
Figure 4-1 Field reconnaissance transect and observed landslide units

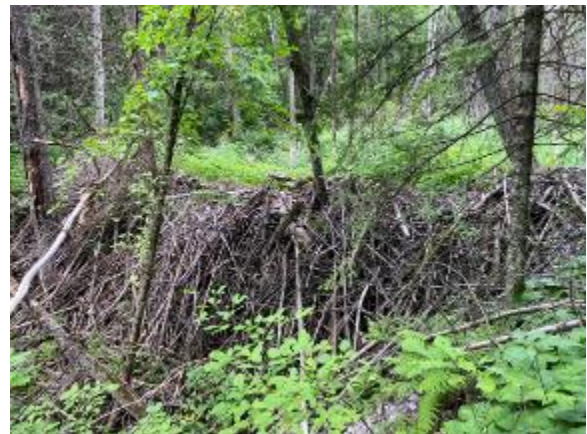
Photo 10: Upstream view of the beaver dam across the unnamed creek.

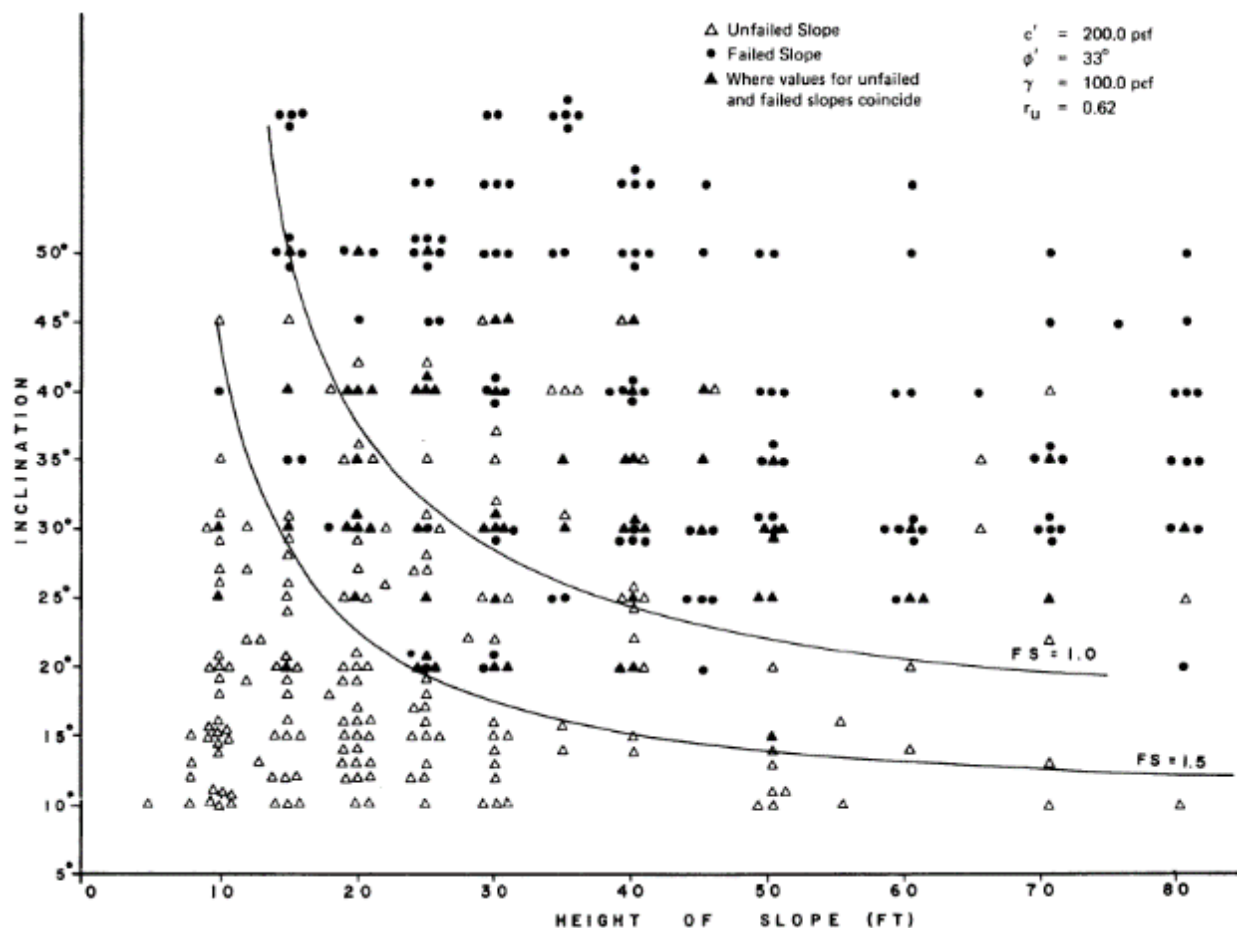
Figure 5-12 presents the unfailed versus failed slopes of 419 survey slopes in the field with calculated slope factor of safety. The factor of safety obtained from our effective stress analysis is within the reasonable range presented in this figure.

Figure 5-12 Calculated FOS and 419 Survey Slopes in the Field (from Klugan and Chung 1976)

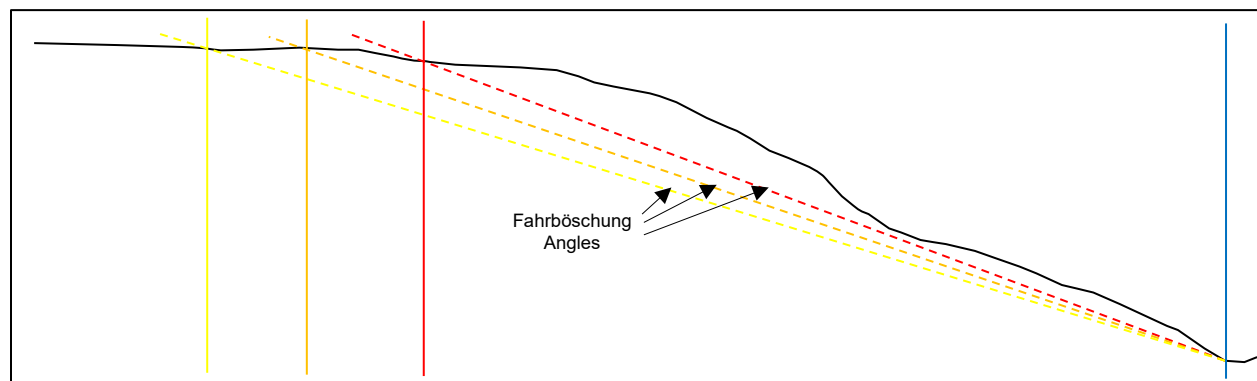
Figure 6-1 Fahrböschung angle of mapped landslides. Solid black line is the existing ground surface, vertical blue line is the toe of the slope, and the red, orange and yellow lines represent different Fahrböschung angles.

Fahrböschung angles were measured at each of 18 landslides on the south-facing slope adjacent to the proposed development. An angle of 16° was selected based on the observable Fahrböschung and the slope stability analysis in Section 5. Flatter angles were noted in the mapping (Landslide 25 and 63). however, Stantec expects that landslide 25 does not include full headscarp height, and landslide 63 is difficult to differentiate from gully erosion occurring within a larger landslide body. The observed Fahrböschung angle for each landslide is given in Table 6-1.

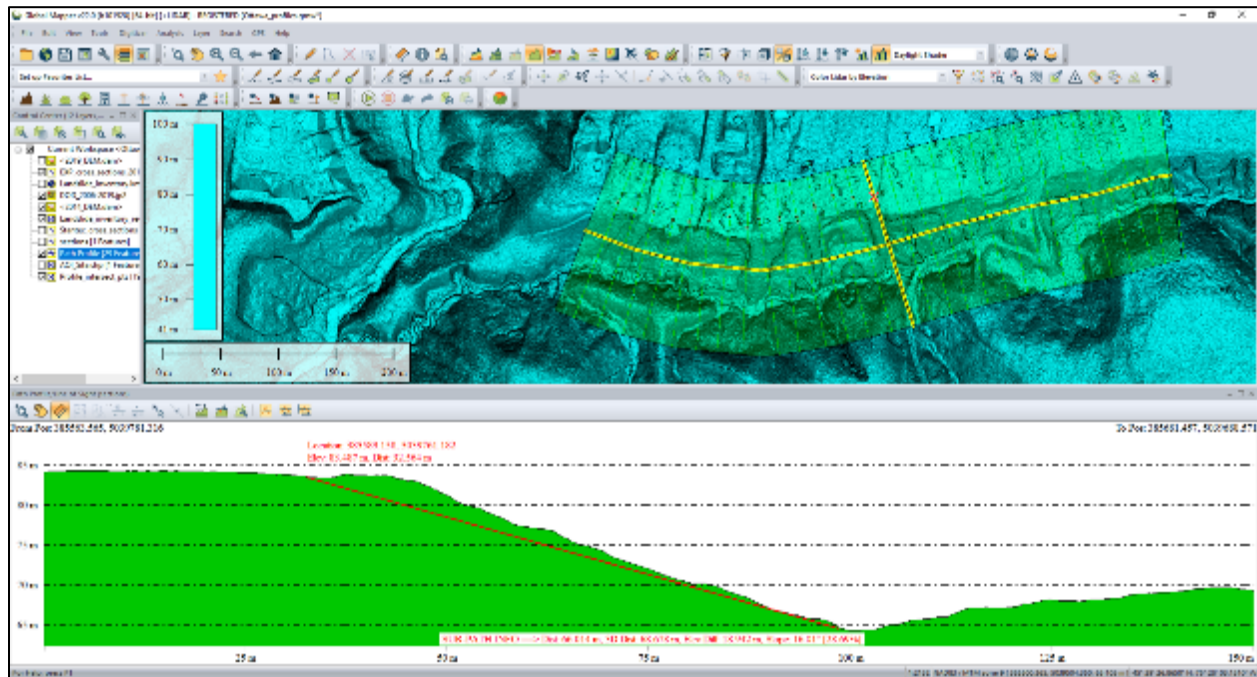
The Fahrböschung angle was calculated along 30 different cross sections, each separated from the others by a 100 m and established along the south-facing slope in a manner that accounted for topographic variation. A cross plane was then projected through each cross-section using the average calculated Fahrböschung angle of mapped landslides, from the toe to the crest of the slopes, along each cross sections. The locations were the projected plane daylighted on the upslope portion of the cross sections was used to delineate setback limits corresponding to different landslide return period. Refer to Figure 6-1 and Figure 6-2 for diagrams illustrating Fahrböschung angles calculated for the assessment.

Figure 6-2 Cross Sections and Example of Setback Calculation

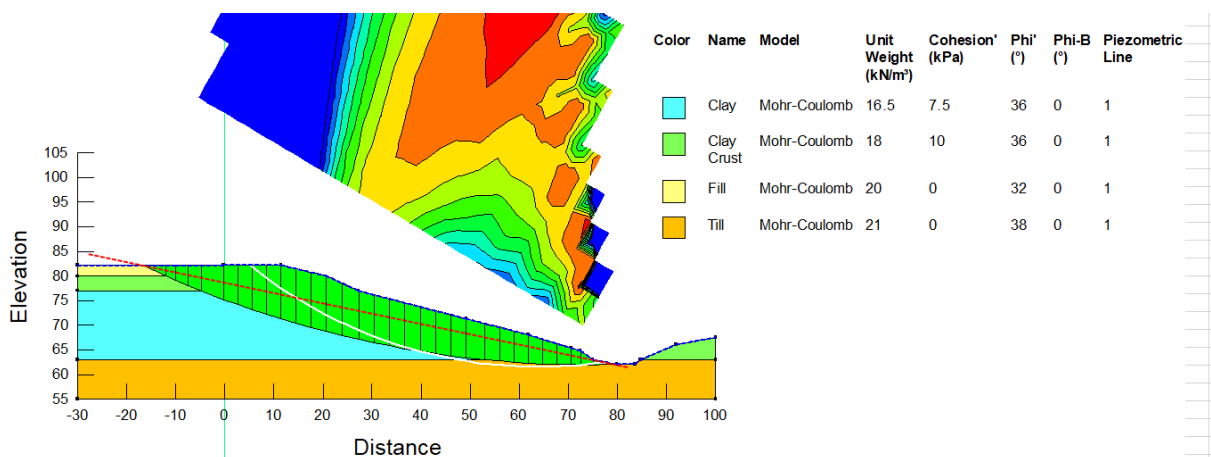
Given the limits of the geotechnical information currently held at the site, using Silva et al (2008), a FoS of 1.58 delimits a zone beyond which the PO is < 1:10,000 (and Fahrböschung of 11-13° (Figure 6-3)).

Figure 6-3 Fahrböschung (11°) of the 1:10,000 return period event (FoS ~1.58)-Section C-C'

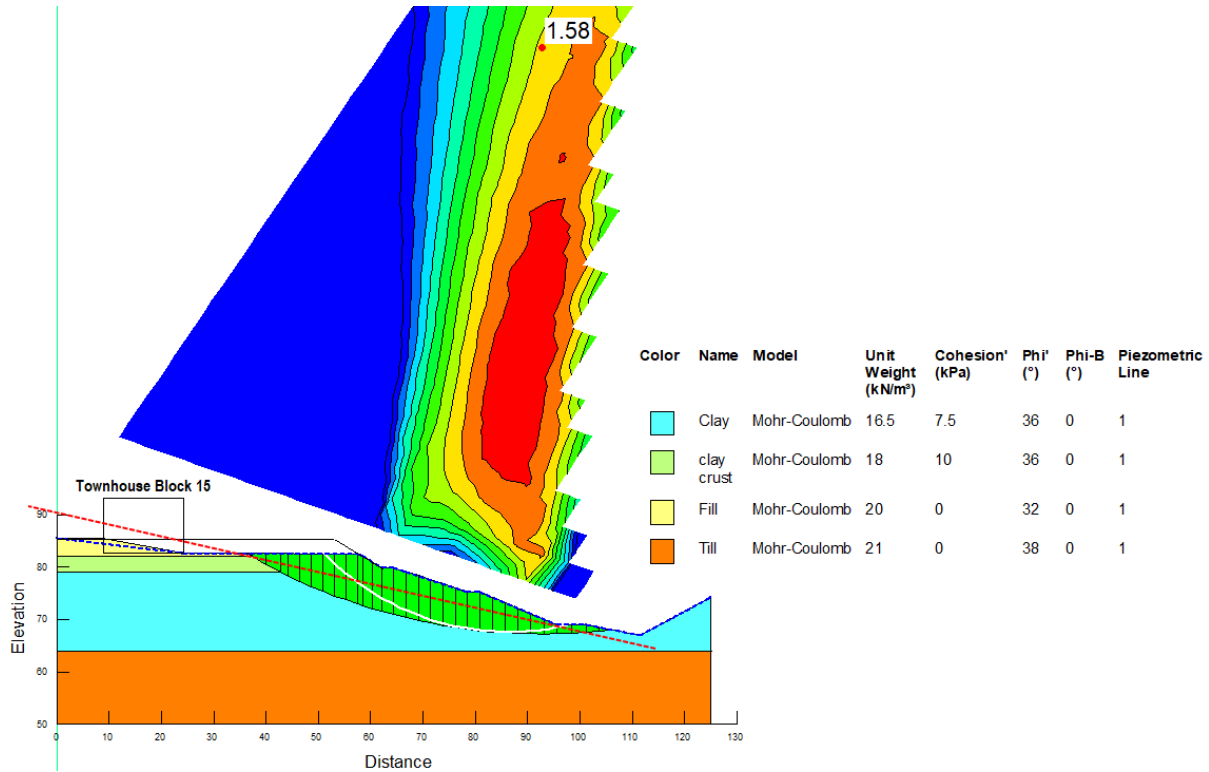
Figure 6-5 Fahrböschung (13°) of the 1:10,000 return period event (FoS ~1.58)-Slope Profile 17 After 2.5 m Grade Lowering

Due to the hazard zone impact to the development plan, the existing slope crest at planned townhouse blocks 15, 16 and 17 are proposed to be lowered by about 2.5 m (see conceptual macro grading plan in Appendix B). Based on the Fahrböschung line at 13° shown on the Figure 6-5, with the proposed grade lowering, the development plan may remain unchanged.

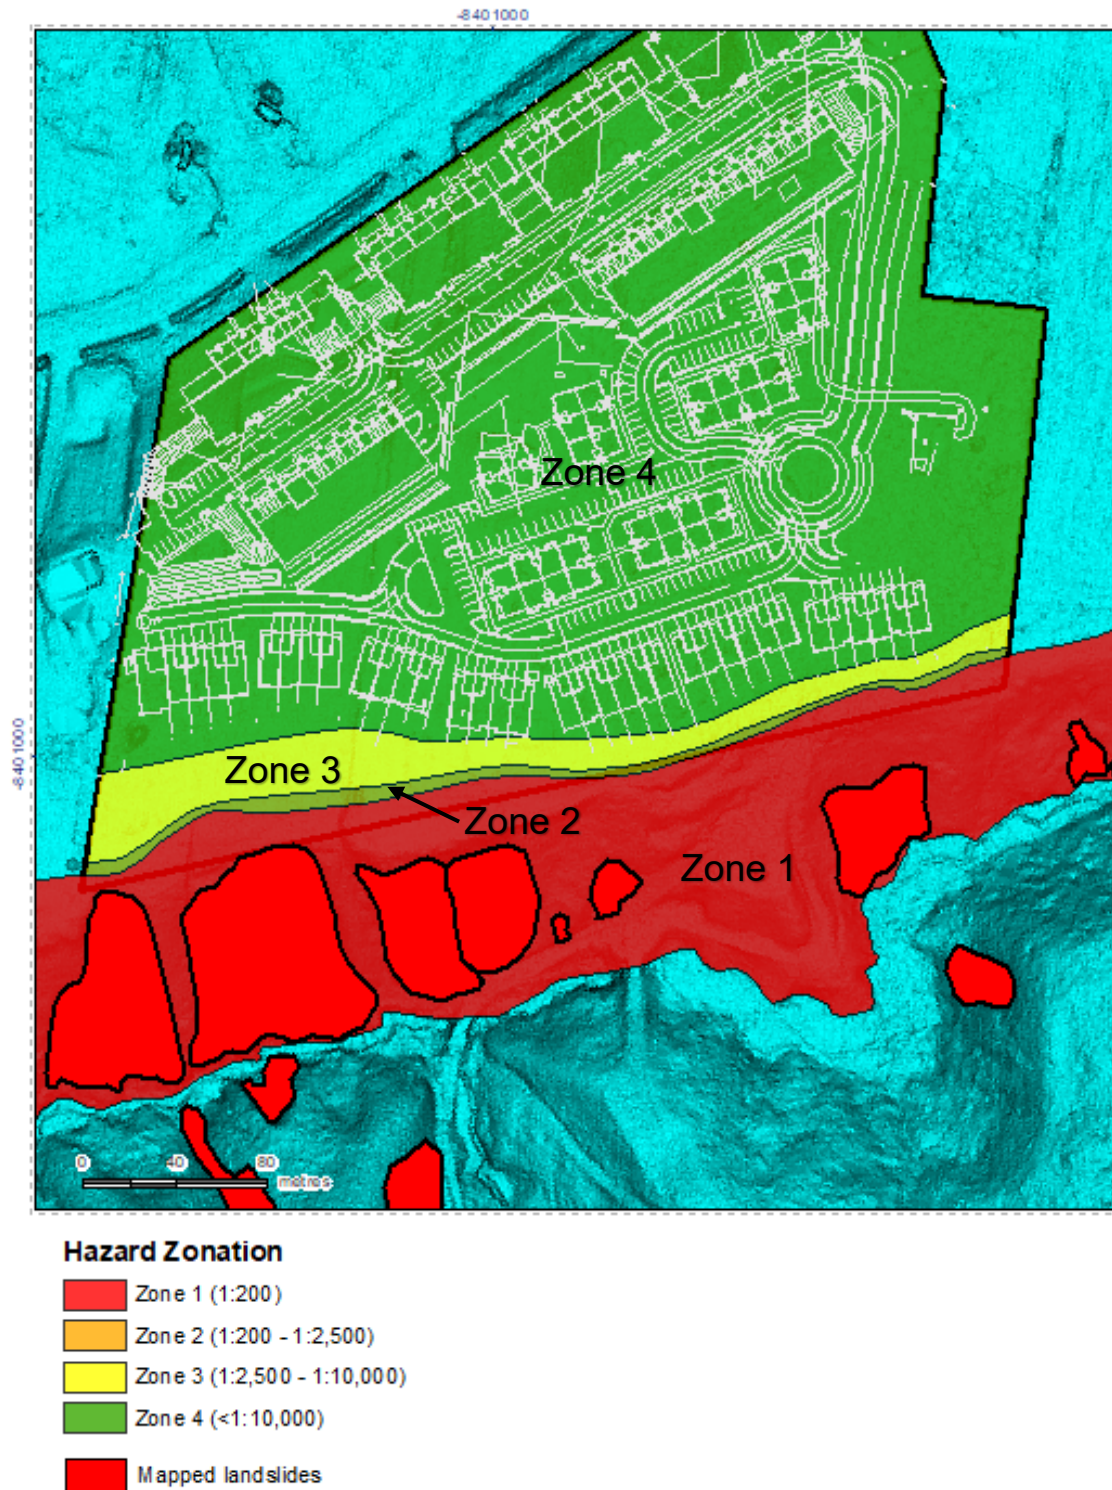
Figure 6-6 shows results of the hazards zonation overlain on the proposed development site plan.

Figure 6-6 Hazard Zonation
