## Geotechnical Investigation

Proposed Residential Development  
Cardinal Creek Village South  
Old Montreal Road  
Ottawa, Ontario

November 29, 2021

Report: PG5201-1  
Revision 5

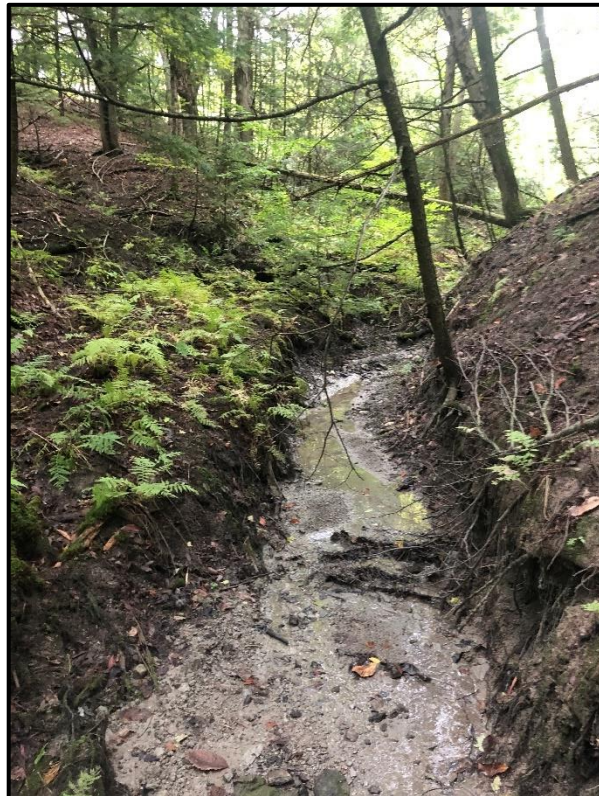
Photo 20: Photo taken on September 10, 2020 along the watercourse along Mid-Branch 1 looking east (upstream) near Section OO.
