Landslide Risk Assessment
Proposed Residential Development
Old Montreal Road
Ottawa, Ontario

Taggart Investments

March 2, 2022

Report: PG5201-1

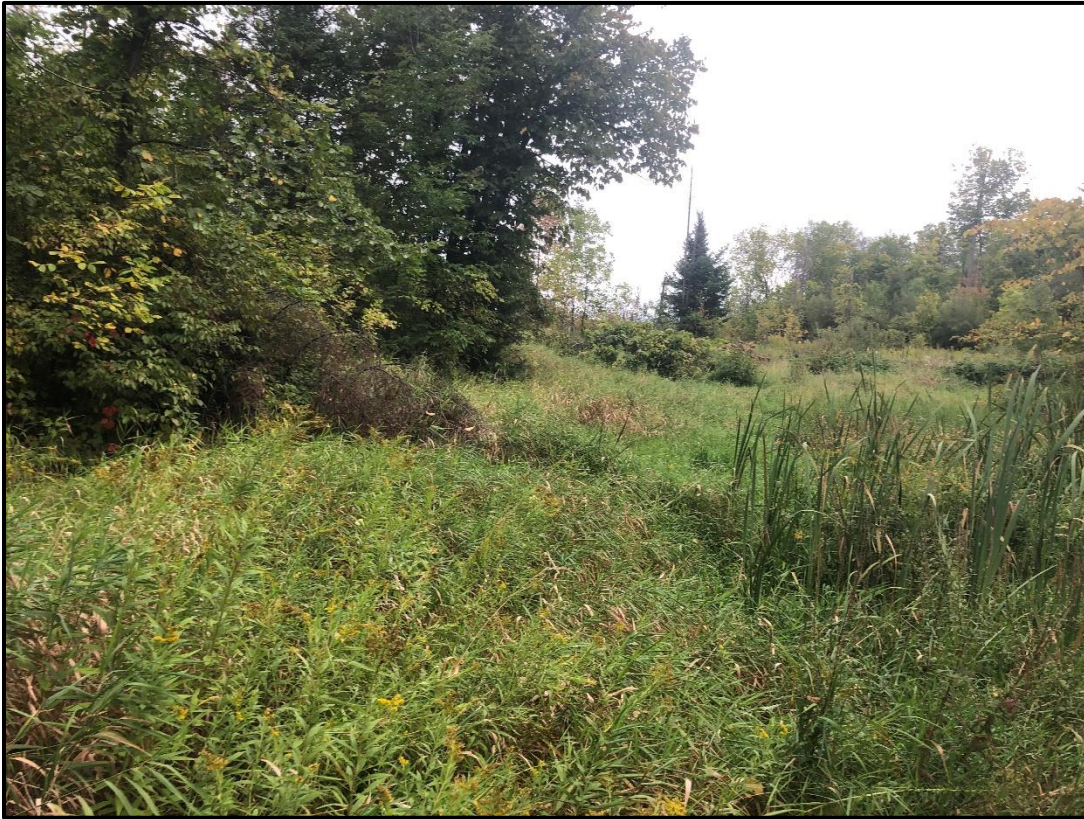
Photo 20: Photo taken on September 10, 2020 along the watercourse along Mid-Branch 1 looking east (upstream) near Section OO.
