FLUVIAL GEOMORPHIC AND EROSION HAZARD ASSESSMENT
STINSON LANDS
OTTAWA, ONTARIO

Prepared for:
NOVATECH ENGINEERING AND CONSULTANTS LTD.

Prepared by:
MATRIX SOLUTIONS INC.

Version 1.0
November 2022
Guelph, Ontario

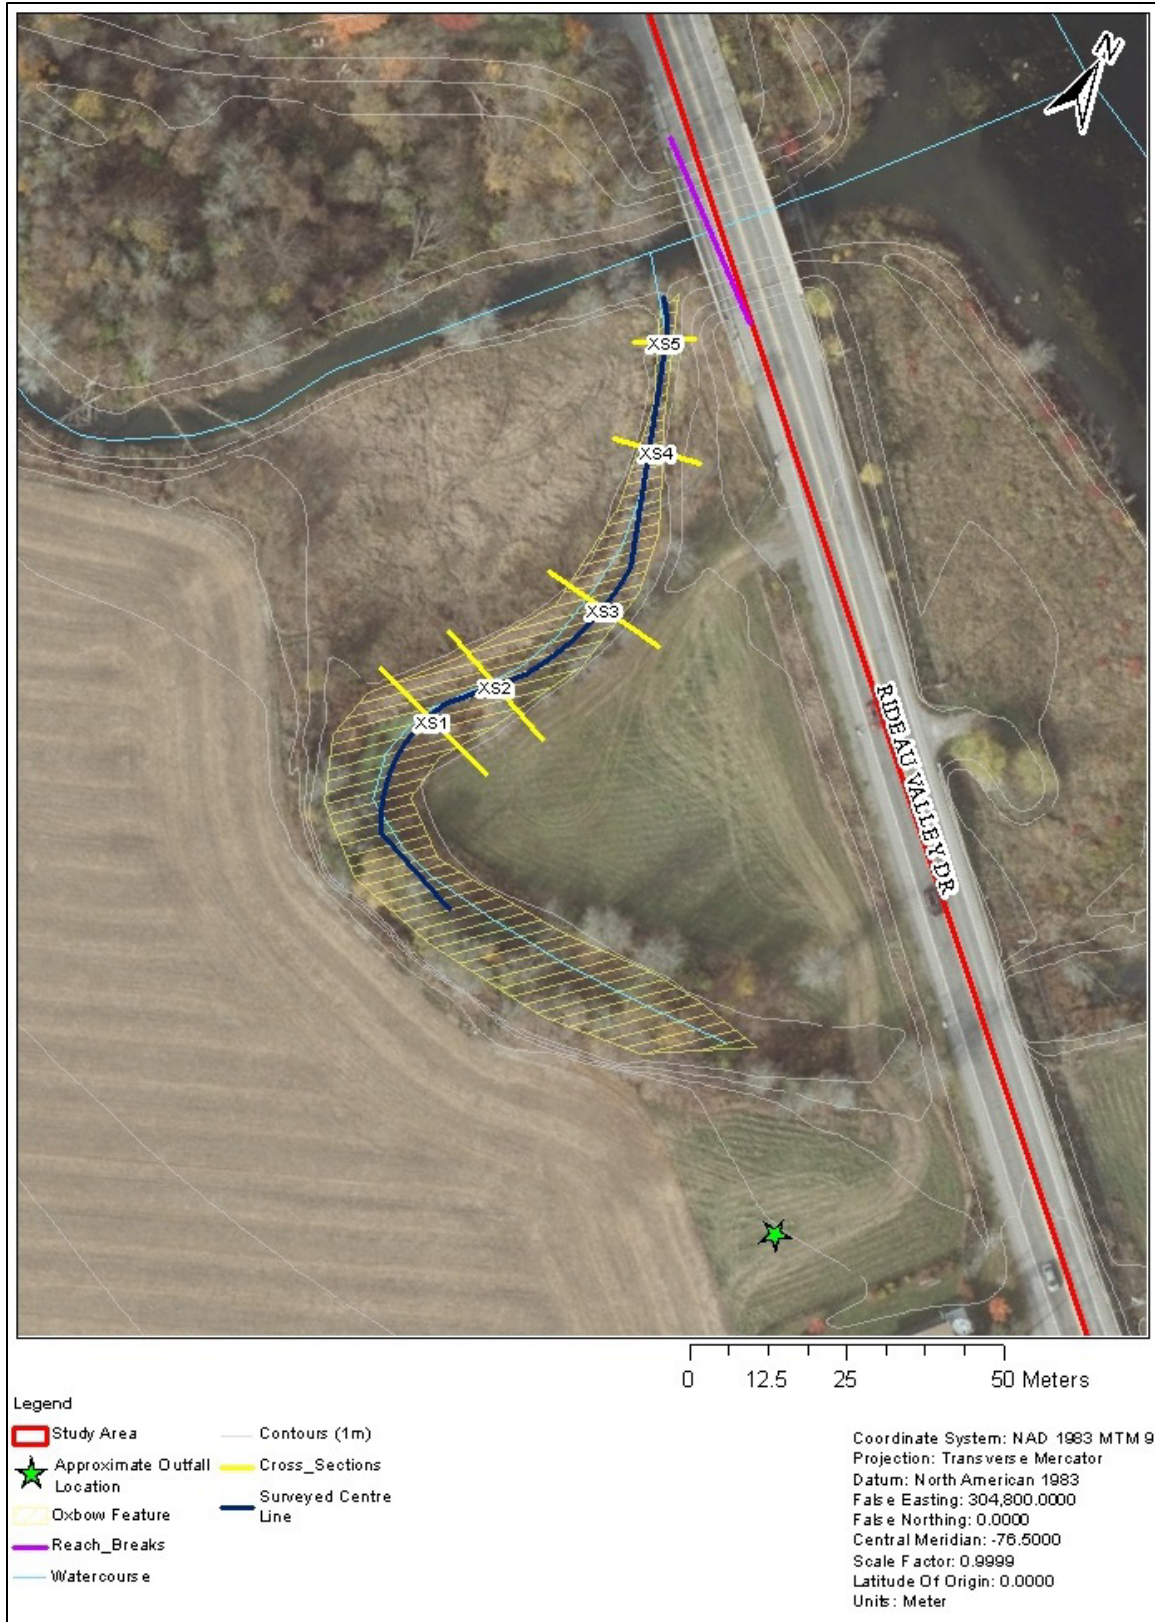
FIGURE 4 Survey Extents and Cross-section Locations Within the Oxbow Feature

The oxbow feature consists of a depression/scar that represents a historic meander of Mud Creek (Figure 4). This is assumed to be a relic feature of Mud Creek based on the feature dimension, orientation/position relative to the upstream planform trends, and straight planform of Mud Creek approaching Rideau Valley Drive. As noted in the historical assessment (Section 14), it has been interpreted that the channel was straightened to support the construction of Rideau Valley Drive prior to 1954 (earliest available air photograph set). The oxbow is approximately 175 m in length and varies in feature width from 2 to 15 m. Observations were made for the length of the feature, extending to Mud

Creek, with detailed surveys of profile and cross-sections being completed for a portion from the apex extending across Mud Creek (Figure 4). Standing water was observed within the feature during the field assessment, with depths exceeding 1.5 m, having a thick layer of unconsolidated silts. The outer banks of the oxbow were well-defined and exhibited signs of previous erosion. The oxbow is currently situated between cropped land to the north and the densely vegetated valley contact to the south. Where defined, widths ranged between 2 and 4 m, while depths ranged between 0.07 and 0.15 m. The entire oxbow is well-vegetated with reeds and cattails. The water depth increases toward the bend in the oxbow with standing water and saturated ground, allowing for survey rods to sink upwards of 0.5 m deep into the sediment. The oxbow becomes shallower in water depth approaching Mud Creek. Evidence of erosion was noted around the confluence with Mud Creek as a result of water flowing over the bank; however, no water was actively flowing from the oxbow into Mud Creek at the time of the site visit and is assumed to occur following precipitation/melt events.

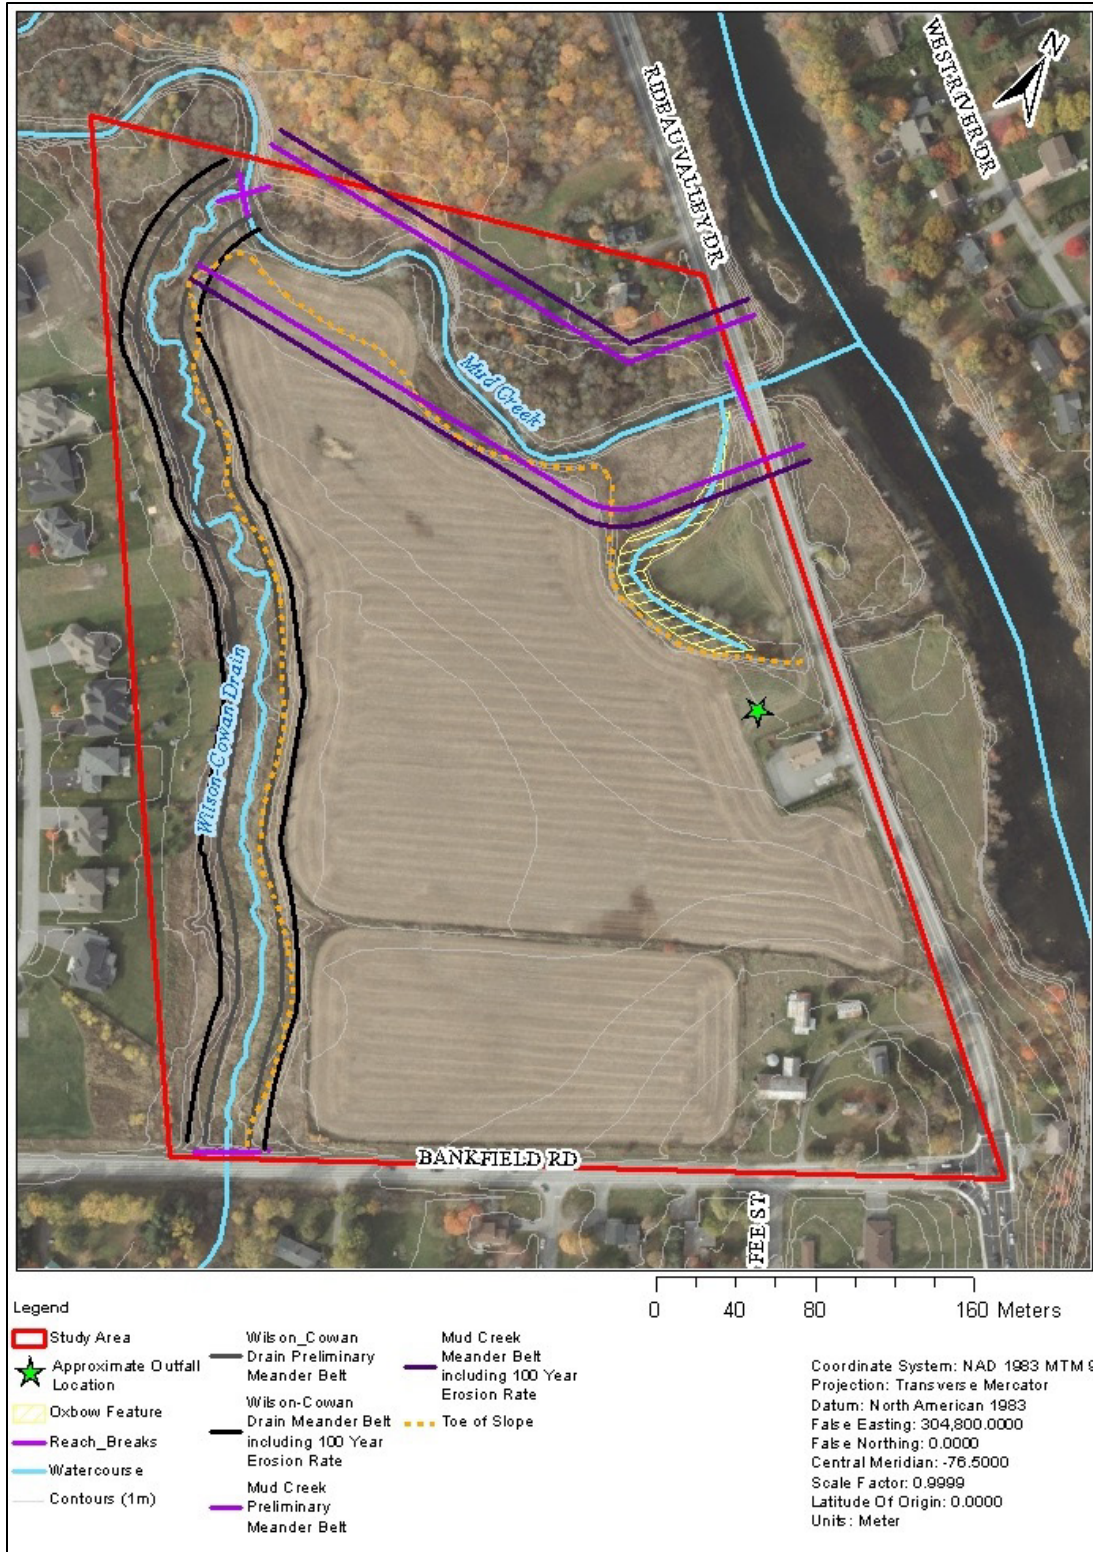
FIGURE 6 Meander Belt Delineation

The confinement of the two channels varied can be seen in Figure 6, meaning the greater hazard of the two approaches was used to provide a final hazard limit. Clay-silt was noted as the dominant substrate during the field investigations, and due to evidence of erosion noted within both channels, a toe erosion allowance of 5 m was selected using the Technical Guide (MNR 2002b) for areas where the watercourse was within 15 m of the valley toe. This value of 5 m also agrees with the findings and recommendations of the Paterson Group Inc. (2021), which applied a 5 m toe erosion allowance to Mud Creek due to its soil type and erosion activity. The 5 m toe erosion allowance was also applied to the Wilson-Cowan Drain due to the observed soil type and the active erosion noted during the field investigations. This value differs from the 1 m toe erosion allowance reported in the Paterson (2021) geotechnical study, as they had not observed active erosion.

Mud Creek and the Wilson-Cowan Drain can be considered confined channels, as their meander belt widths with 100-year erosion rates extend beyond the toe of slope.

The preliminary meander belt width derived for the unconfined portion of Mud Creek is 60 m, as determined from the maximum meander amplitude offset from the meander axis. A 100-year erosion rate of 0.2 m/year (or 20 m per 100 years) was calculated, resulting in a final meander belt width of 80 m. For Wilson-Cowan Drain, the preliminary meander belt was determined to be 22 m in width. The final meander belt was determined by adding a 100-year erosion rate of 17 m as a factor of safety, resulting in a 38 m corridor (Figure 6). In this instance, the meander belt extends beyond the toe and top-of-slope within this confined valley setting.

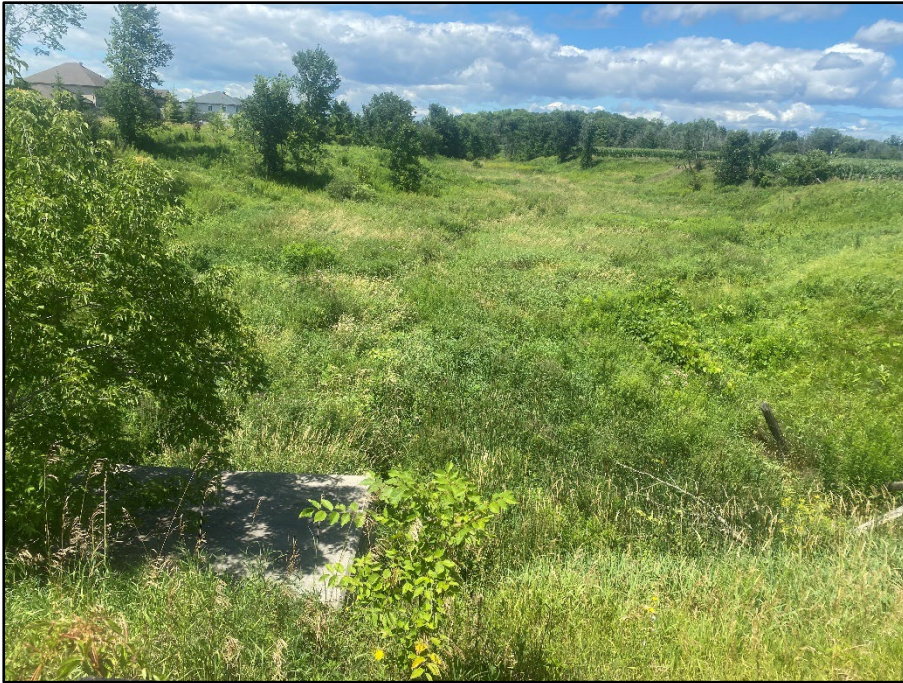
1. Wilson Cowan Drain - Facing downstream, Wilson-Cowan Drain and valley from Bankfield Road

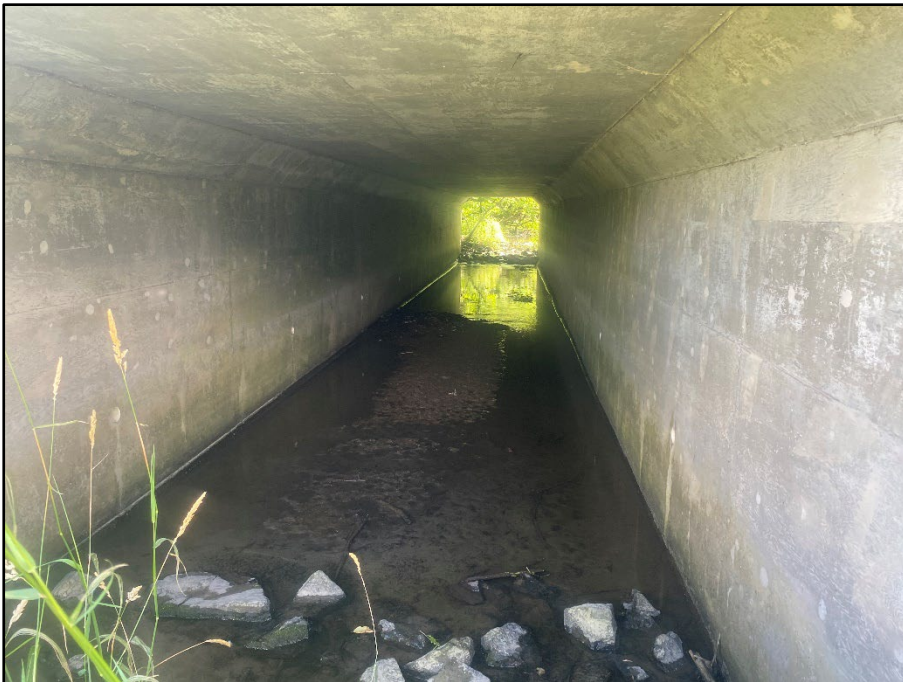
2. Wilson Cowan Drain - Facing upstream from outlet of culvert passing under Bankfield Road

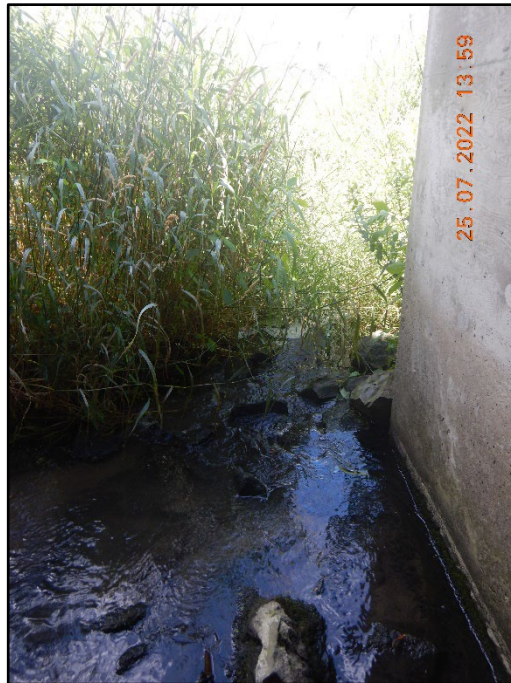
3. Wilson Cowan Drain - Facing downstream from inside culvert, the flow path is to the right side of the culvert flowing into a defined channel

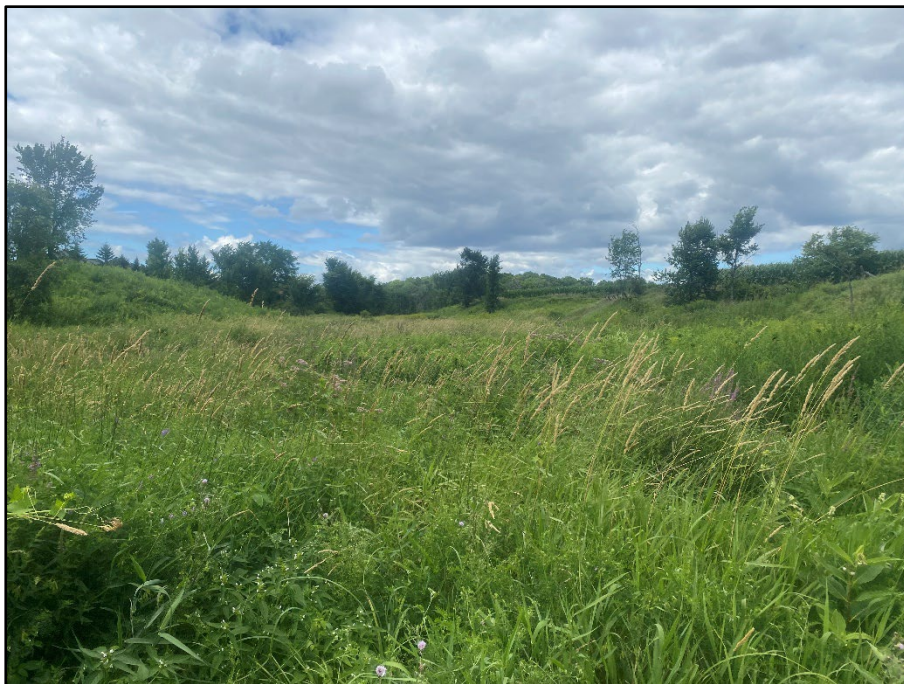
4. Wilson Cowan Drain - Facing downstream from culvert, the valley is well vegetated with tall grasses and aquatic vegetation

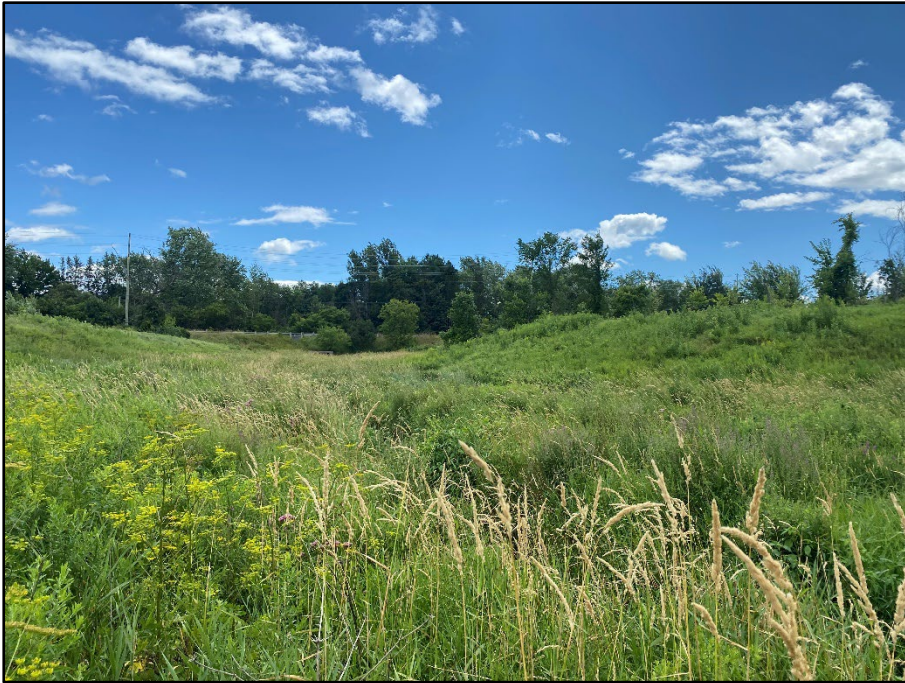
5. Wilson Cowan Drain - Looking upstream, despite being well vegetated, the channel maintains it's definition along the reach

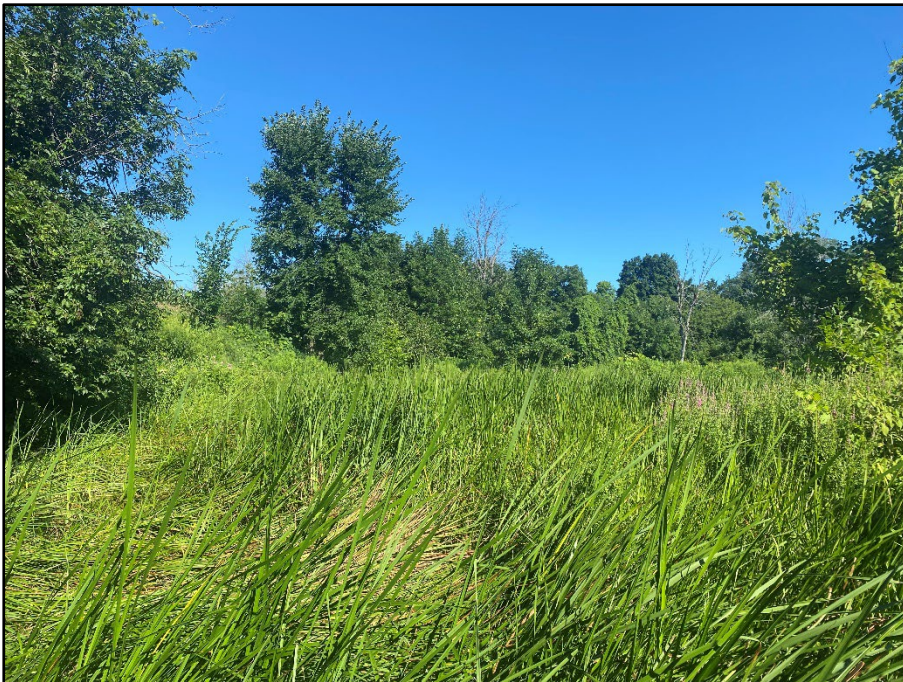
14. Oxbow Feature– Facing downstream, between the define banks, the feature is heavily grasses but maintains water
