**re: Slope Stability Assessment of Existing Slope Failure**  
Existing Residential Dwelling  
1320 Grand-Chêne Court – Ottawa, Ontario

**date:** November 13, 2023

**file:** PG5201-MEMO.03

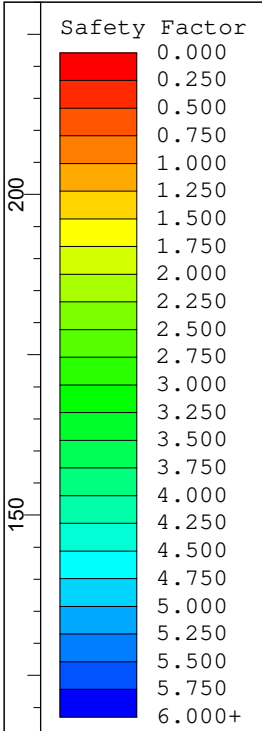
The results for the slope stability analysis at Section A are shown in Figure 1A, attached to the present memo report. The factor of safety was found to be less than 1.5 and mostly affecting the infilled portion of the slope. The lower factor of safety can be attributed to increased grade raise and surcharge along the top of the slope. Based on our review, the above-mentioned lowest factor of safety generally coincided with the location of the observed existing failure surface at the top of slope.

It is recommended to restrict the potential for any grade raise or landscaping work that could result in raising the ground surface throughout the 1320 and 1325 Grand-Chêne Court parcels until further investigations and analysis have been completed to verify the in-situ soil characteristics.
