## Appendix 5

### Fluvial Geomorphological Detailed Information

## INTRODUCTION

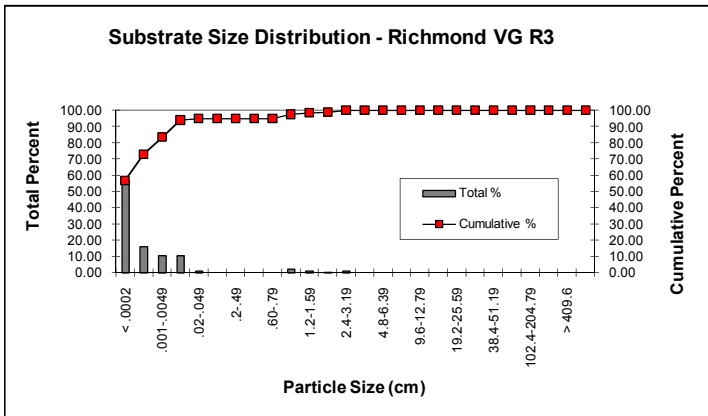
XS1 - Soft unconsolidated substrate

XS3 - Same conditions as XS 1&2, heavy veg, low flow

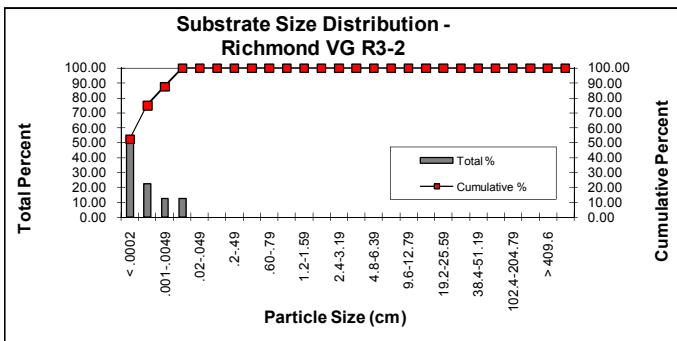
XS1 - Located in one of the few areas with water in channel  
 Wood debris in channel both US & DS of XS  
 Mature trees in channel (growing)  
 XS2 - Difficult to pin banks due to lack of water in channel  
 Major debris in channel, mature trees growing in channel  
 TOB XS GPS - 0433943  
 Erosion Pins - RB @ XS - 25.5cm, LB 4m DS - 30cm  
 XS3 - No water  
 Mature trees in channel and along banks  
 XS4 - Reach is dry, heavily wooded, very thick  
 XS5 - SEE XS 1-4

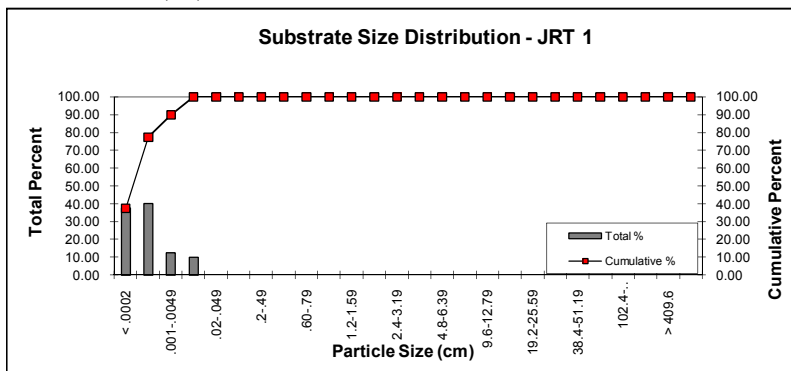
XS1 - TOB - GPS Coordinates - 0434161, 5002959

Channel is heavily vegetated with tall grasses on both banks

Little or no particles in substrate (all clay)
