# **Kanata West Development Area Meander Belt Width Assessment and Erosion Analysis**

## **Feedmill Creek**

### **Draft Report**

Report Title: Kanata West Development Area Meander Belt  
Assessment and Erosion Analysis, Feedmill Creek

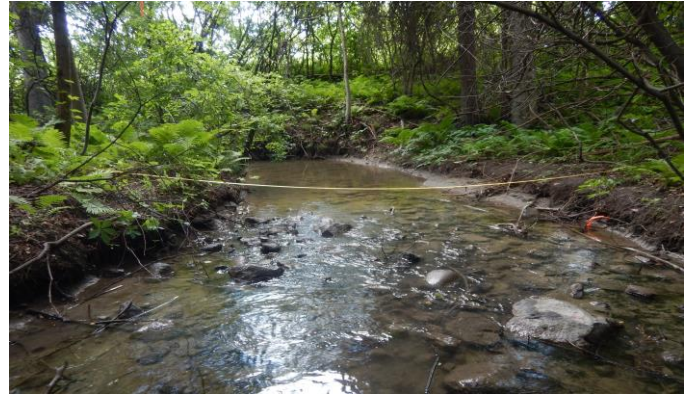
Photograph at cross section 4 (looking downstream)

Reach 3 follows a meandering path within a continuous cedar forest. The reach is partially confined, has a moderate gradient and a meander amplitude of approximately 15 m. Riffles and pools are well-developed. Some riffles within the reach but outside of the surveyed extent were much longer than those surveyed. Bed substrate ranged from clay to large cobbles. Sand deposits were noted on meander bends. Bank angles ranged from 60 to 90° with undercuts up to 0.5 m but typically in the range of 0.20 m. Bank erosion was 30-60%. Most banks were well supported by both fine and large woody root matrix. Woody debris was frequently encountered in the channel.
