3194 Jockvale Road Development Tree Conservation Report

December 2018
Prepared for Richcraft Homes Inc.

RE: Tree Conservation Report for the 3194 Jockvale Road Development

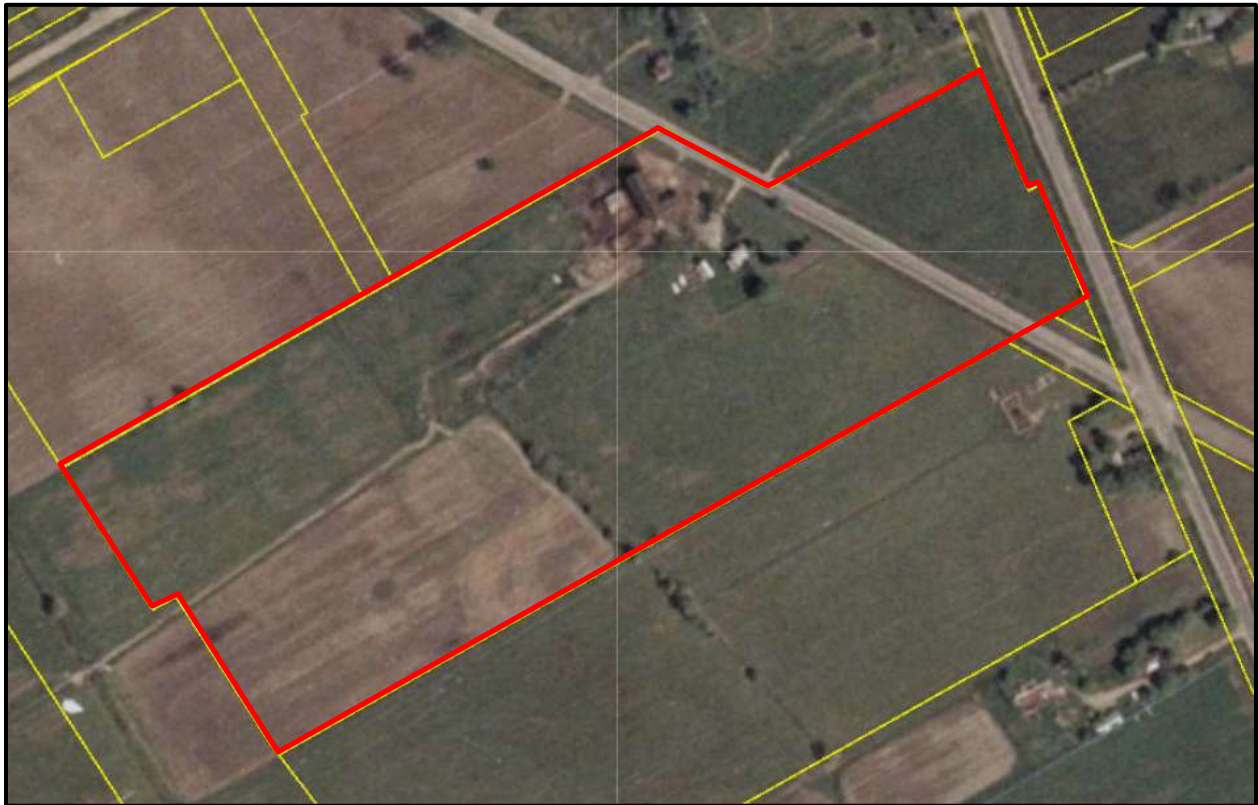
Historic Air Photograph 1: Historic Air Photo from 1976 (Site limits shown in red). Note the Site appears to be farmed. In 1976, there appears to be very little tree cover within the Site, with only a few young trees present in the southern part of the Site (Tree Stand M) and around the historic farmhouse (Photos from City of Ottawa 2018).

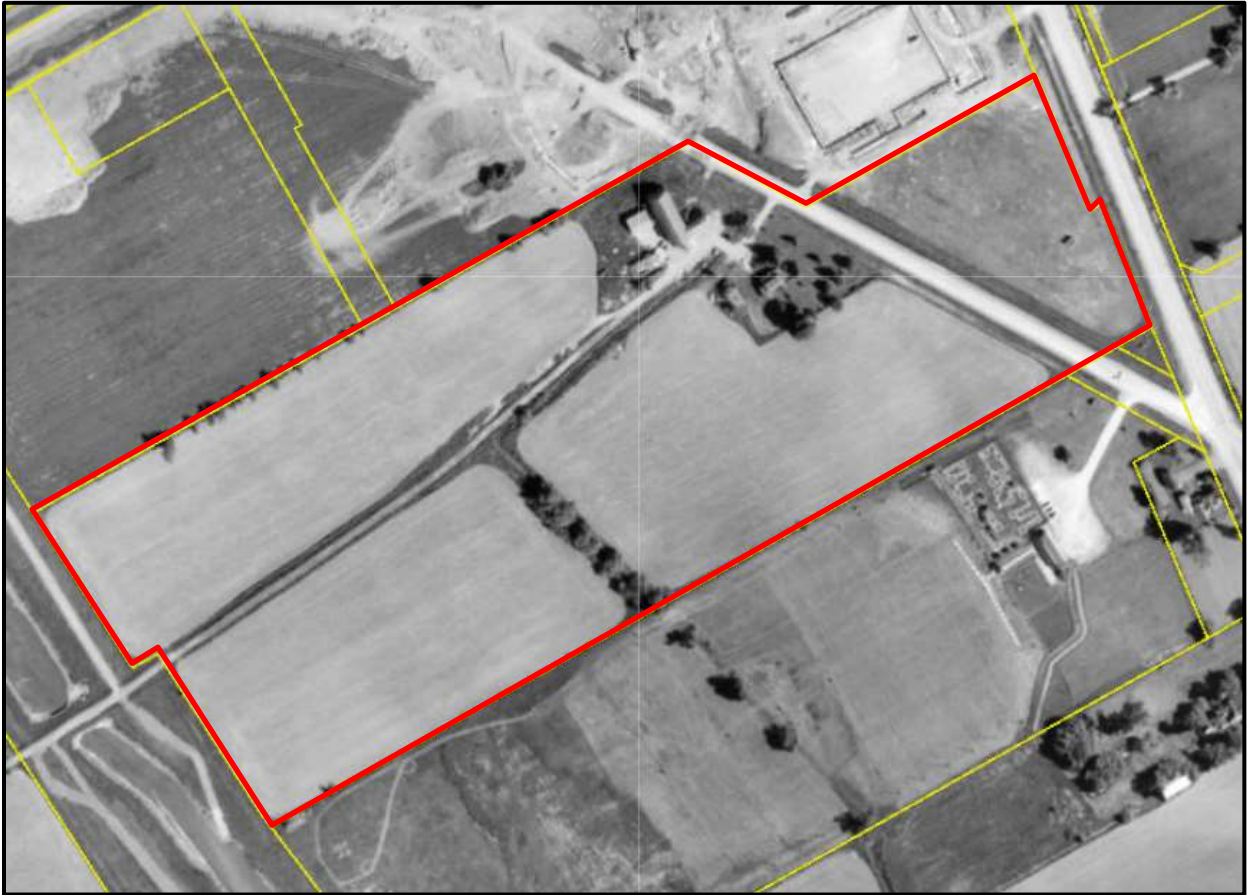
Historic Air Photograph 2: Historic Air Photo from 1991 (Site limits shown in red). Note the Site appears to be farmed in 1991. By 1991, trees found within the southern part of the Site (Tree Stand M) appear more mature, and additional stems are visible around the farmhouse (Photos from City of Ottawa 2018).

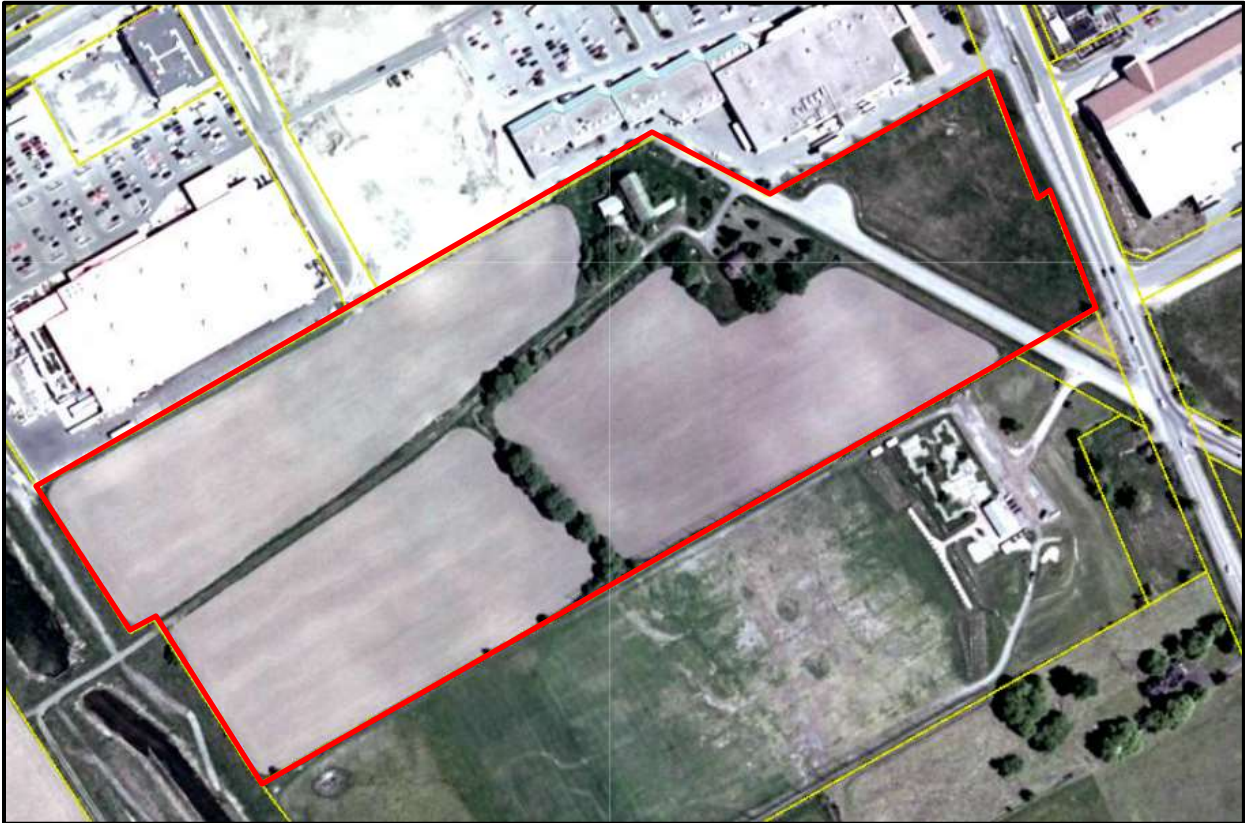
Historic Air Photograph 3: Historic Air Photo from 2005 (Site limits shown in red). Note the Site appears to be farmed in 2005. By 2005, the Deciduous Hedgerows (Tree Stand M) and the tree coverage surrounding the farmhouse have expanded. The farmhouse, barn, and other agricultural buildings that are visible within the historic air photos were demolished sometime after 2005 (Photos from City of Ottawa 2018).

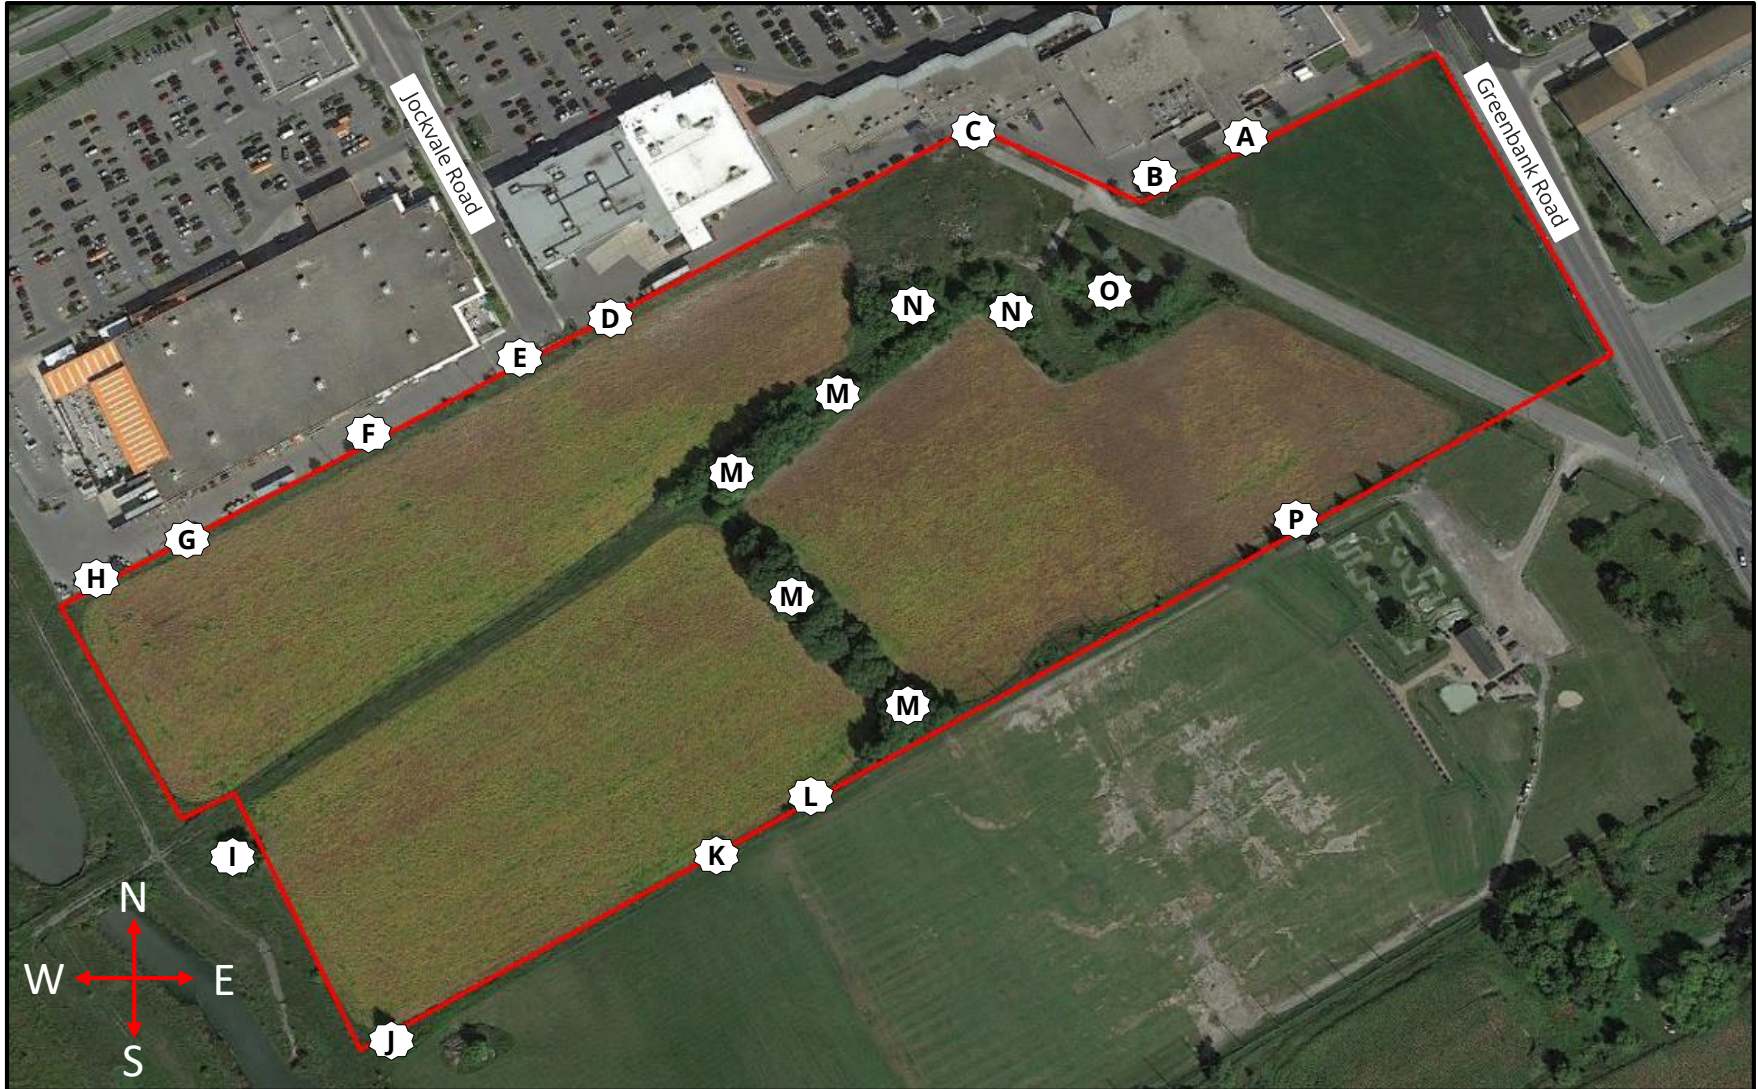
FIGURE 2: TREE LOCATIONS

As noted above, due to the fragmented nature of the remaining tree cover within the Site, trees were not classified according to Ecological Land Classification vegetation communities. Instead, individual tree stands were identified and are described below. Tree stand locations are shown in Figure 2. Photographs of each Tree Stand are included in Appendix A. The following tree stands were noted within the Site:

In summary, no tree retention within the development area is recommended. Where feasible, trees that occur within adjacent properties and/or at the property line should be retained during development. These include Tree Stands A, C, D, E, F, G, and H. Mitigation measures to protect retained trees on adjacent properties are discussed below.
