Geotechnical Investigation

Proposed Multi-Storey Building St. Joseph Boulevard and Duford Drive Ottawa, Ontario

January 18, 2018

Report: PG4083-1 Revision 2

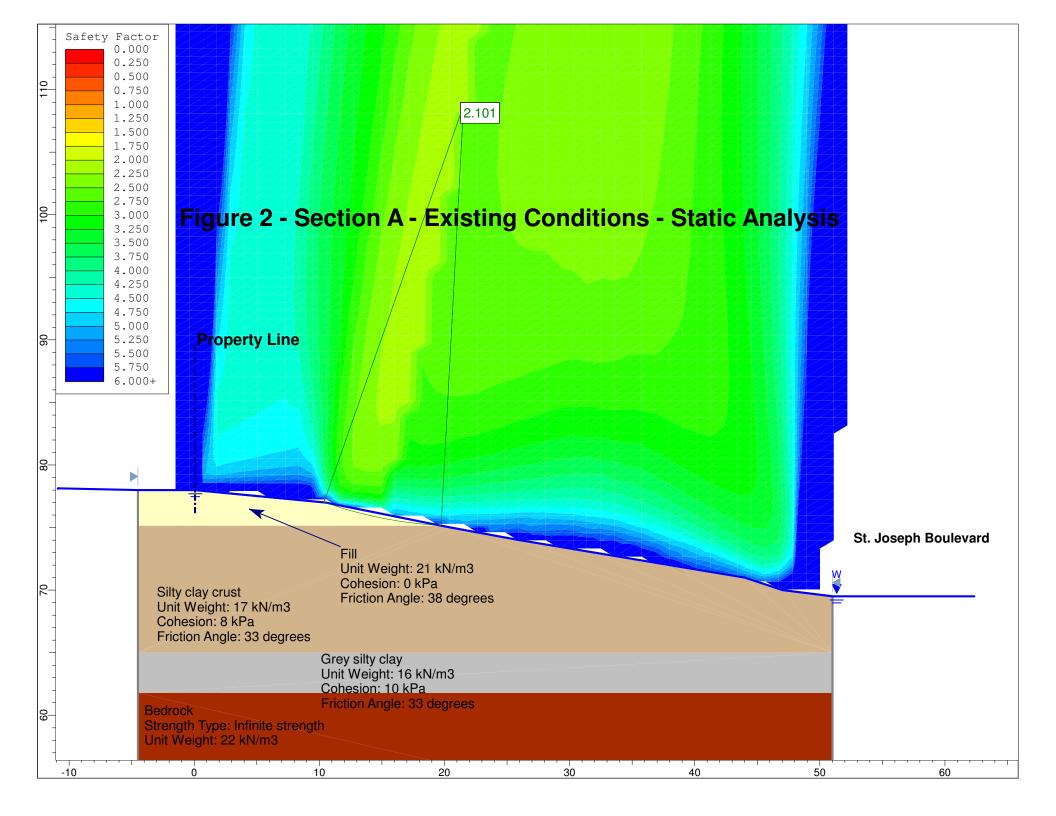
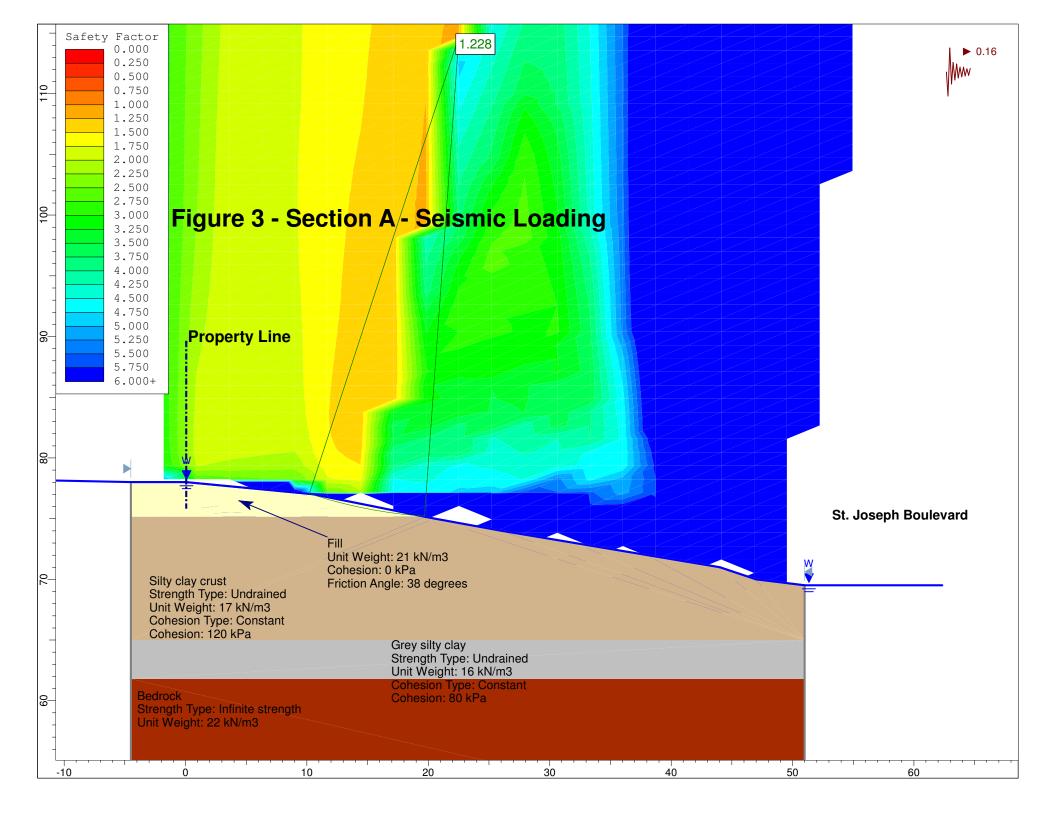
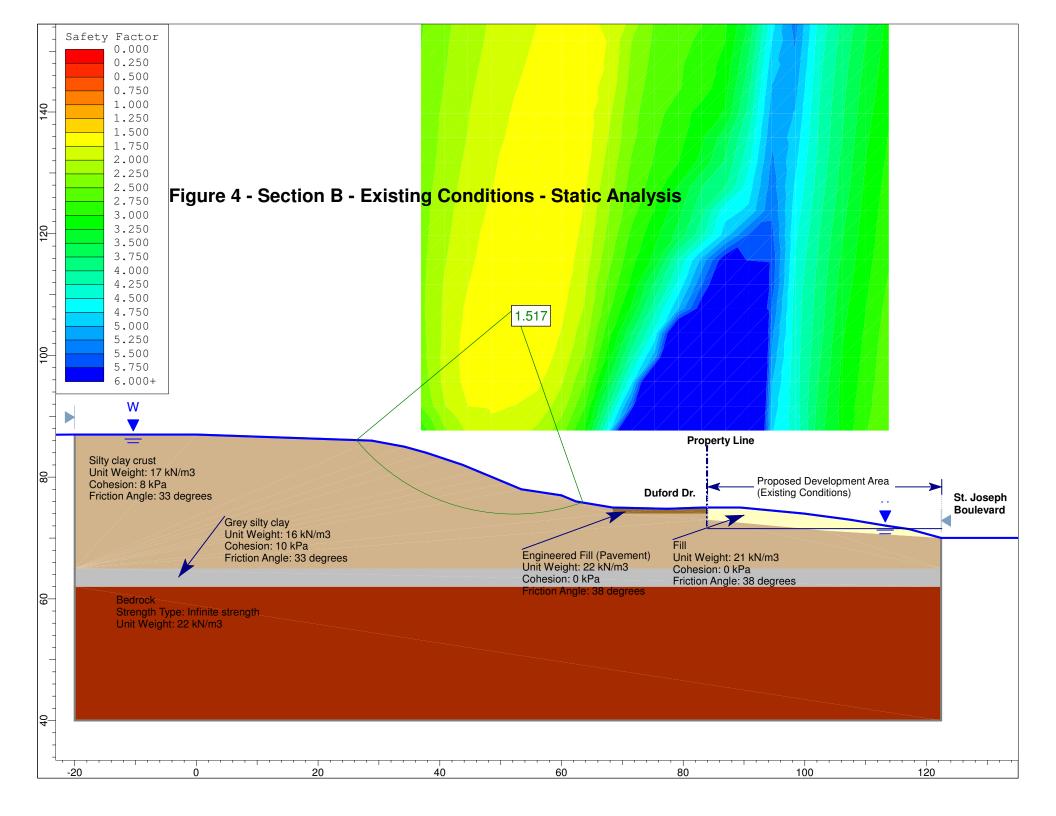
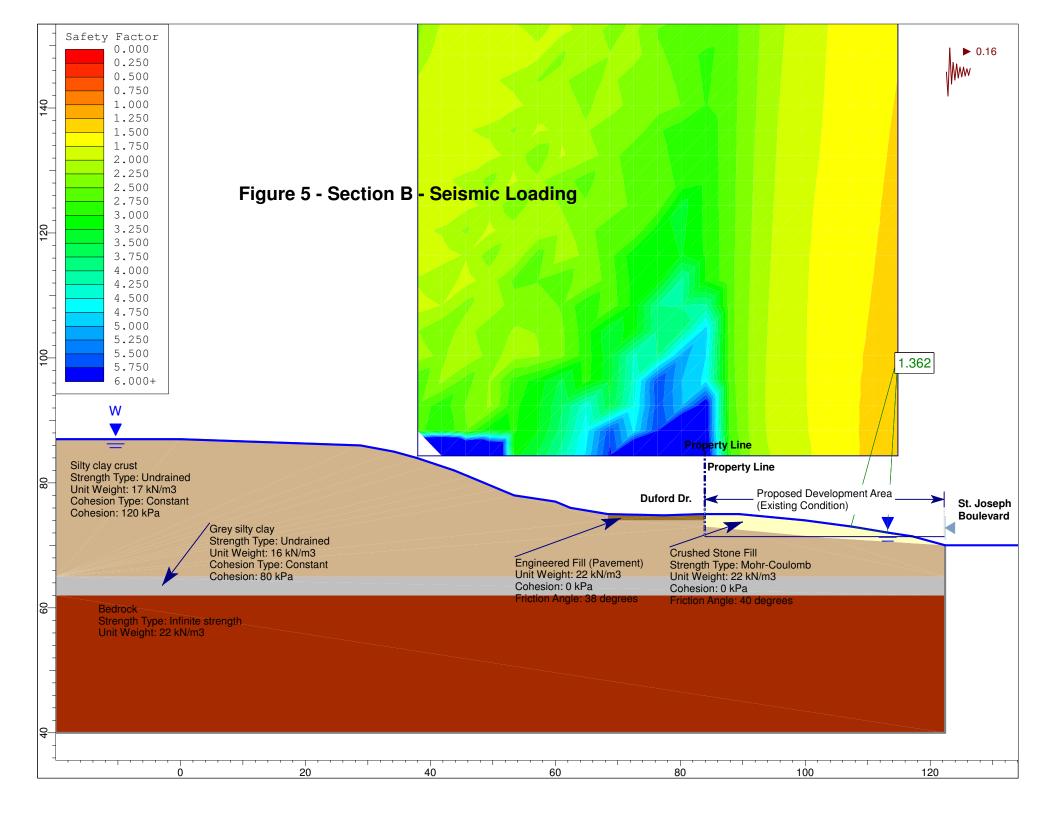
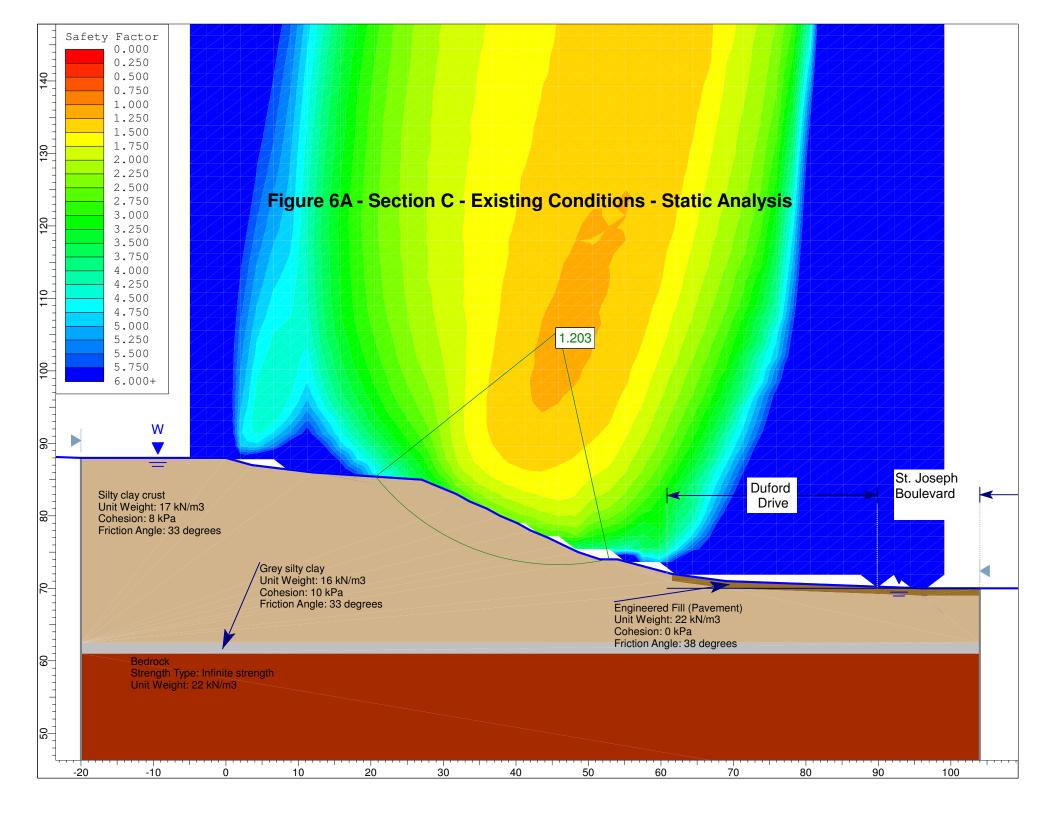
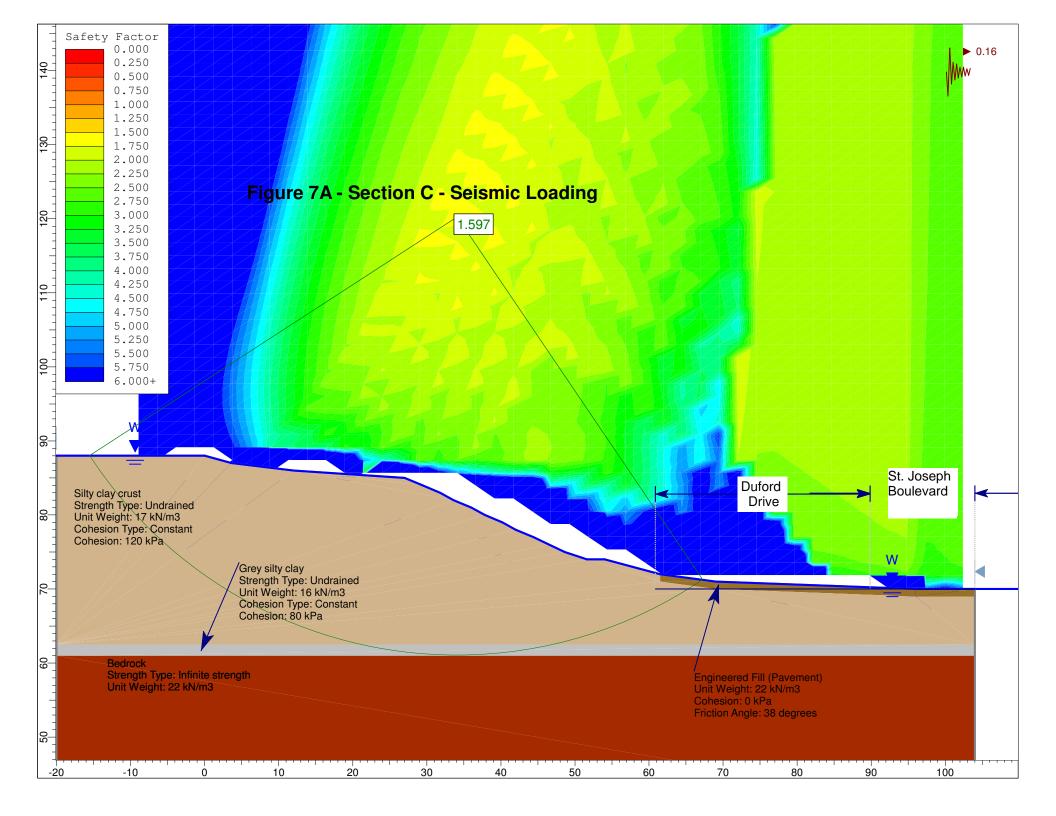
The results of the analyses including seismic loading are shown in Figure 3, Figure 5, and Figure 7B for the slope sections. The results indicate that the factor of safety at Section A, B and C is greater than 1.1. Based on these results, the slopes are considered to be stable under seismic loading.
