**Phase One Environmental Site Assessment
Proposed School Development
2405 and 2419 Mer Bleue Road
Ottawa, Ontario**

May 28, 2018
Project: 62721.07

**Re: Phase One Environmental Site Assessment
2405 and 2419 Mer Bleue Road, Ottawa, Ontario**

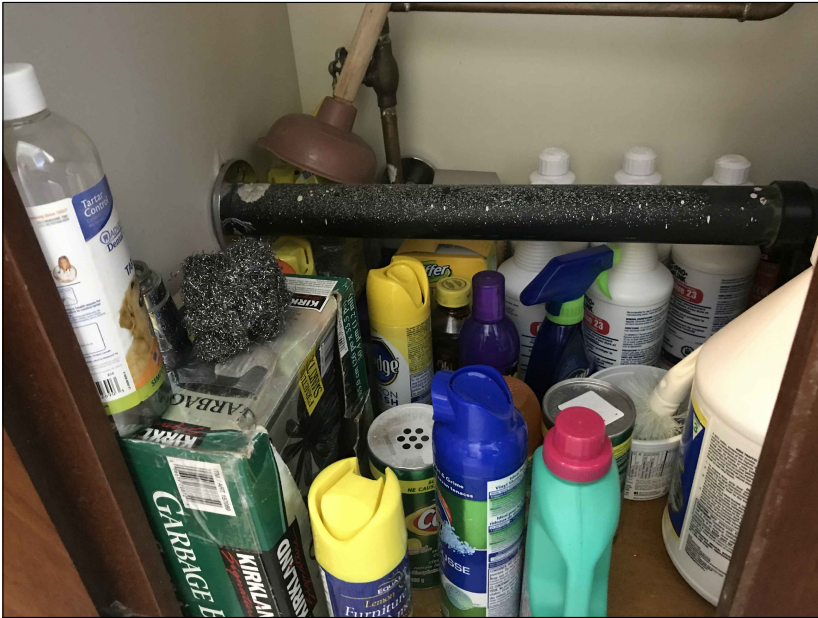
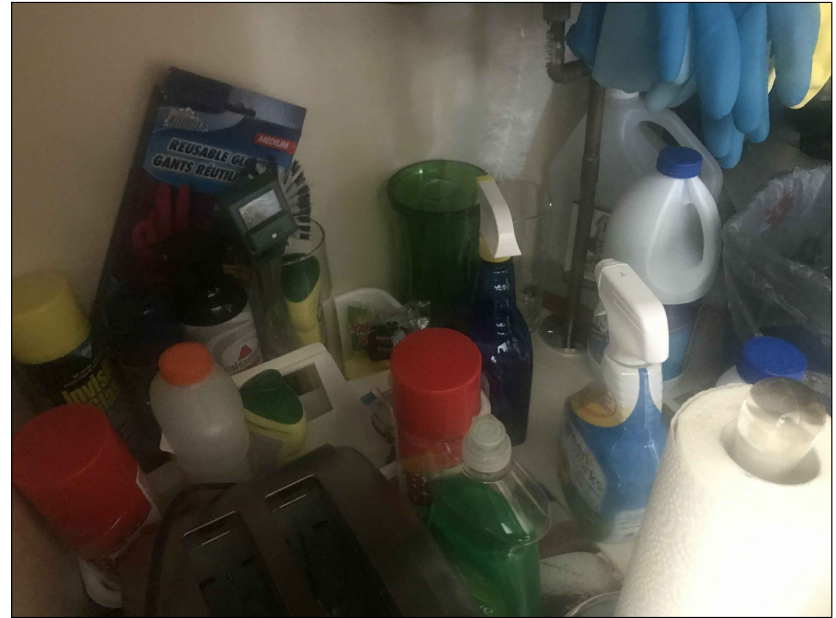
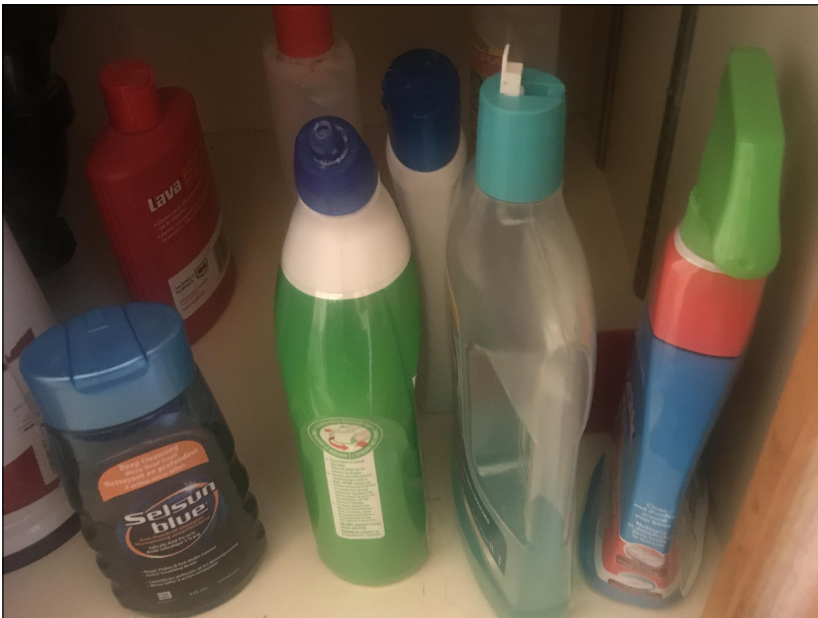
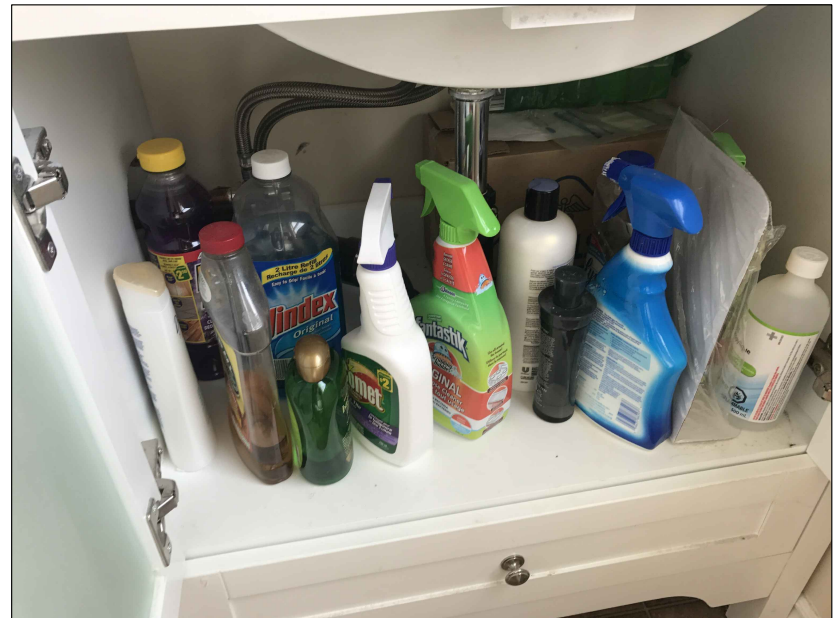
SITE PHOTO
PAINTS STORED ON
THE SUBJECT PROPERTY
