| Project:<br><b>Gladstone and Loretta</b> | |
| Drawing:<br><b>TREE CONSERVATION REPORT</b> | |
| Project Number:<br>1987-01 | Sheet Number:<br>TCR 1.0 |

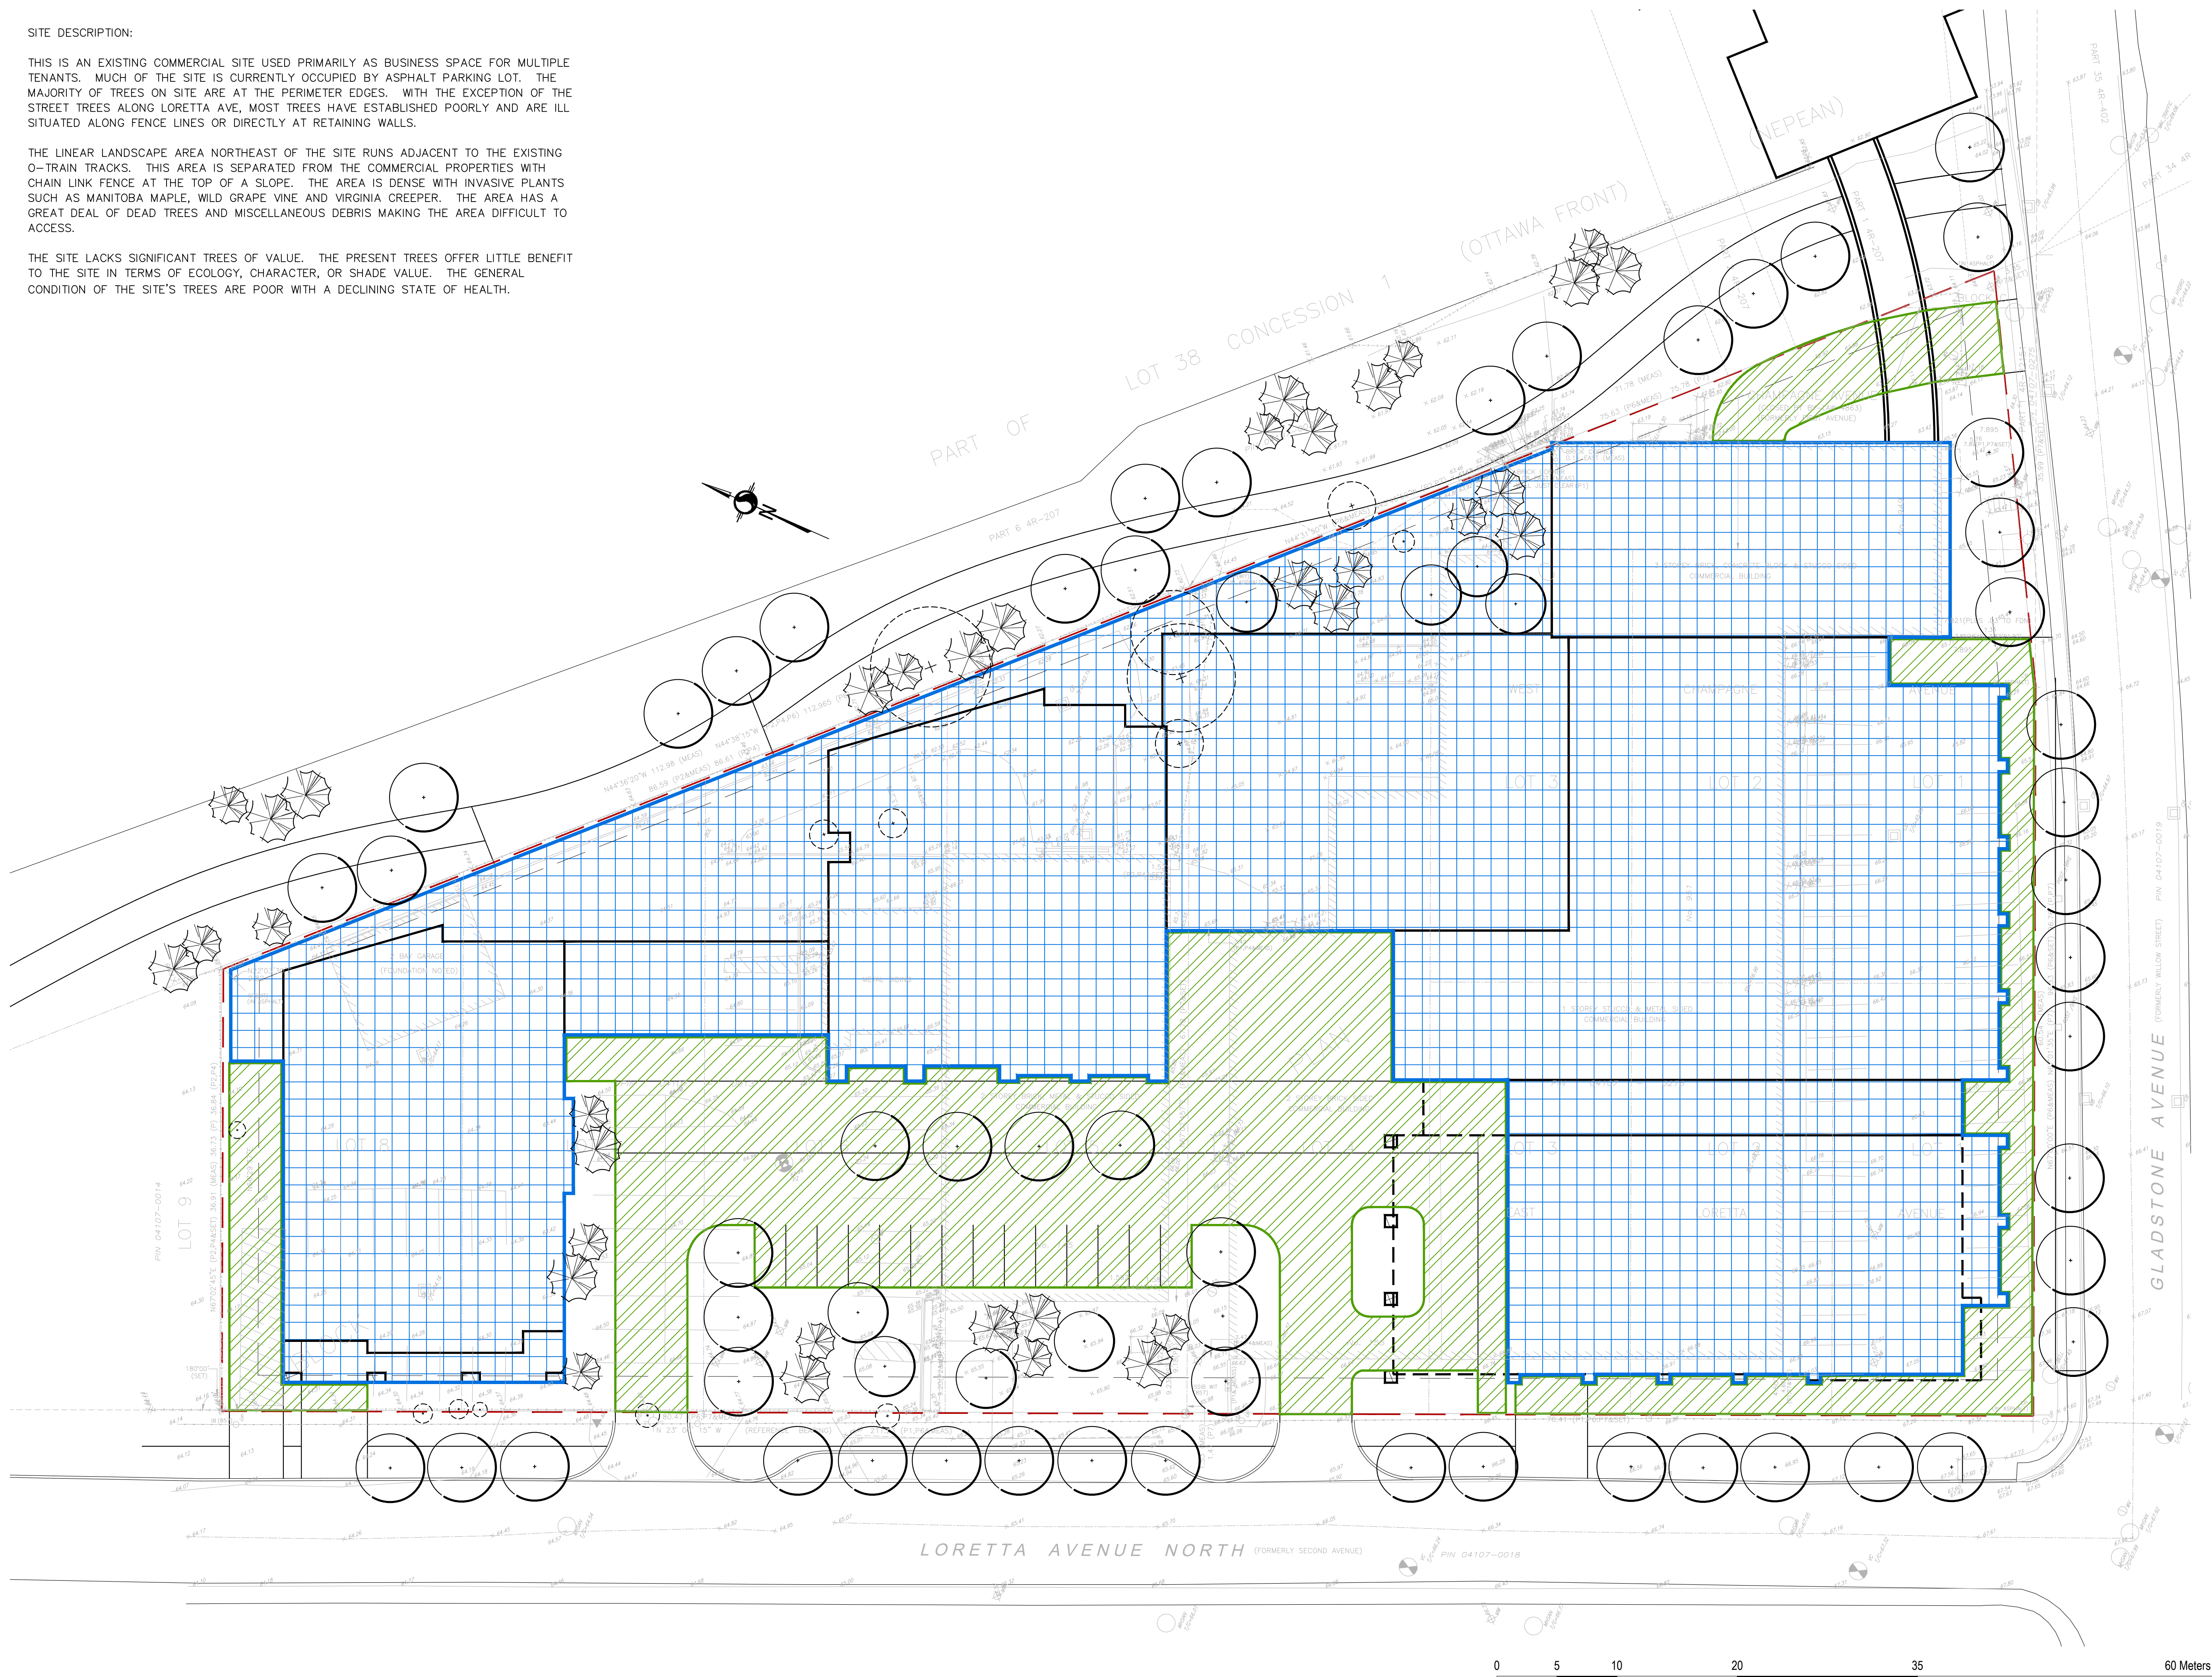
THIS IS AN EXISTING COMMERCIAL SITE USED PRIMARILY AS BUSINESS SPACE FOR MULTIPLE TENANTS. MUCH OF THE SITE IS CURRENTLY OCCUPIED BY ASPHALT PARKING LOT. THE MAJORITY OF TREES ON SITE ARE AT THE PERIMETER EDGES. WITH THE EXCEPTION OF THE STREET TREES ALONG LORETTA AVE, MOST TREES HAVE ESTABLISHED POORLY AND ARE ILL SITUATED ALONG FENCE LINES OR DIRECTLY AT RETAINING WALLS.

THE SITE LACKS SIGNIFICANT TREES OF VALUE. THE PRESENT TREES OFFER LITTLE BENEFIT TO THE SITE IN TERMS OF ECOLOGY, CHARACTER, OR SHADE VALUE. THE GENERAL CONDITION OF THE SITE'S TREES ARE POOR WITH A DECLINING STATE OF HEALTH.
