Gladstone and Loretta

TREE CONSERVATION REPORT

| 1987-01 | TCR 1.0 |

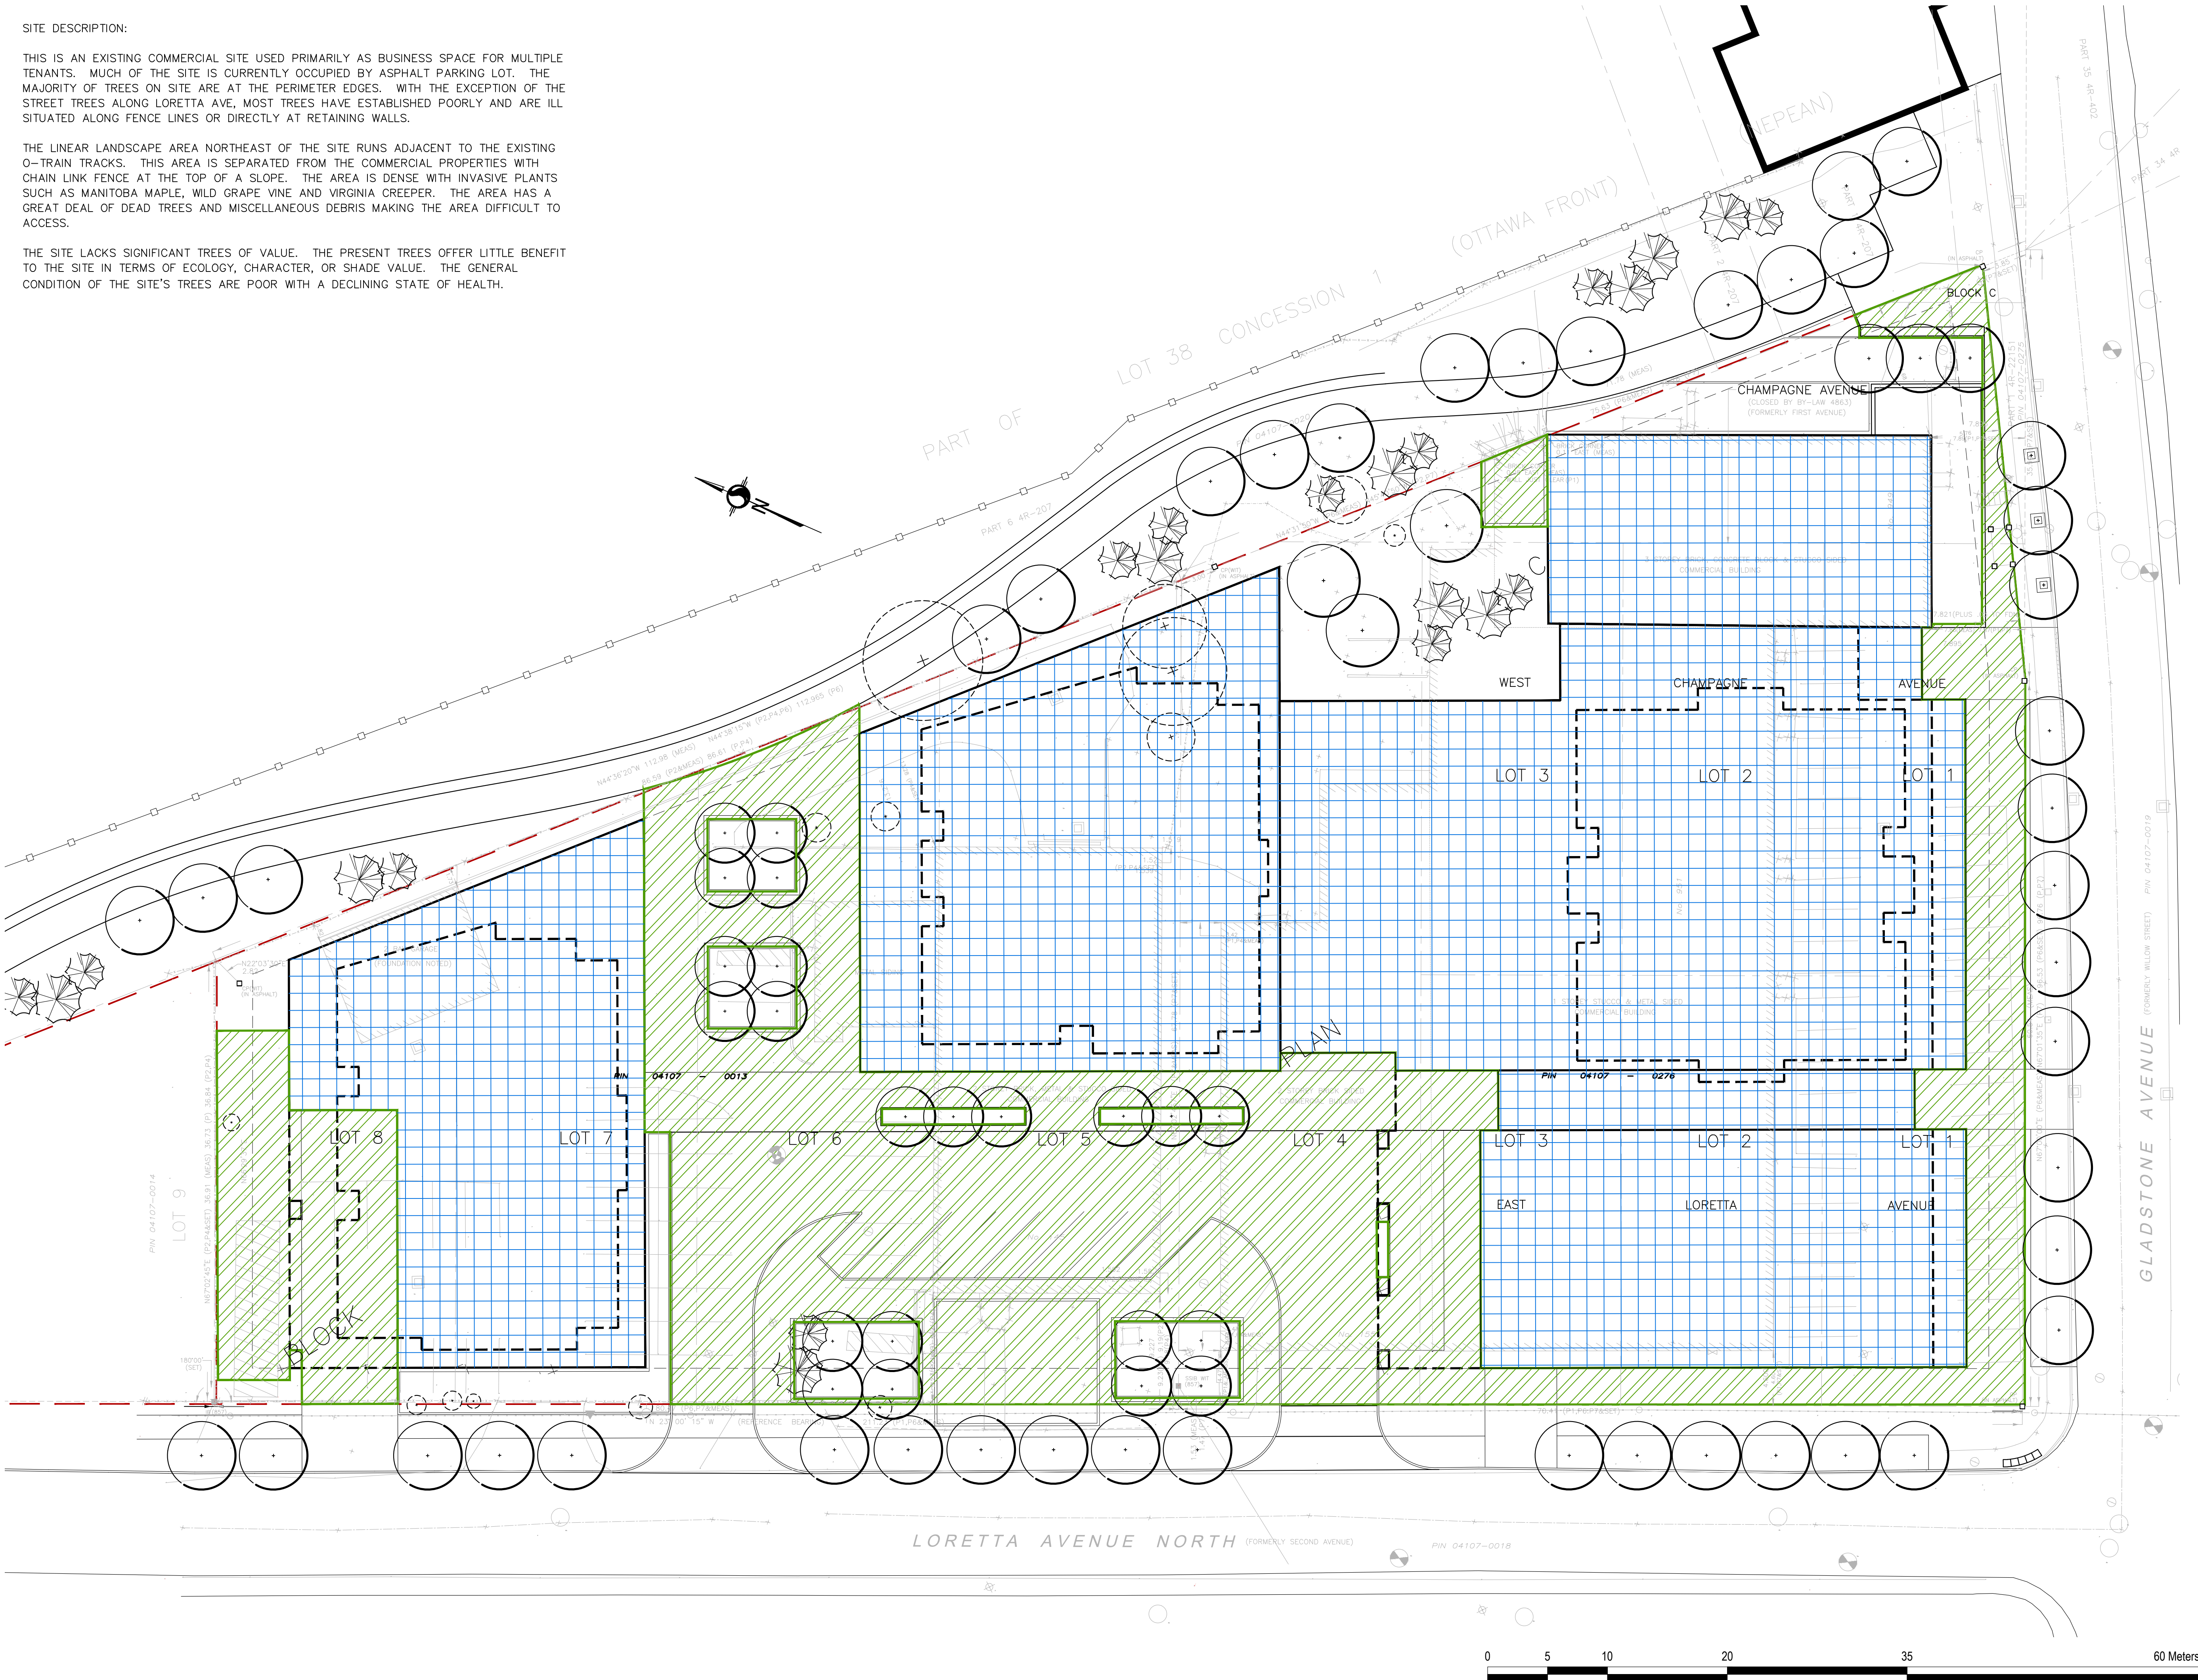
THE LINEAR LANDSCAPE AREA NORTHEAST OF THE SITE RUNS ADJACENT TO THE EXISTING O-TRAIN TRACKS. THIS AREA IS SEPARATED FROM THE COMMERCIAL PROPERTIES WITH CHAIN LINK FENCE AT THE TOP OF A SLOPE. THE AREA IS DENSE WITH INVASIVE PLANTS SUCH AS MANITOBA MAPLE, WILD GRAPE VINE AND VIRGINIA CREEPER. THE AREA HAS A GREAT DEAL OF DEAD TREES AND MISCELLANEOUS DEBRIS MAKING THE AREA DIFFICULT TO ACCESS.

THE SITE LACKS SIGNIFICANT TREES OF VALUE. THE PRESENT TREES OFFER LITTLE BENEFIT TO THE SITE IN TERMS OF ECOLOGY, CHARACTER, OR SHADE VALUE. THE GENERAL CONDITION OF THE SITE'S TREES ARE POOR WITH A DECLINING STATE OF HEALTH.
