Hazardous Building Materials Assessment

320 McRae Avenue and 311 &
315 Tweedsmuir Avenue,
Ottawa, Ontario

February 14, 2020

Pinchin File: 230236.003

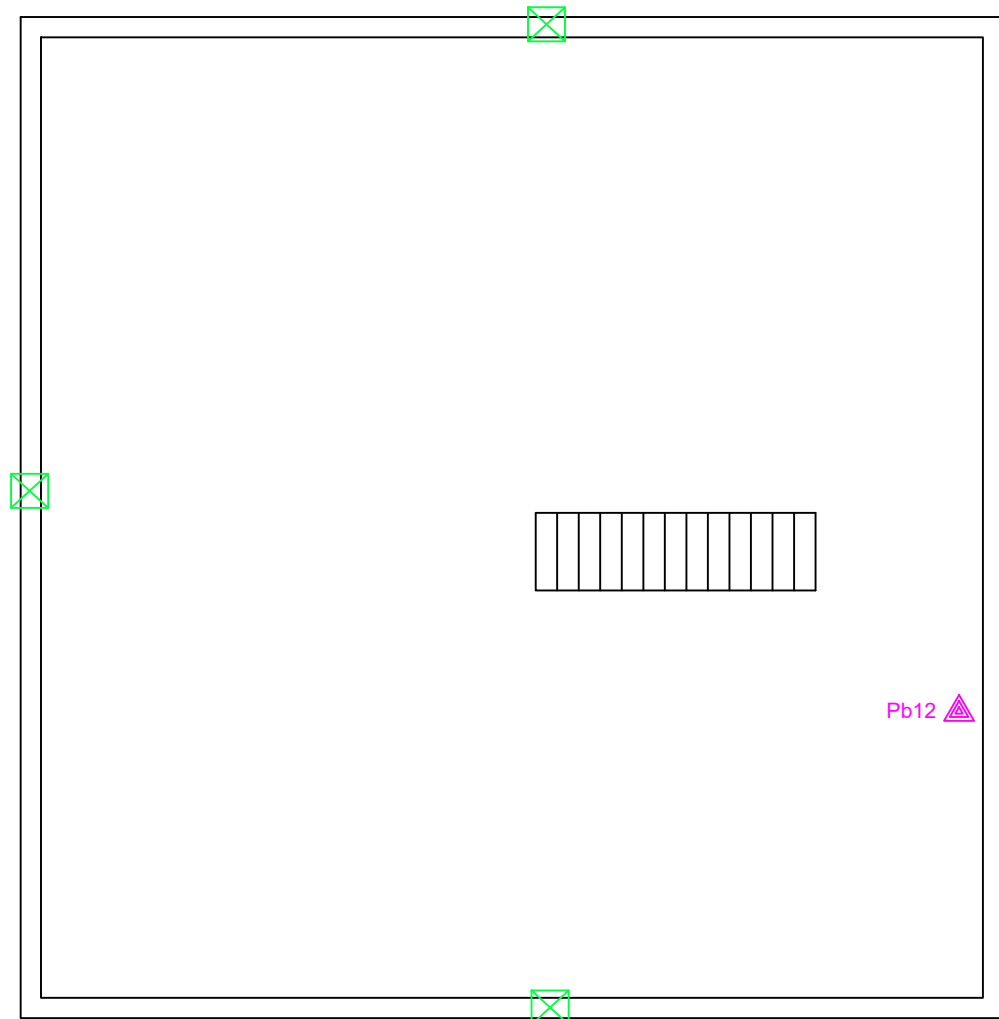
FIGURE NAME:
HAZARDOUS BUILDING
MATERIALS ASSESSMENT
BASEMENT

- ASBESTOS-CONTAINING SMOOTH PLASTER PRESENT ON WALLS AND CEILINGS THROUGHOUT HOUSE.

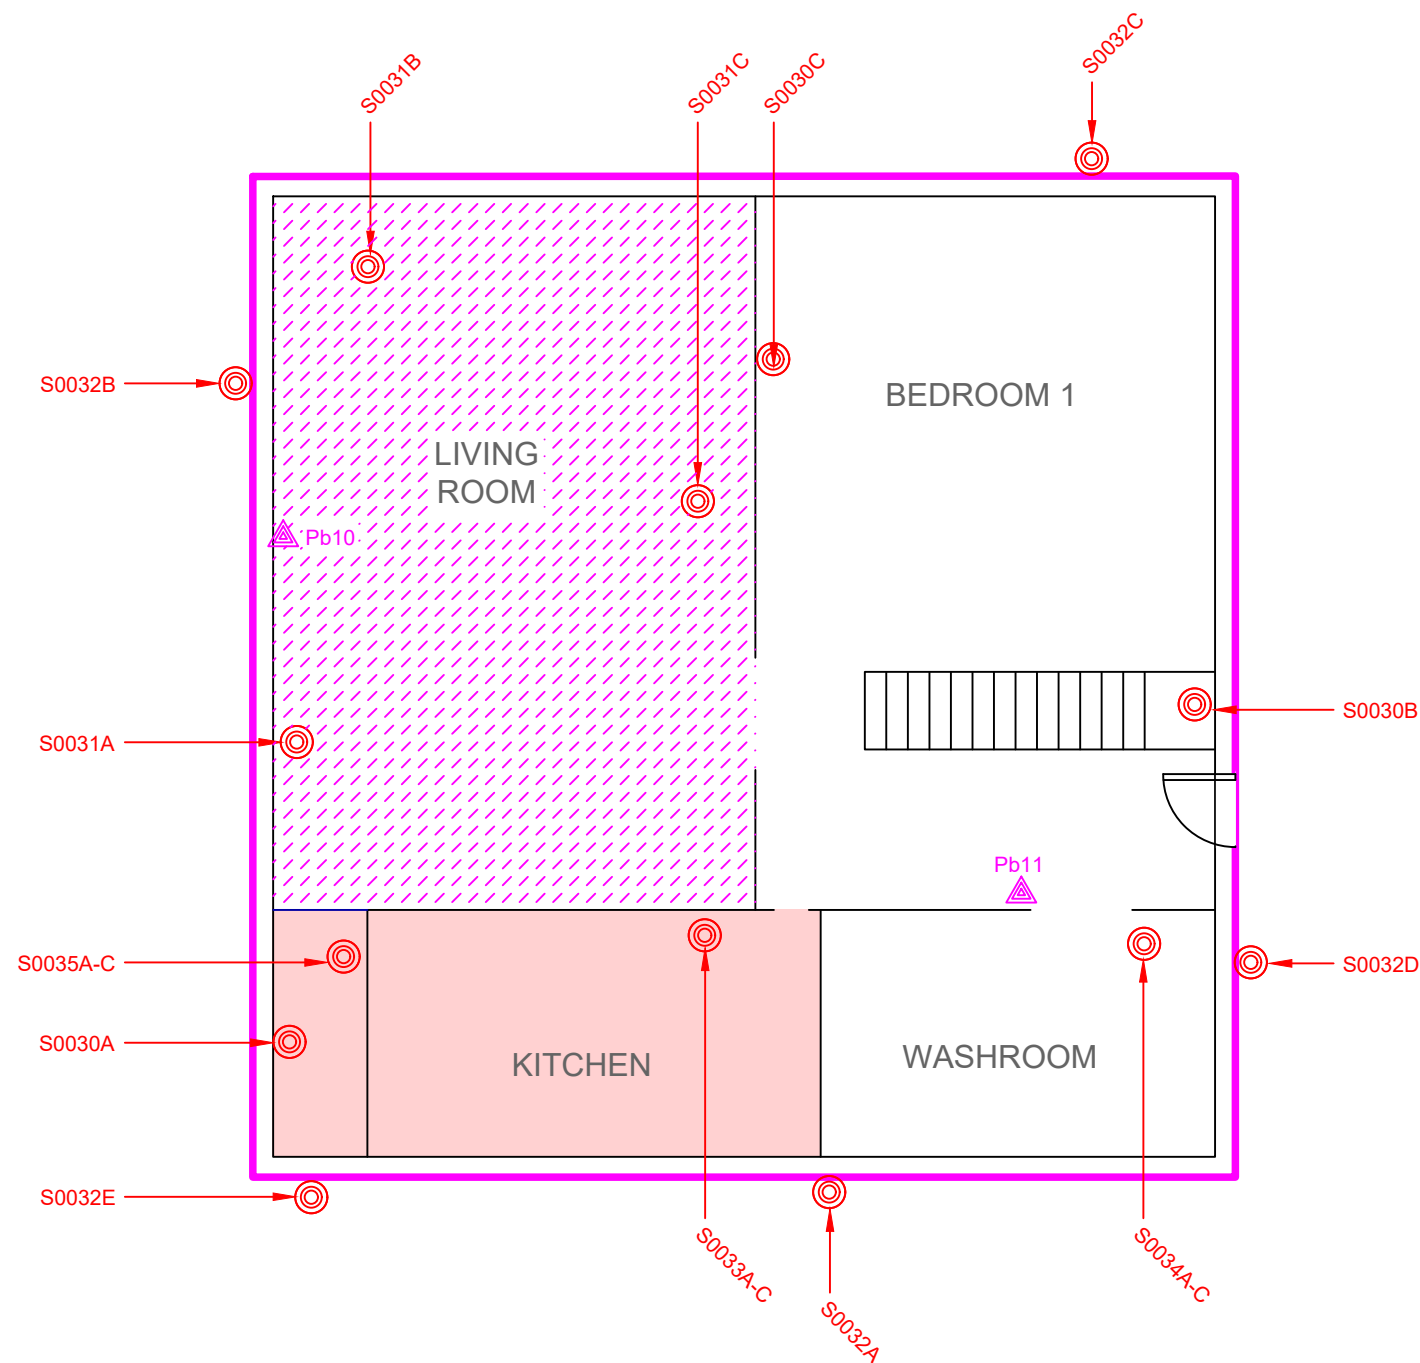
- ASBESTOS-CONTAINING SMOOTH PLASTER PRESENT ON WALLS AND CEILINGS THROUGHOUT HOUSE.
- LEAD PAINT/SURFACE COATING PRESENT ON INTERIOR TRIM.

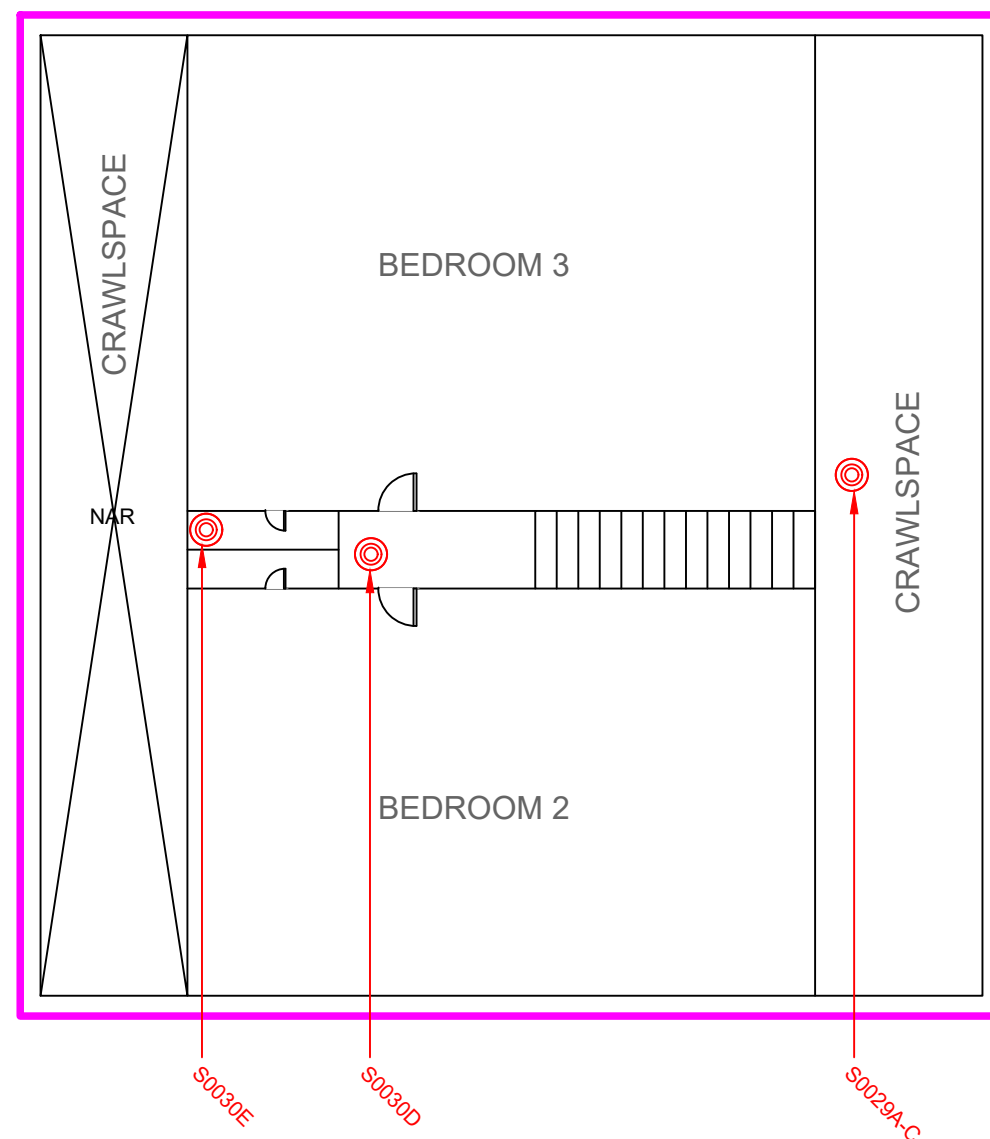
- ASBESTOS-CONTAINING SMOOTH PLASTER PRESENT ON WALLS AND CEILINGS THROUGHOUT HOUSE.

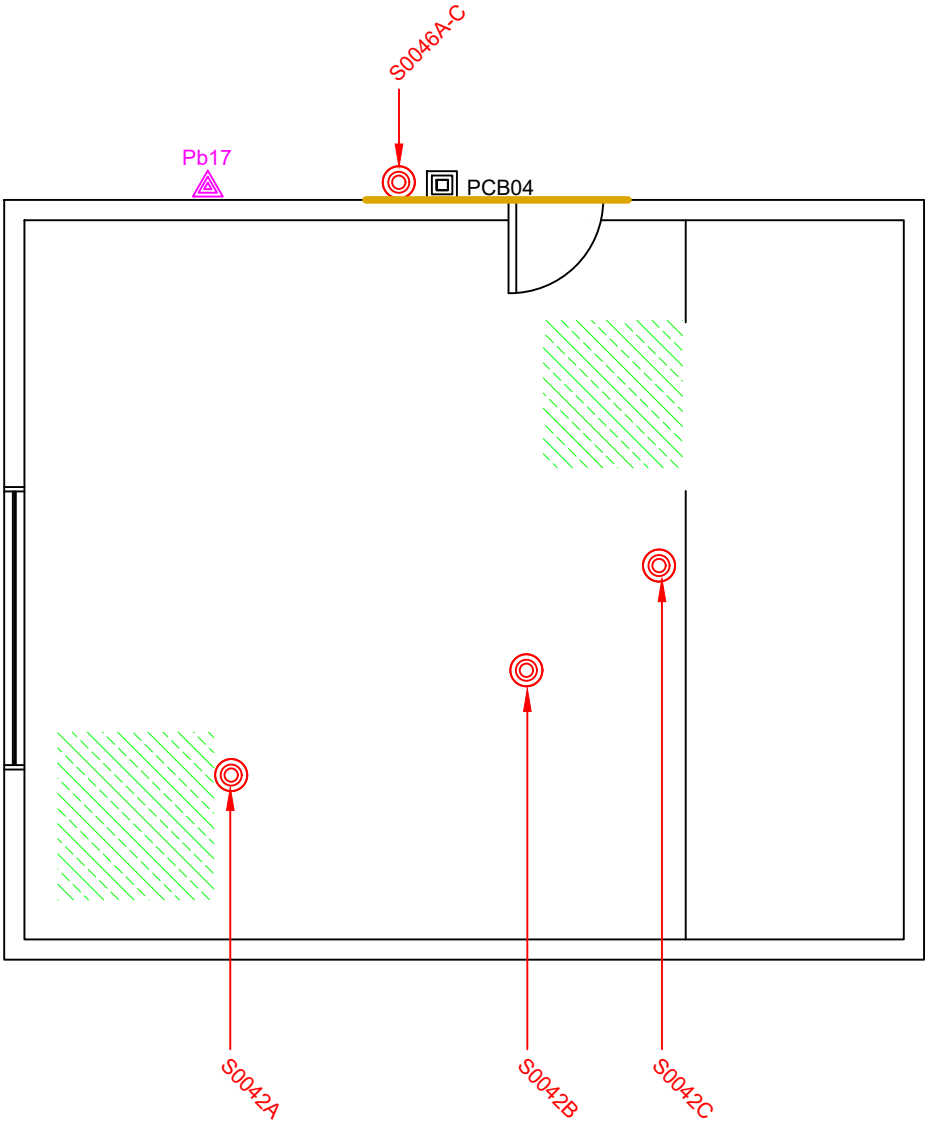
- COMPOSITE LEAD PAINT/SURFACE COATINGS PRESENT ON EXTERIOR OF GARAGE.
