**TREE INVENTORY, PRESERVATION PLANS, AND  
TREE CONSERVATION REPORT**

**4 RANGE ROAD MULTI-UNIT RESIDENTIAL DEVELOPMENT,  
CITY OF OTTAWA, ONTARIO**

**JULY, 2020**

**OUR FILE: LA 473-20**

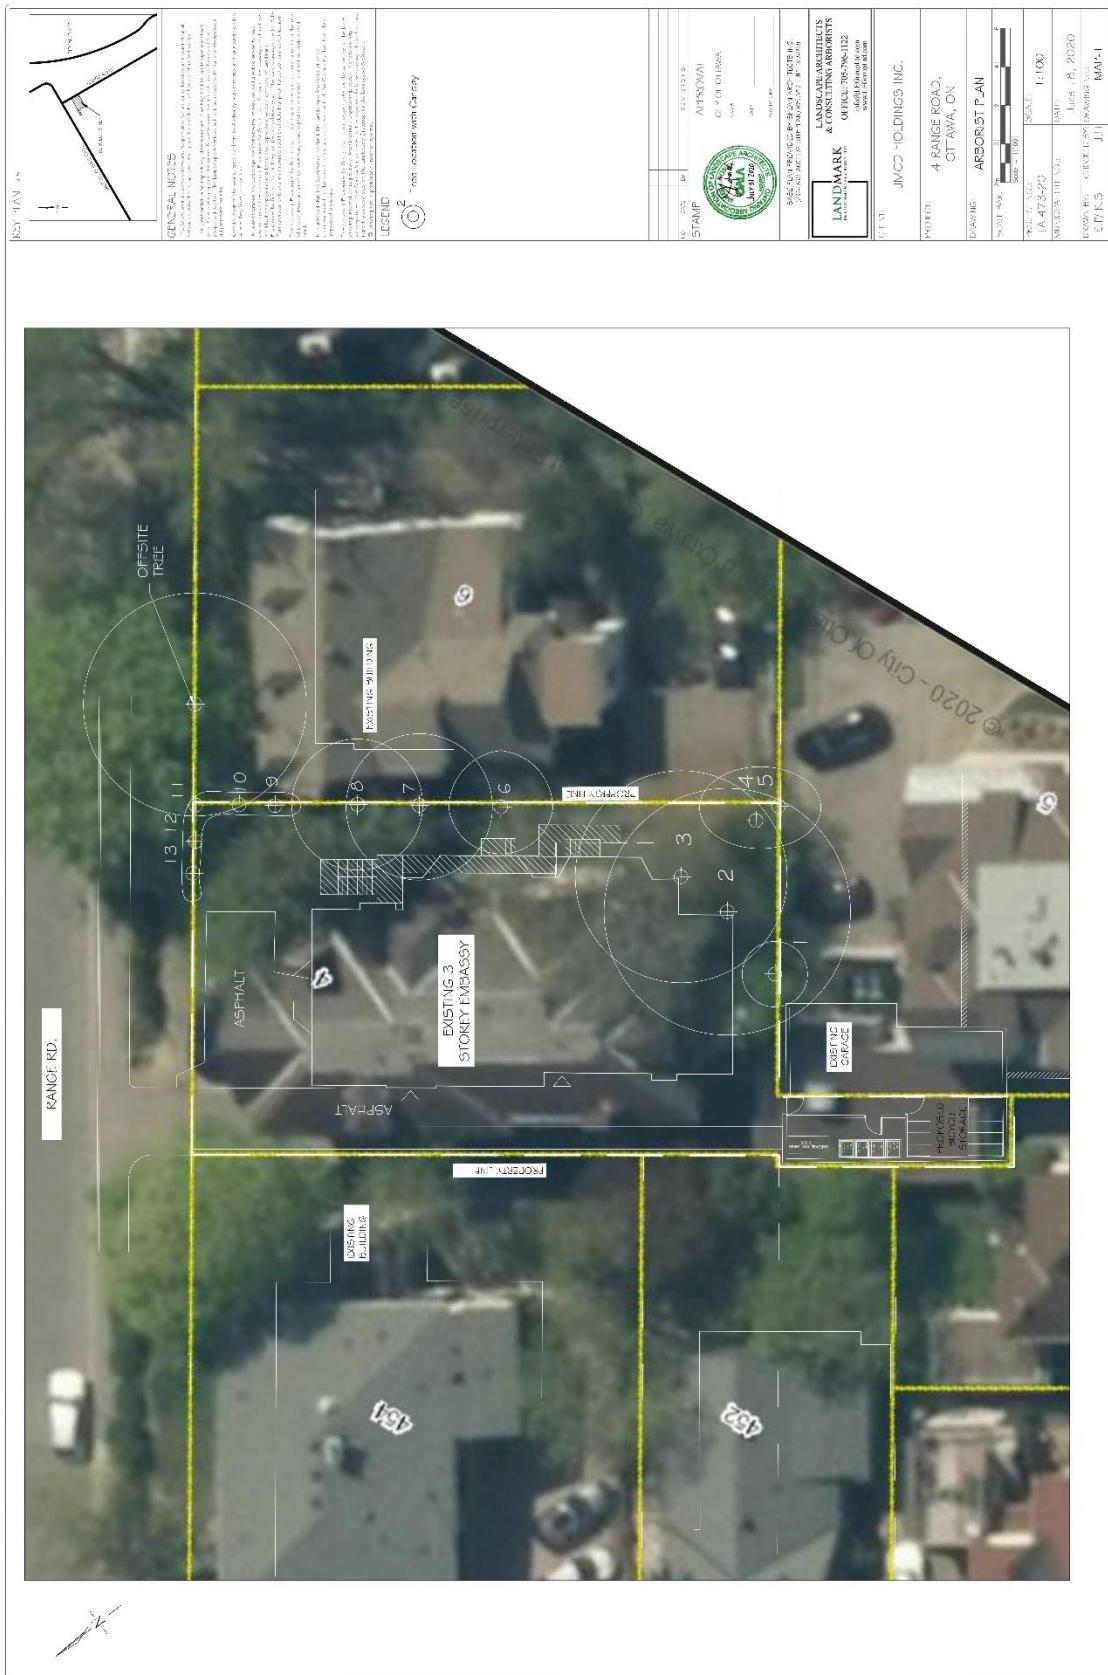
LEGroup observed one offsite Sugar Maple offsite whose canopy has crossed over into the subject site on the north east corner (**see Map 1, Map 2, Appendix B**). This native/indigenous tree appears to be in good condition and extends into the site between 1m beyond the common boundary line.
