McKINLEY
ENVIRONMENTAL
SOLUTIONS

April 23rd, 2020

RE: Woodlot S-23 Large Tree Inventory – Minto Communities and Valecraft Homes Kanata North
Developments (Revised)

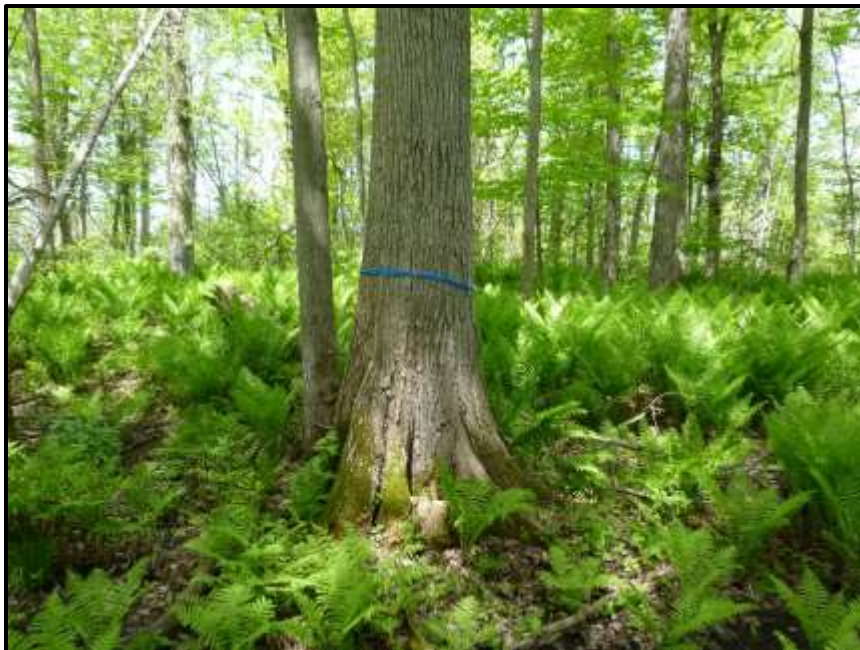
Photograph 45: Tree #46 – White Cedar in good condition (May 27th, 2019).
