TREE CONSERVATION REPORT V2.0

109-115 Dalhousie

Tree Conservation Report submitted as Partial
Requirements for a Site Plan Control Application,
February 16, 2022

Tree Conservation Report v2.0

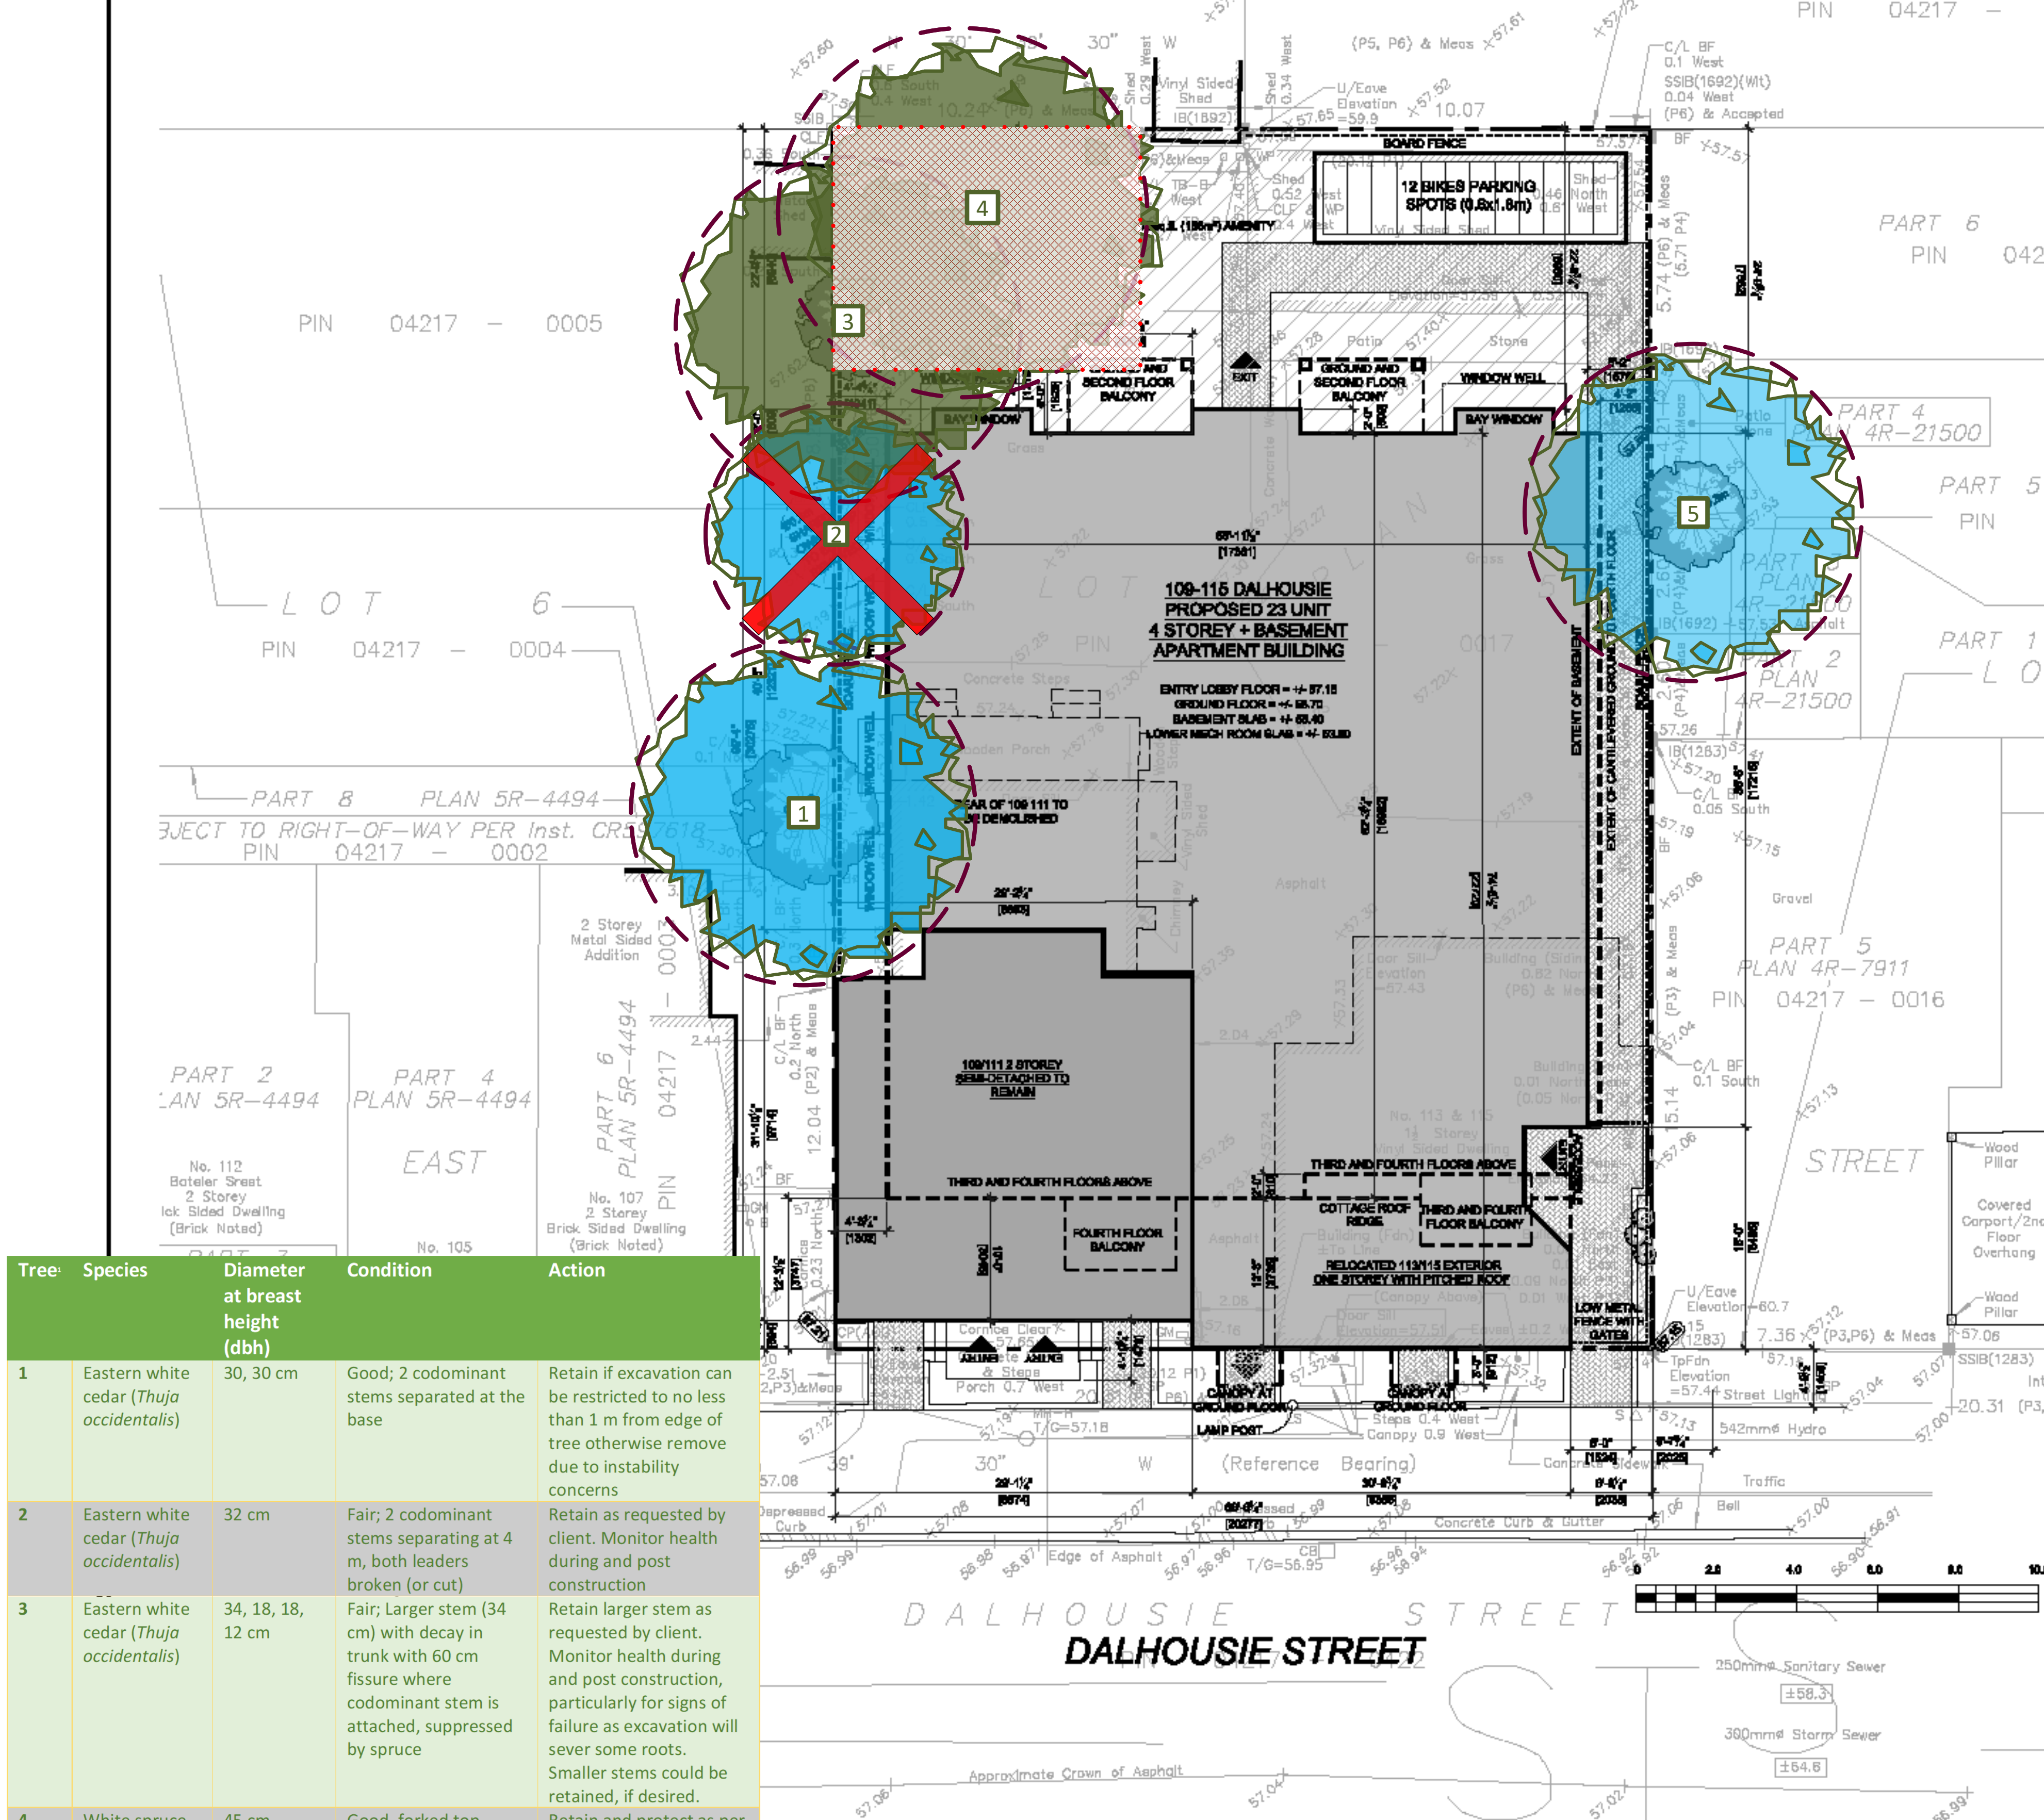
Tree	Species	Diameter at breast height (dbh)	Condition	Action
1	Eastern white cedar (<i>Thuja occidentalis</i>)	30, 30 cm	Good; 2 codominant stems separated at the base	Retain if excavation can be restricted to no less than 1 m from edge of tree otherwise remove due to instability concerns
2	Eastern white cedar (<i>Thuja occidentalis</i>)	32 cm	Fair; 2 codominant stems separating at 4 m, both leaders broken (or cut)	Retain as requested by client. Monitor health during and post construction
3	Eastern white cedar (<i>Thuja occidentalis</i>)	34, 18, 18, 12 cm	Fair; Larger stem (34 cm) with decay in trunk with 60 cm fissure where codominant stem is attached, suppressed by spruce	Retain larger stem as requested by client. Monitor health during and post construction, particularly for signs of failure as excavation will sever some roots. Smaller stems could be retained, if desired.
4	White spruce (<i>Picea glauca</i>)	45 cm	Good, forked top	Retain and protect as per protection measures in report

5	Eastern white cedar (<i>Thuja occidentalis</i>)	42 cm	Good; 2 codominant stems, 20 cm grade higher than subject property	Retain
