TREE CONSERVATION REPORT

PROJECT NAME:	Scouts Canada
PROJECT NO.	22831-1
LOCATION	1345 Baseline Rd, Ottawa ON, K4B 1P6
DATE:	June 1 st 2022

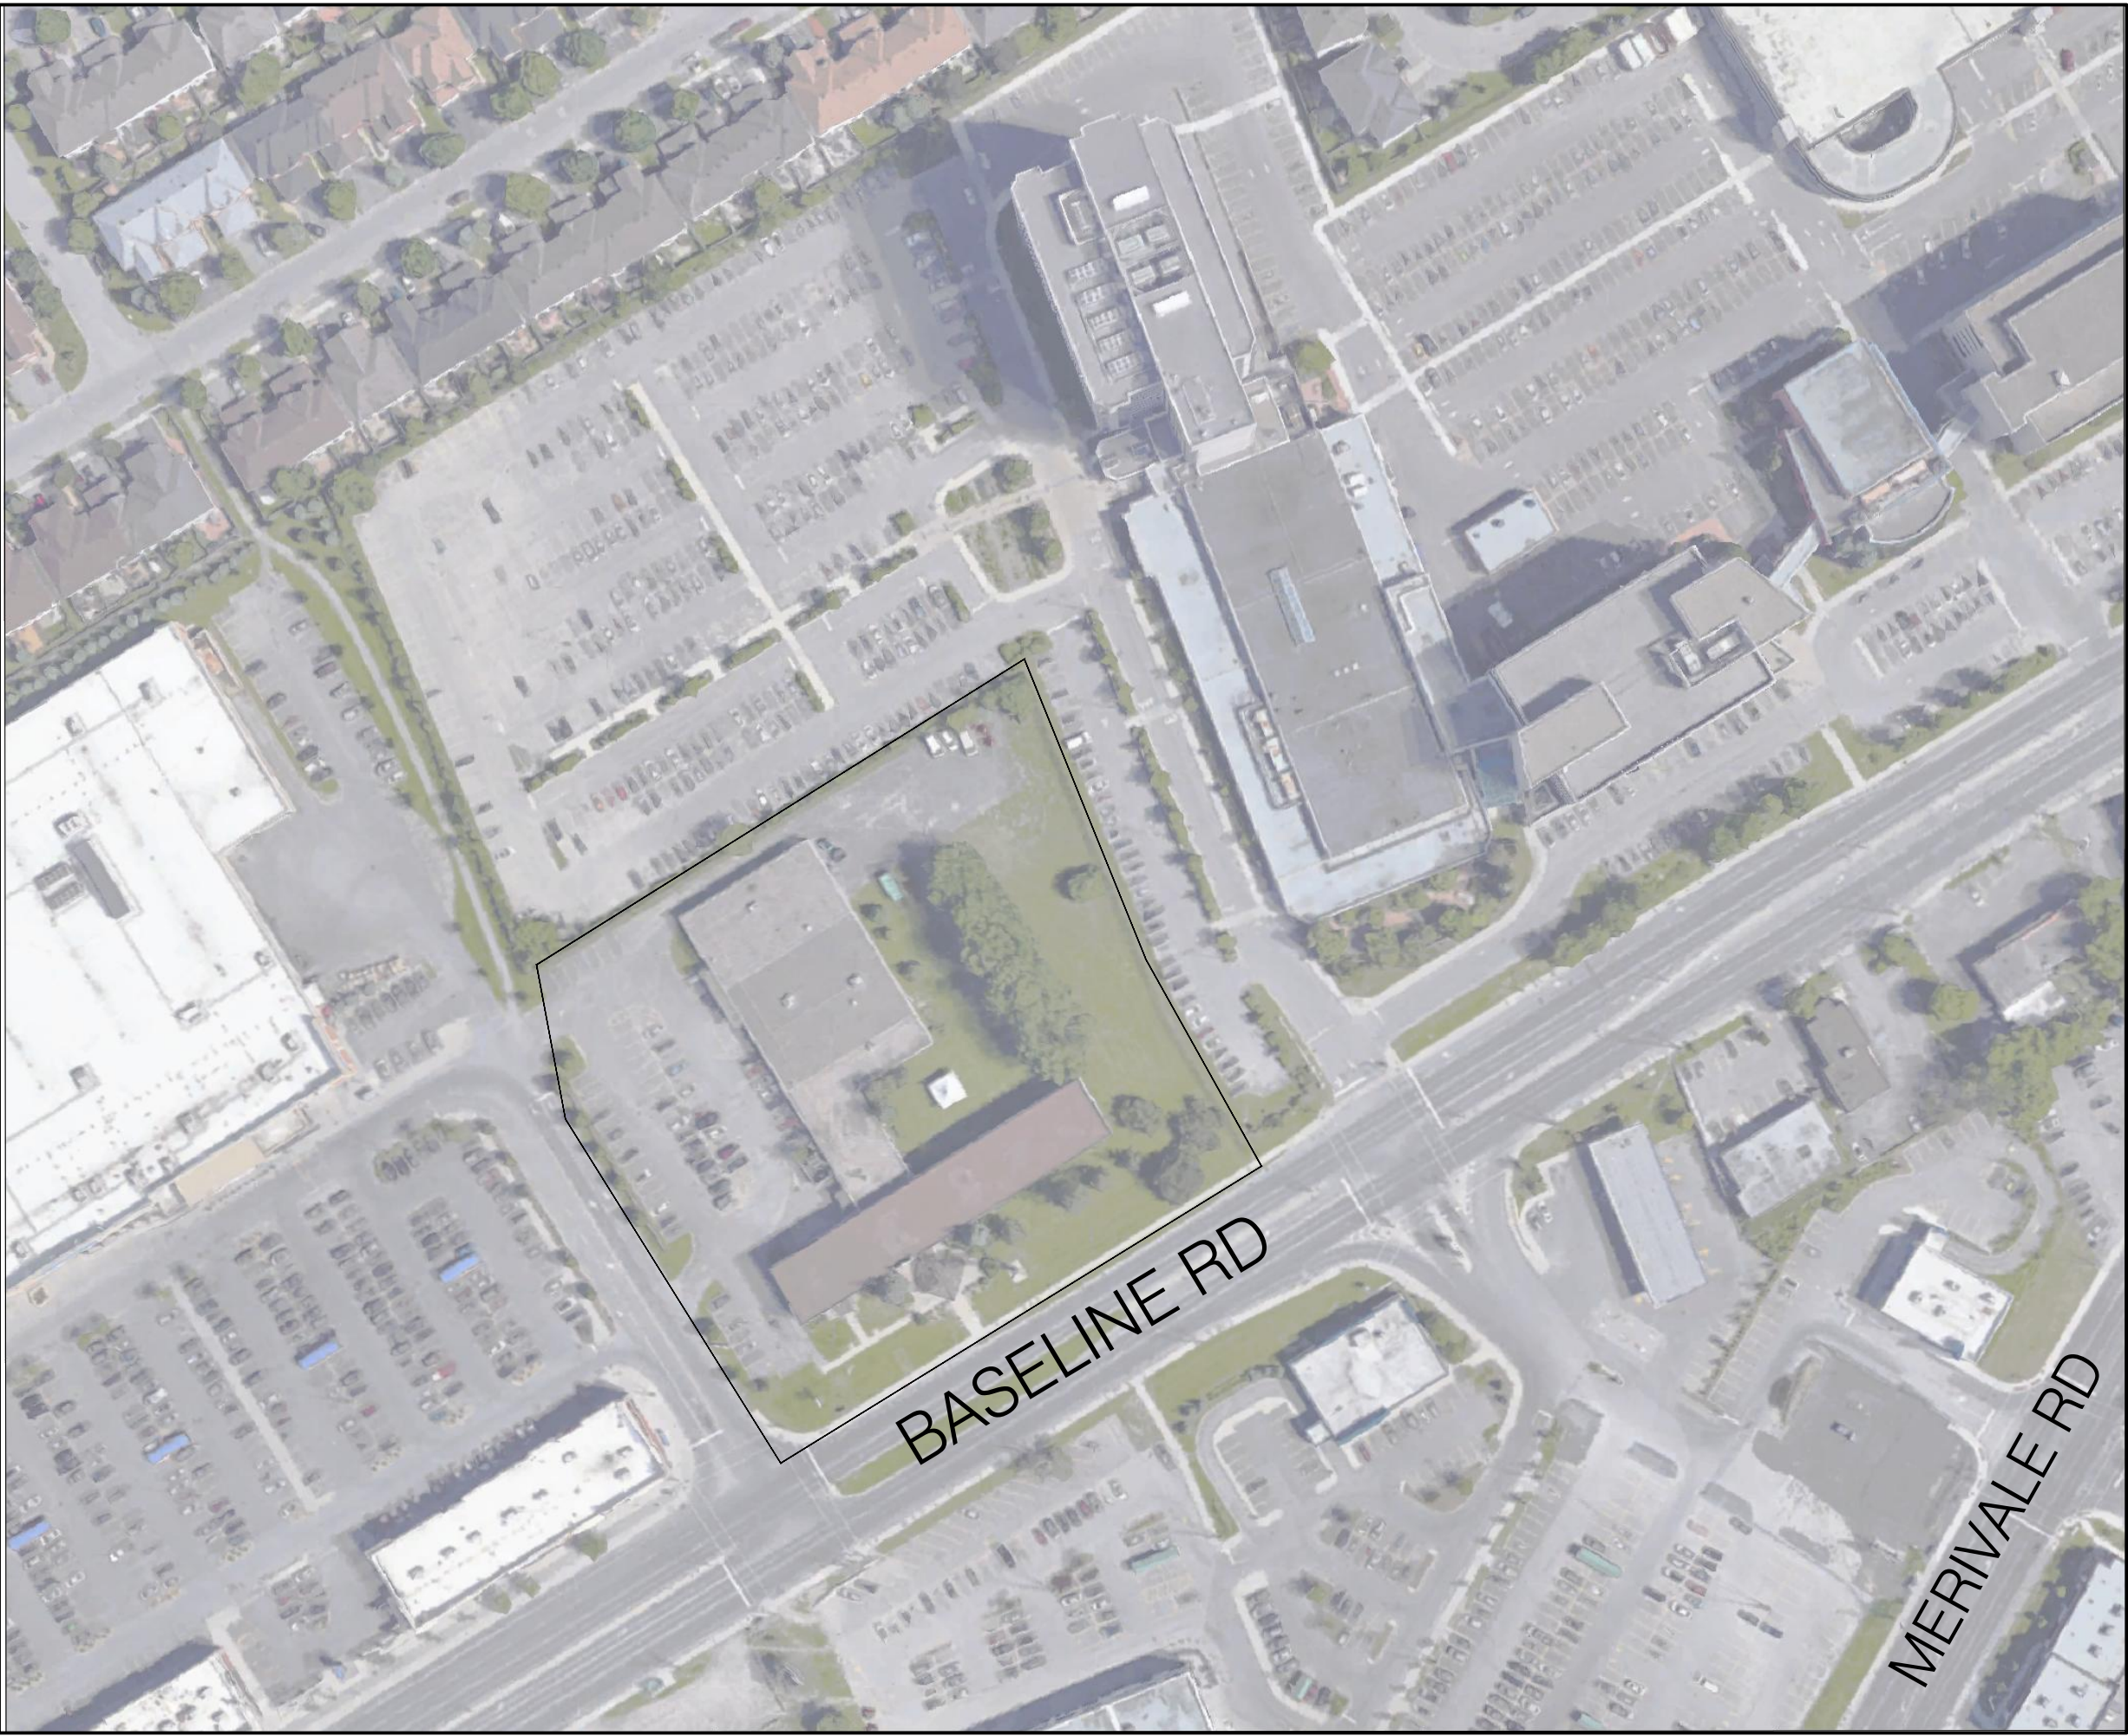
DRAWN BY: CR **L-TP1**

NO.	TREE SPECIES	DBH (cm)	CONDITION	COMMENTS
1	Little Leaf Linden/ <i>Tilia cordata</i>	9	Poor	Stressed
2	Little Leaf Linden/ <i>Tilia cordata</i>	17	Good	
3	Little Leaf Linden/ <i>Tilia cordata</i>	17	Good	
4	Little Leaf Linden/ <i>Tilia cordata</i>	15	Good	
5	Little Leaf Linden/ <i>Tilia cordata</i>	13	Poor	Wound in trunk, stressed
6	Little Leaf Linden/ <i>Tilia cordata</i>	14	Fair	Stressed, east lean
7	Little Leaf Linden/ <i>Tilia cordata</i>	15	Good	
8	Little Leaf Linden/ <i>Tilia cordata</i>	16	Good	
9	Little Leaf Linden/ <i>Tilia cordata</i>	14	Good	
10	Little Leaf Linden/ <i>Tilia cordata</i>	14	Good	
11	Colorado Blue Spruce/ <i>Picea pungens</i>	53	Good	
12	Colorado Blue Spruce/ <i>Picea pungens</i>	44	Good	
13	Black Spruce/ <i>Picea mariana</i>	18, 13	Poor	50% dead
14	White Spruce/ <i>Picea glauca</i>	35	Good	
15	White Spruce/ <i>Picea glauca</i>	26	Good	
16	White Spruce/ <i>Picea glauca</i>	16	Fair	Stressed

17	Crab Apple/ <i>Malus sylvestris</i>	51	Good	
18	Crab Apple/ <i>Malus sylvestris</i>	18,22,18,17,16	Good	
19	Crab Apple/ <i>Malus sylvestris</i>	23,28	Good	
20	Silver Maple/ <i>Acer saccharium</i>	27,30,25	Good	
21	Silver Maple/ <i>Acer saccharium</i>	16,17	Fair	Crowded out
22	Silver Maple/ <i>Acer saccharium</i>	30,29,40	Good	
23	Silver Maple/ <i>Acer saccharium</i>	22,18	Fair	Crowded out, weak stem
24	Silver Maple/ <i>Acer saccharium</i>	18,16	Dead	
25	Silver Maple/ <i>Acer saccharium</i>	18	Poor	50% dead
26	Silver Maple/ <i>Acer saccharium</i>	18,16,16,13	Poor	50% dead, dry stem
27	Silver Maple/ <i>Acer saccharium</i>	26,19	Fair	Dead limbs
28	Silver Maple/ <i>Acer saccharium</i>	25,27	Fair	Weak stem
29	Silver Maple/ <i>Acer saccharium</i>	20,6,10,13,13	Fair	Abnormal trunk joints
30	Silver Maple/ <i>Acer saccharium</i>	20,21	Good	
31	Silver Maple/ <i>Acer saccharium</i>	15,17	Poor	Dead limbs
32	Silver Maple/ <i>Acer saccharium</i>	27,26,29	Good

33	Silver Maple/ <i>Acer saccharium</i>	15,12,21,27	Fair	Weak base
34	Silver Maple/ <i>Acer saccharium</i>	12,15,27,31	Fair	Dead limbs
35	Silver Maple/ <i>Acer saccharium</i>	28,35,49	Good	
36	White Spruce/ <i>Picea glauca</i>	26	Good	
37	White Spruce/ <i>Picea glauca</i>	22	Good	
38	White Spruce/ <i>Picea glauca</i>	16,18	Good	
39	White Spruce/ <i>Picea glauca</i>	25	Good	
40	Colorado Blue Spruce/ <i>Picea pungens</i>	22	Good	
41	White Pine/ <i>Pinus strobus</i>	6,10	Good	
42	Colorado Blue Spruce/ <i>Picea pungens</i>	25	Good	
43	Balsam poplar/ <i>Populus balsamifera</i>	15,17,19	Good	
44	Hackberry/ <i>Celtis occidentalis</i>	12	Good	
45	Siberian Elm/ <i>Ulmus pumila</i>	16,17,17,20	Fair	Stressed, leaf loss
46	Red Maple/ <i>Acer rubrum</i>	10	Good	
47	Red Maple/ <i>Acer rubrum</i>	10	Good

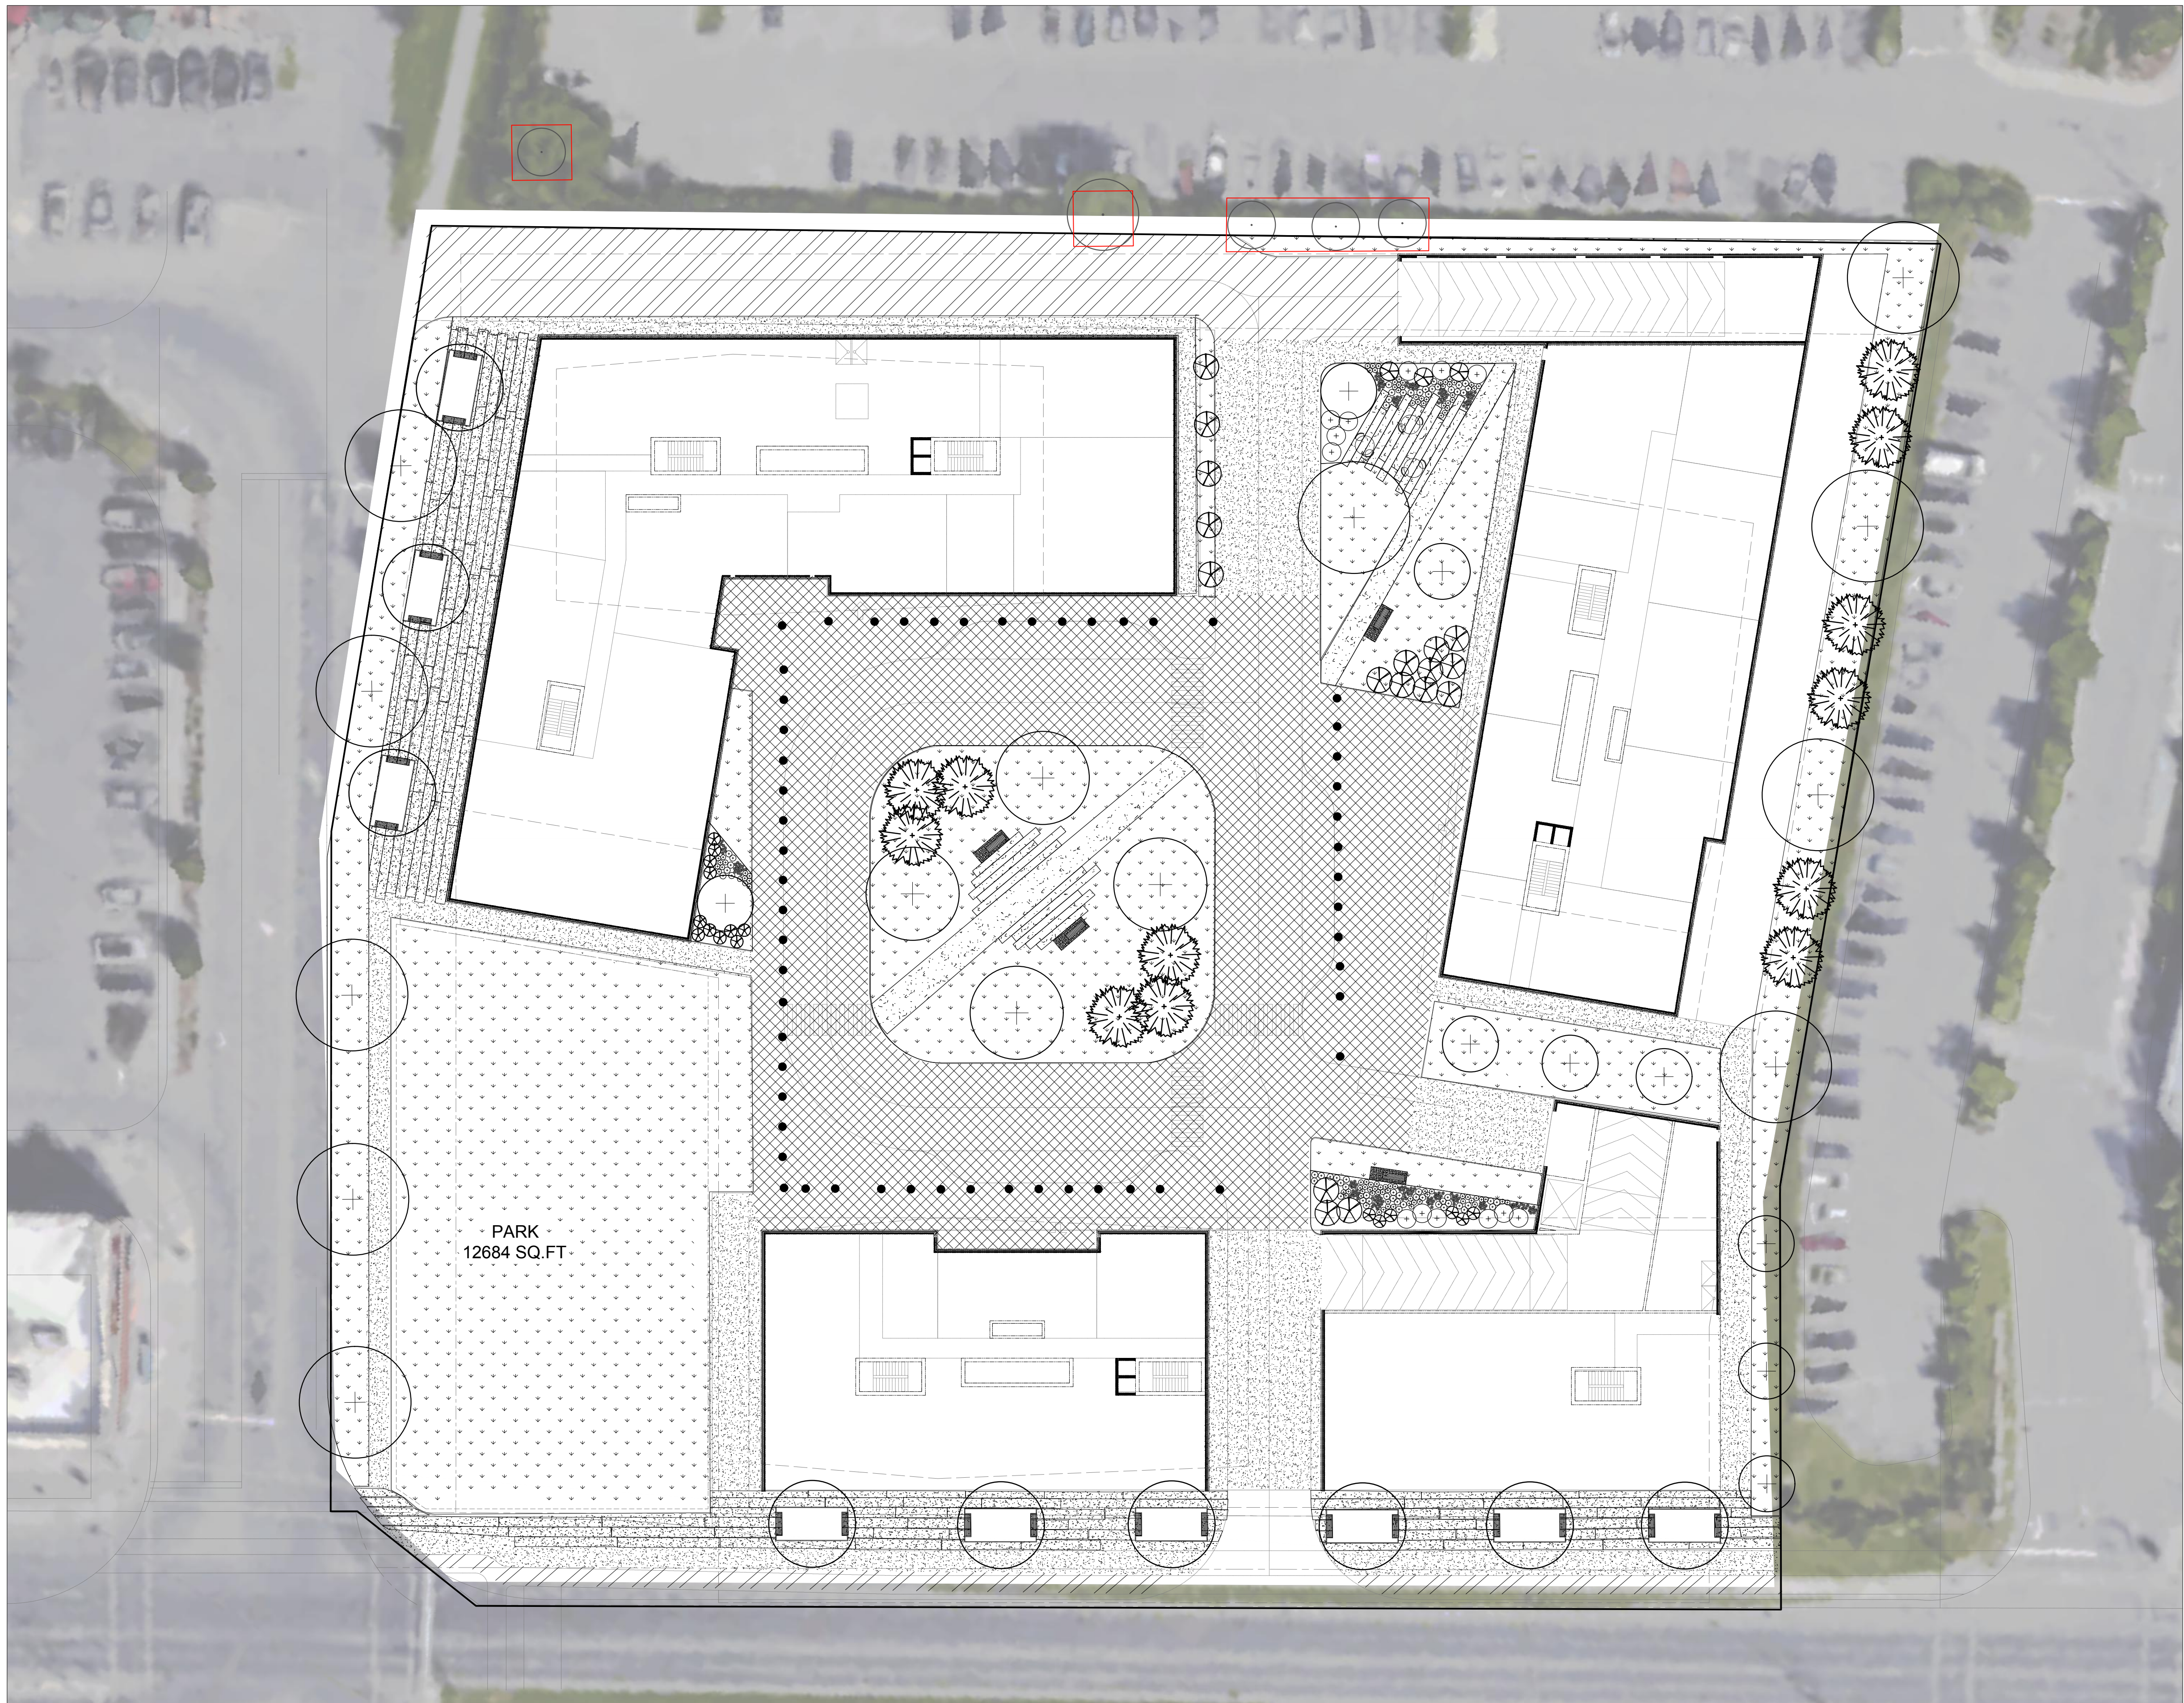
DATE: 2022-06-01 DRAWING NO.: _____
SCALE: AS SHOWN
DRAWN BY: CR
LA PROJECT NO. 22831-1 **L-TP2**

NO.	TREE SPECIES	DBH (cm)	CONDITION	COMMENTS
43	Balsam poplar/ <i>Populus balsamifera</i>	15,17,19	Good	
44	Hackberry/ <i>Celtis occidentalis</i>	12	Good	
45	Siberian Elm/ <i>Ulmus pumila</i>	16,17,17,20	Fair	Stressed, leaf loss
46	Red Maple/ <i>Acer rubrum</i>	10	Good	
47	Red Maple/ <i>Acer rubrum</i>	10	Good

NO.	TREE SPECIES	DBH (cm)	CONDITION	COMMENTS
1	Little Leaf Linden/ <i>Tilia cordata</i>	9	Poor	Stressed
2	Little Leaf Linden/ <i>Tilia cordata</i>	17	Good	
3	Little Leaf Linden/ <i>Tilia cordata</i>	17	Good	
4	Little Leaf Linden/ <i>Tilia cordata</i>	15	Good	
5	Little Leaf Linden/ <i>Tilia cordata</i>	13	Poor	Wound in trunk, stressed
6	Little Leaf Linden/ <i>Tilia cordata</i>	14	Fair	Stressed, east lean
7	Little Leaf Linden/ <i>Tilia cordata</i>	15	Good	
8	Little Leaf Linden/ <i>Tilia cordata</i>	16	Good	
9	Little Leaf Linden/ <i>Tilia cordata</i>	14	Good	
10	Little Leaf Linden/ <i>Tilia cordata</i>	14	Good	
11	Colorado Blue Spruce/ <i>Picea pungens</i>	53	Good	
12	Colorado Blue Spruce/ <i>Picea pungens</i>	44	Good	
13	Black Spruce/ <i>Picea mariana</i>	18, 13	Poor	50% dead
14	White Spruce/ <i>Picea glauca</i>	35	Good	
15	White Spruce/ <i>Picea glauca</i>	26	Good	
16	White Spruce/ <i>Picea glauca</i>	16	Fair	Stressed

17	Crab Apple/ <i>Malus sylvestris</i>	51	Good	
18	Crab Apple/ <i>Malus sylvestris</i>	18,22,18,17,16	Good	
19	Crab Apple/ <i>Malus sylvestris</i>	23,28	Good	
20	Silver Maple/ <i>Acer saccharium</i>	27,30,25	Good	
21	Silver Maple/ <i>Acer saccharium</i>	16,17	Fair	Crowded out
22	Silver Maple/ <i>Acer saccharium</i>	30,29,40	Good	
23	Silver Maple/ <i>Acer saccharium</i>	22,18	Fair	Crowded out, weak stem
24	Silver Maple/ <i>Acer saccharium</i>	18,16	Dead	
25	Silver Maple/ <i>Acer saccharium</i>	18	Poor	50% dead
26	Silver Maple/ <i>Acer saccharium</i>	18,16,16,13	Poor	50% dead, dead stem
27	Silver Maple/ <i>Acer saccharium</i>	26,19	Fair	Dead limbs
28	Silver Maple/ <i>Acer saccharium</i>	25,27	Fair	Weak stem
29	Silver Maple/ <i>Acer saccharium</i>	20,6,10,13,13	Fair	Abnormal trunk joints
30	Silver Maple/ <i>Acer saccharium</i>	20,21	Good	
31	Silver Maple/ <i>Acer saccharium</i>	15,17	Poor	Dead limbs
32	Silver Maple/ <i>Acer saccharium</i>	27,26,29	Good

33	Silver Maple/ <i>Acer saccharium</i>	15,12,21,27	Fair	Weak base
34	Silver Maple/ <i>Acer saccharium</i>	12,15,27,31	Fair	Dead limbs
35	Silver Maple/ <i>Acer saccharium</i>	28,35,49	Good	
36	White Spruce/ <i>Picea glauca</i>	26	Good	
37	White Spruce/ <i>Picea glauca</i>	22	Good	
38	White Spruce/ <i>Picea glauca</i>	16,18	Good	
39	White Spruce/ <i>Picea glauca</i>	25	Good	
40	Colorado Blue Spruce/ <i>Picea pungens</i>	22	Good	
41	White Pine/ <i>Pinus strobus</i>	6,10	Good	
42	Colorado Blue Spruce/ <i>Picea pungens</i>	25	Good
