Cardinal Creek Village – South Side

Headwater Drainage Feature Assessment

March 2021

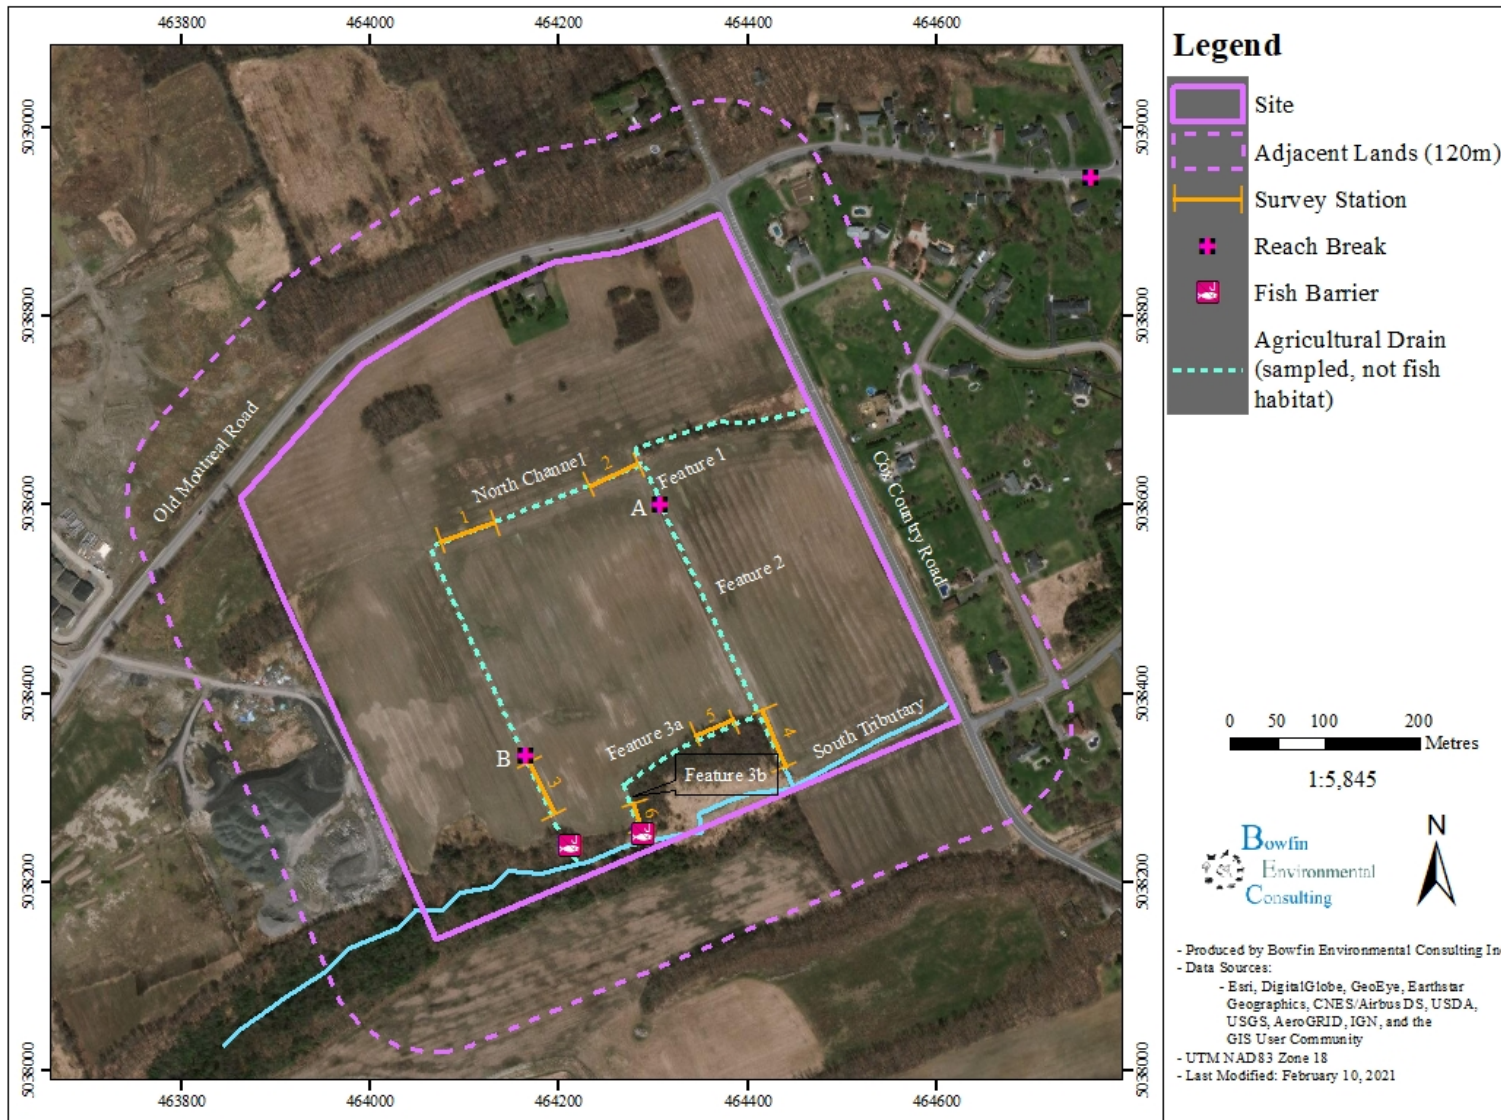
Figure A: Fish Habitat and Sampling Stations

The entire site was flat, and some features did not flow, even during the early spring. All but the North Channel were poorly constructed resulting in gradient barriers. Six stations were established and are described below (Figure A).
