# **Geotechnical Investigation**

## **Proposed Residential Development**

4386 Rideau Valley Drive  
Ottawa, Ontario

Report PG5828-1 Revision 2 dated October 14, 2022

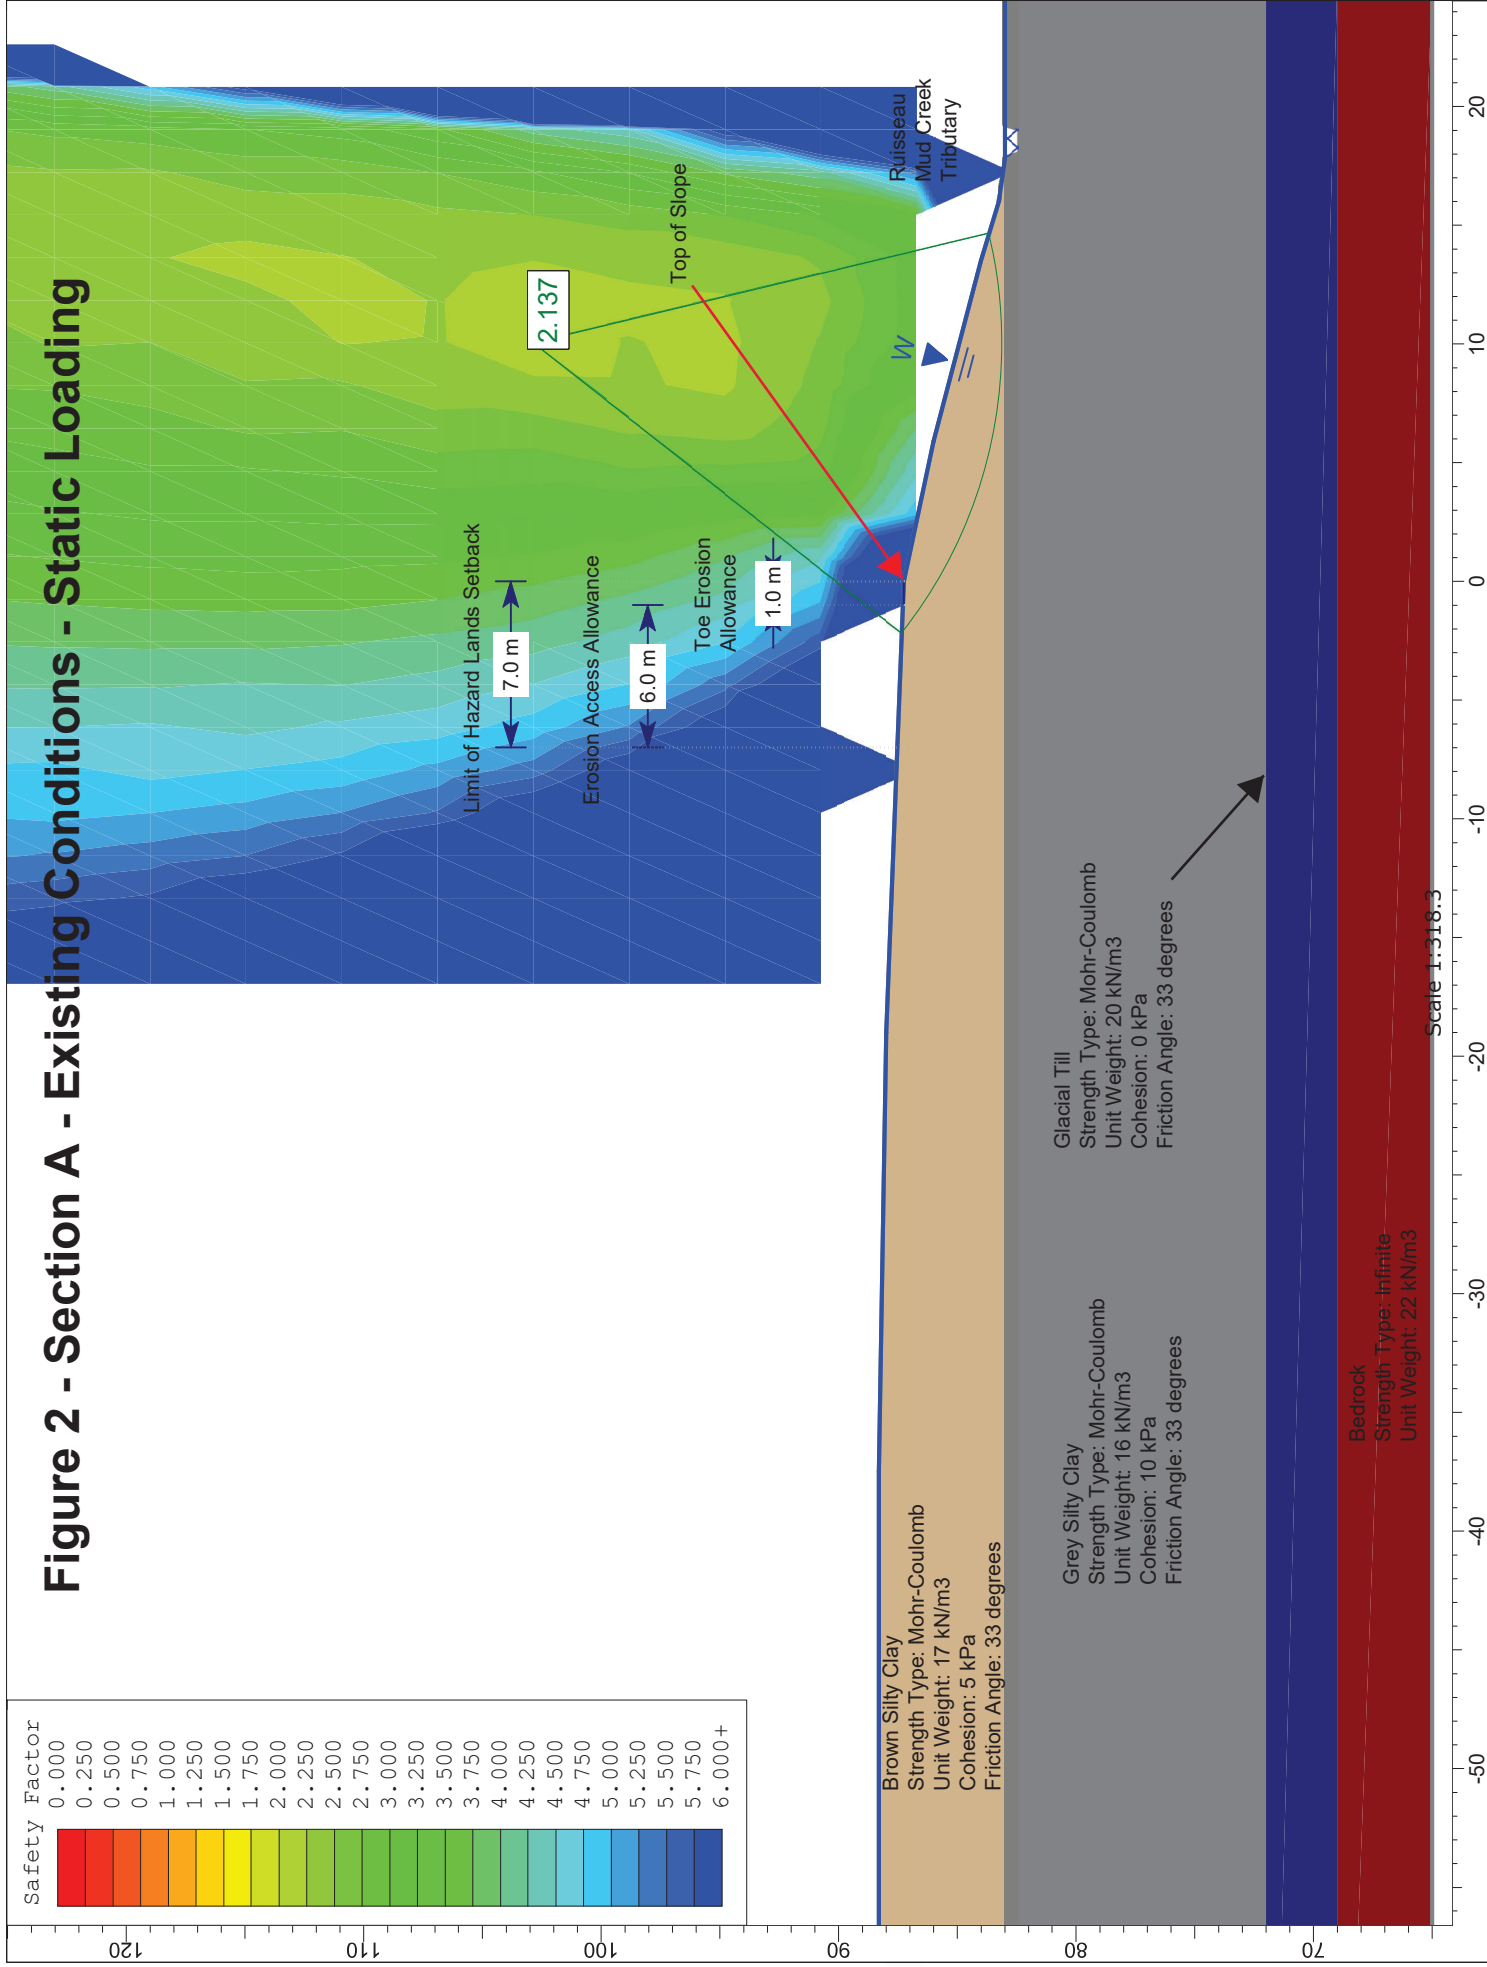
# Figure 2 - Section A - Existing Conditions - Static Loading

The results are shown in Figures 2, 4, 6 and 8 in Appendix 2. The results indicate a slope with a factor of safety of 2.1 and 2.4 at Section A and Section B, respectively. The results also indicate slopes with factors of safety less than 1.5 beyond the top of slope at Section C and D. Based on these results, a stable slope setback varying between 1.3 and 5.3 m from the top of the slope are required to achieve a factor of safety of 1.5 for the limit of the hazard lands in the area of Sections C and D.

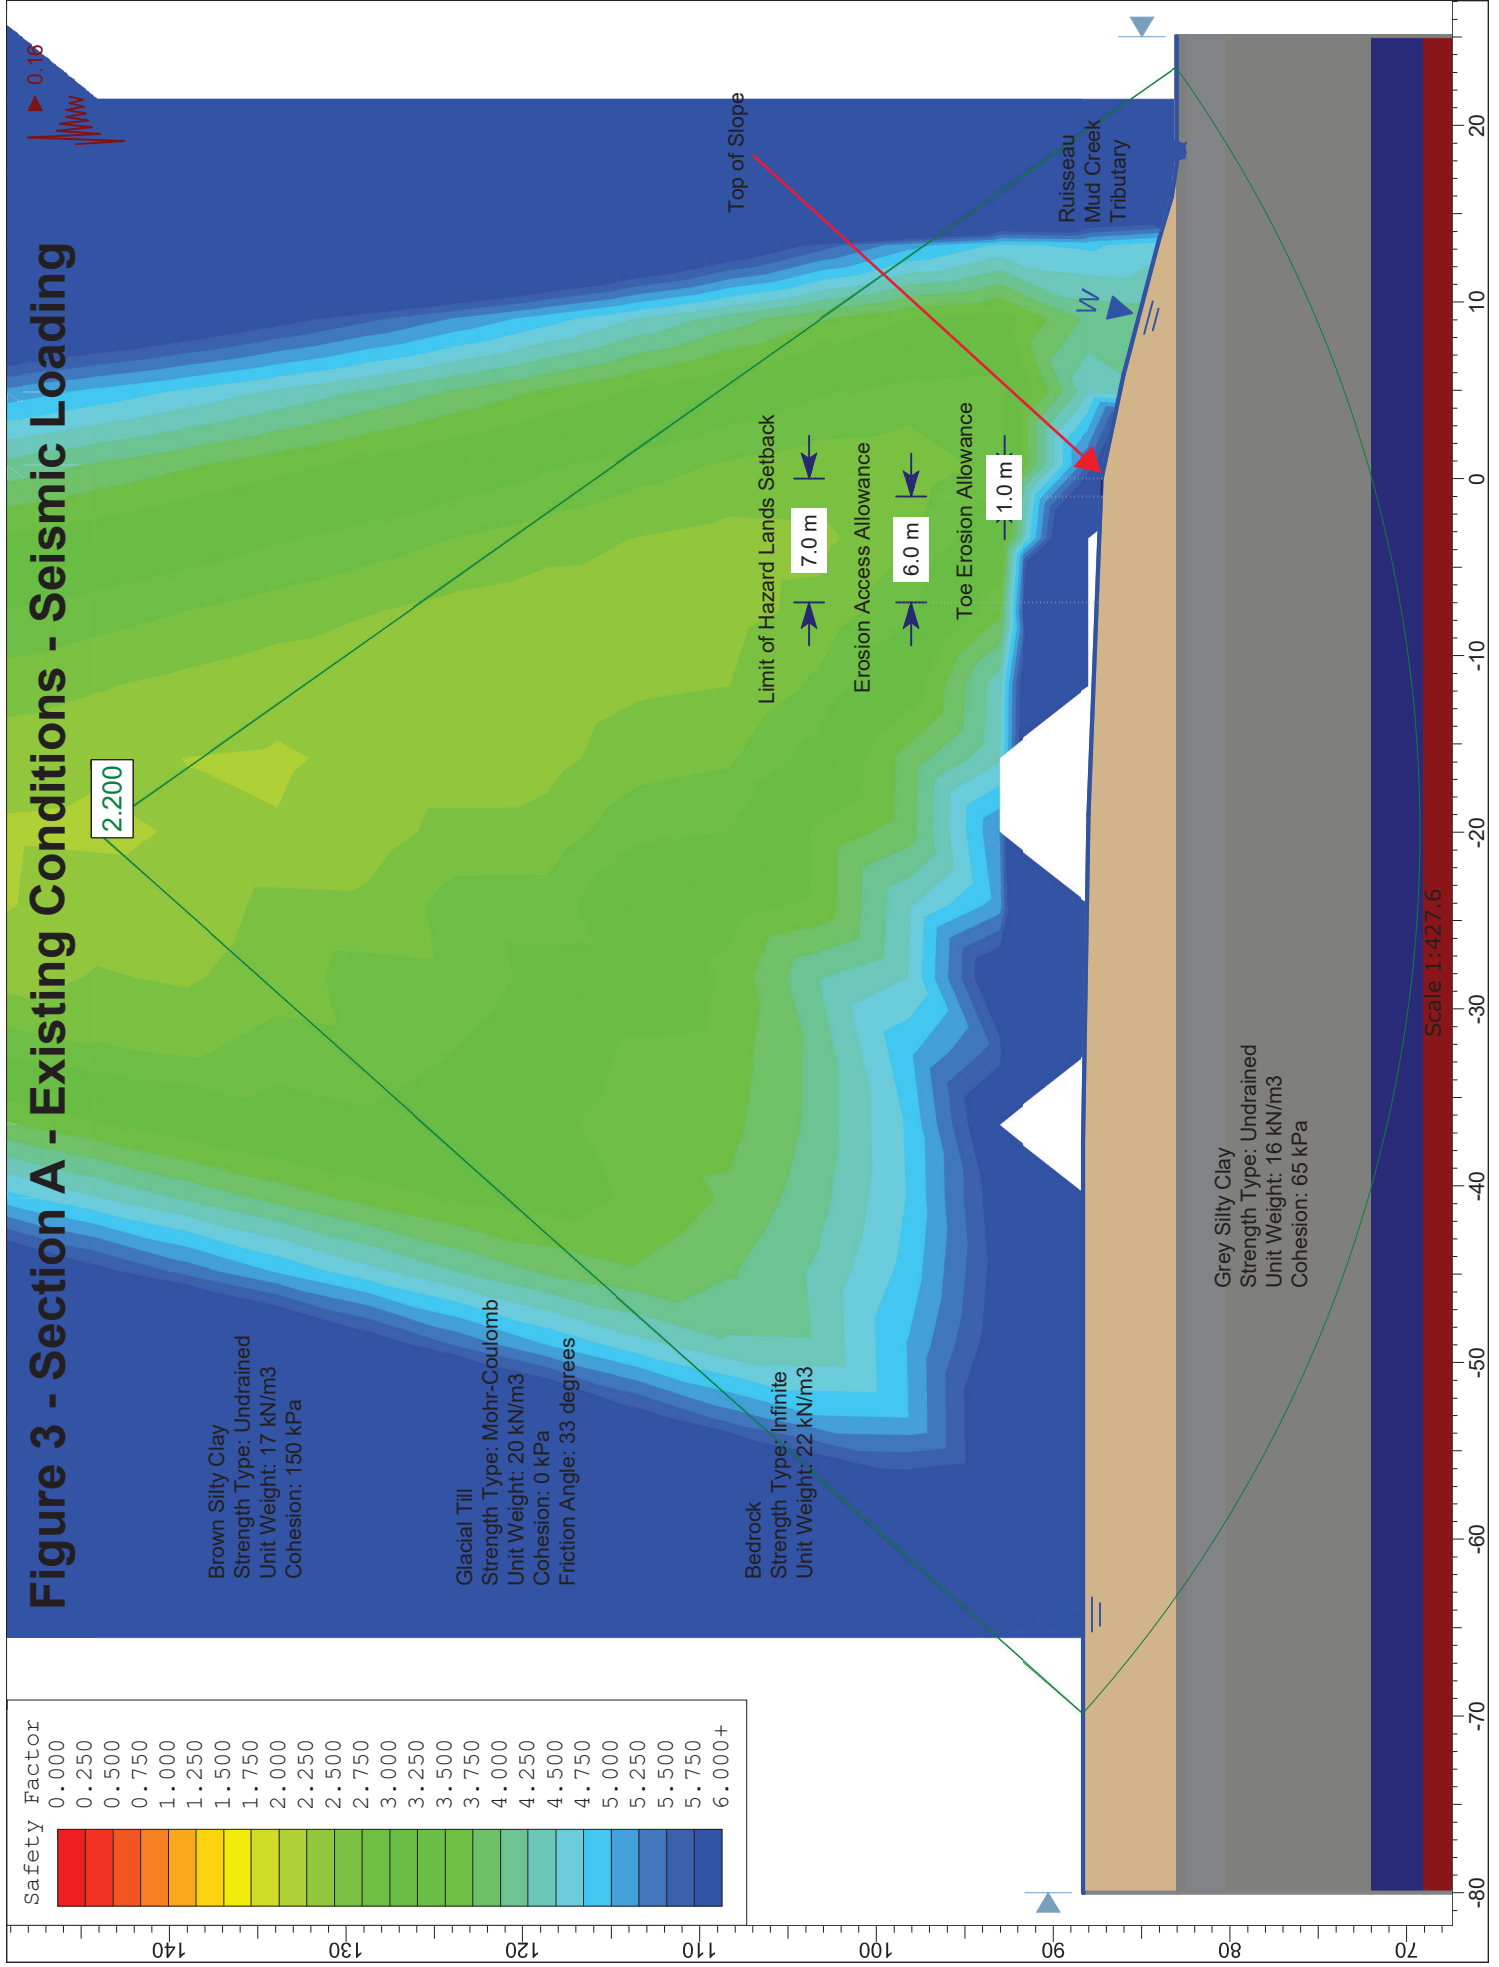
# Figure 3 - Section A - Existing Conditions - Seismic Loading

The results of the analyses including seismic loading are shown in Figures 3, 5, 7 and 9 in Appendix 2. The results indicate a slope with a factor of safety greater than 1.1 at all sections. However, it should be noted that the stable slope setback associated with our static loading analysis governs the required stable slope setback required for static conditions.
