November 03, 2023

1900 and 2000 CITYPARK DRIVE TREE INVENTORY AND RETENTION REVIEW

1900 & 2000 CITY PARK DRIVE

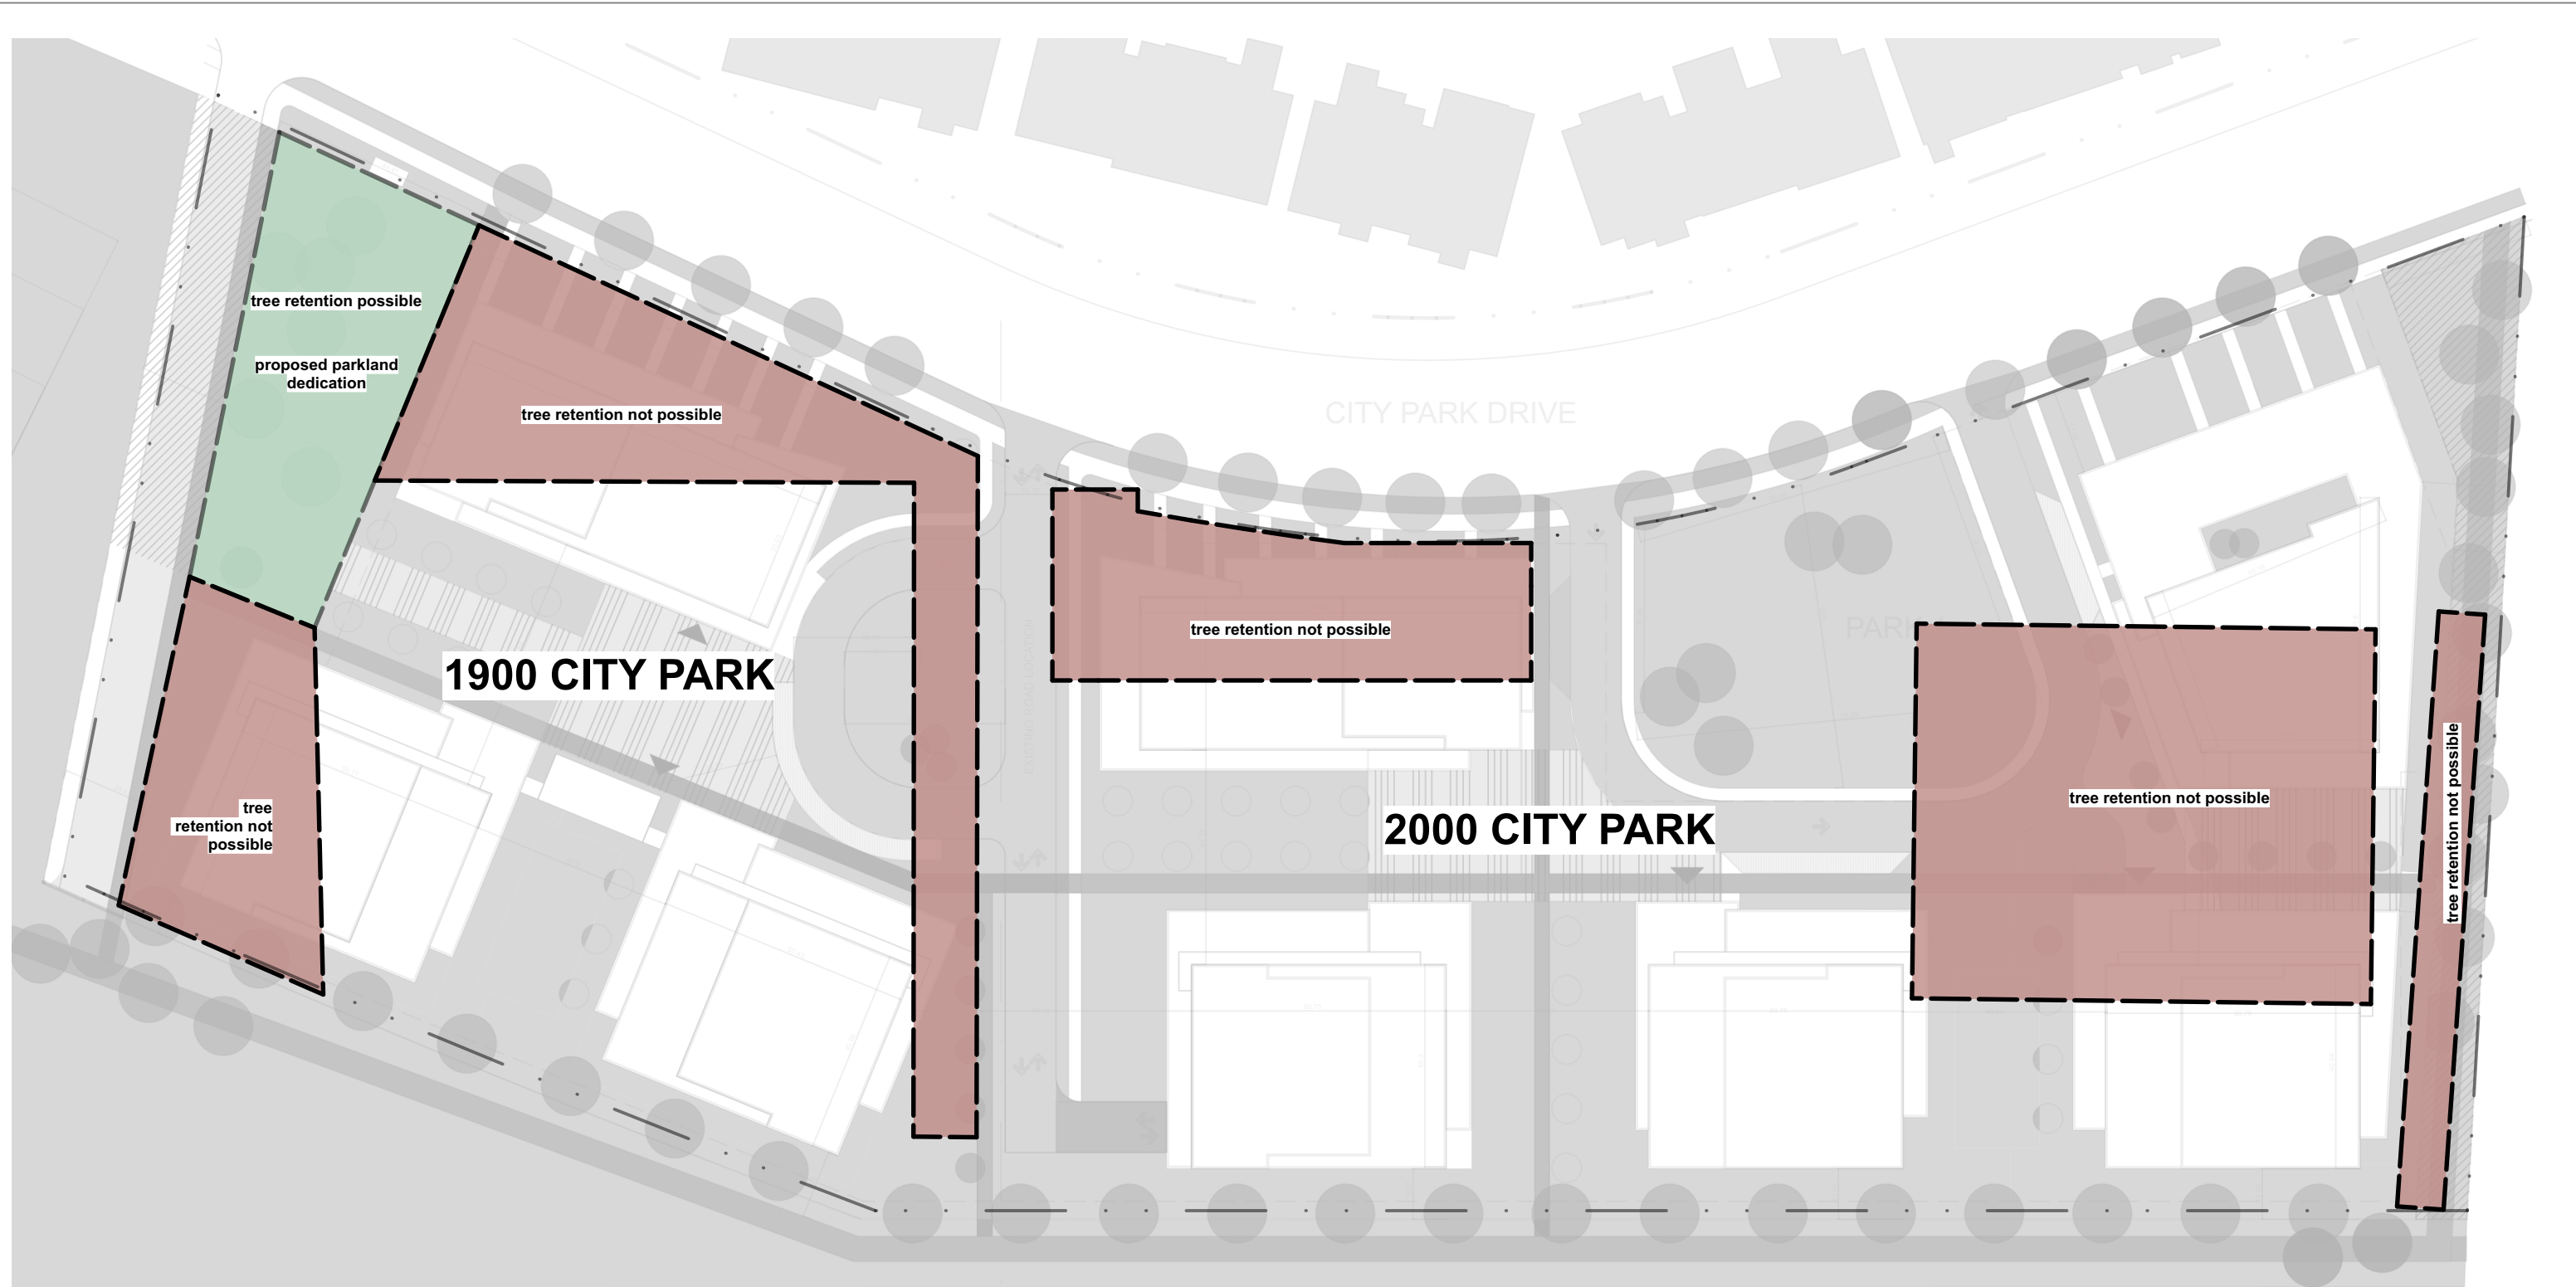
1 EXISTING VEGETATION
Scale: 1:500

Majority of this block is vacant field. Existing planted trees are located in the north-western portion (young to maturing Norway Maple and Crab Apple) and along the eastern property line (young Norway Maple, Colorado Spruce and White Elm). A naturalized vegetation area is centrally located consisting mainly of young White Elm and Buckthorn. Condition is very poor to good, refer to chart.

This block consists of an existing 5 storey building, parking and built landscape with semi mature trees. The majority of the species here are Norway Maple, Colorado Spruce and Japanese Tree Lilac, semi-mature to mature size, from poor to good condition, refer to chart.
