TREE CONSERVATION REPORT

1887 St Joseph Boulevard, Ottawa, ON

Tree Conservation Report submitted as Partial
Requirements for a Rezoning Application, July
13, 2023

Dendron Forestry Services

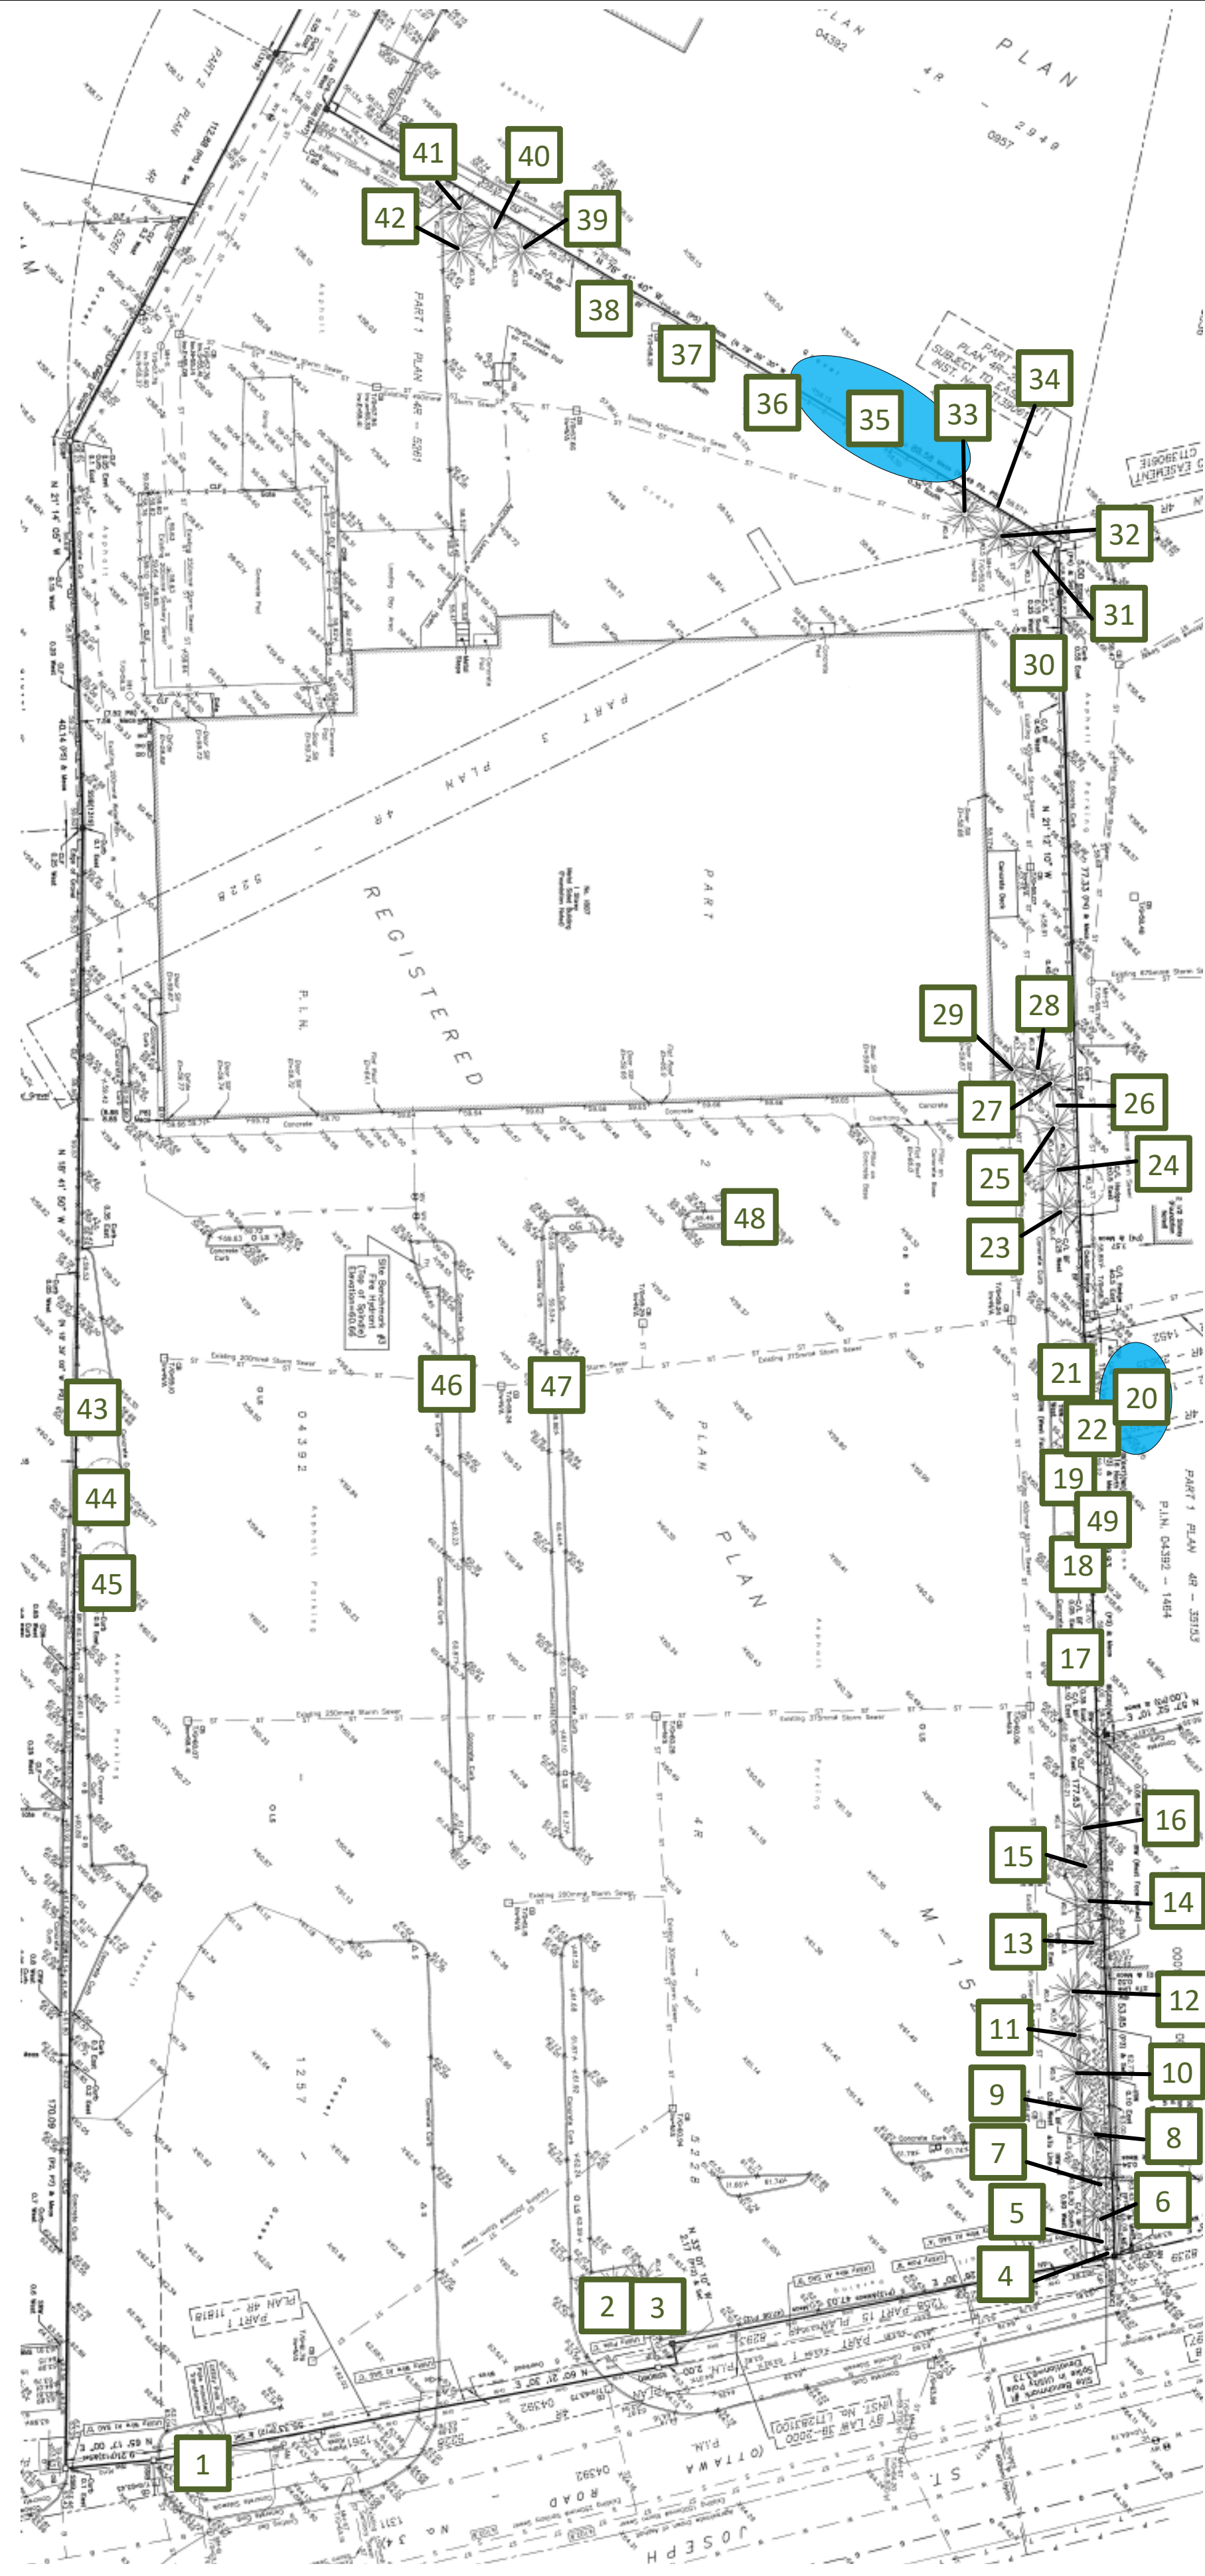
Tree Conservation Report Map 1 – 1887 St Joesph Boulevard
 Tree layer prepared by Dendron Forestry Services
 Current Vegetation, May 16, 2023
 For more information, please contact info@dendronforestry.ca

48 ⁴	Norway maple (<i>A. platanoides</i>)	10	Subject property	Fair/Good: recently planted; wound at base sealing
49	Manitoba maple (<i>A. negundo</i>)	12	Boundary – 1252 Marenger	Poor: small stem growing from old stump; heavy lean
