Geotechnical Investigation

Proposed Residential Development

4386 Rideau Valley Drive
Ottawa, Ontario

Report PG5828-1 Revision 4 dated April 4, 2024

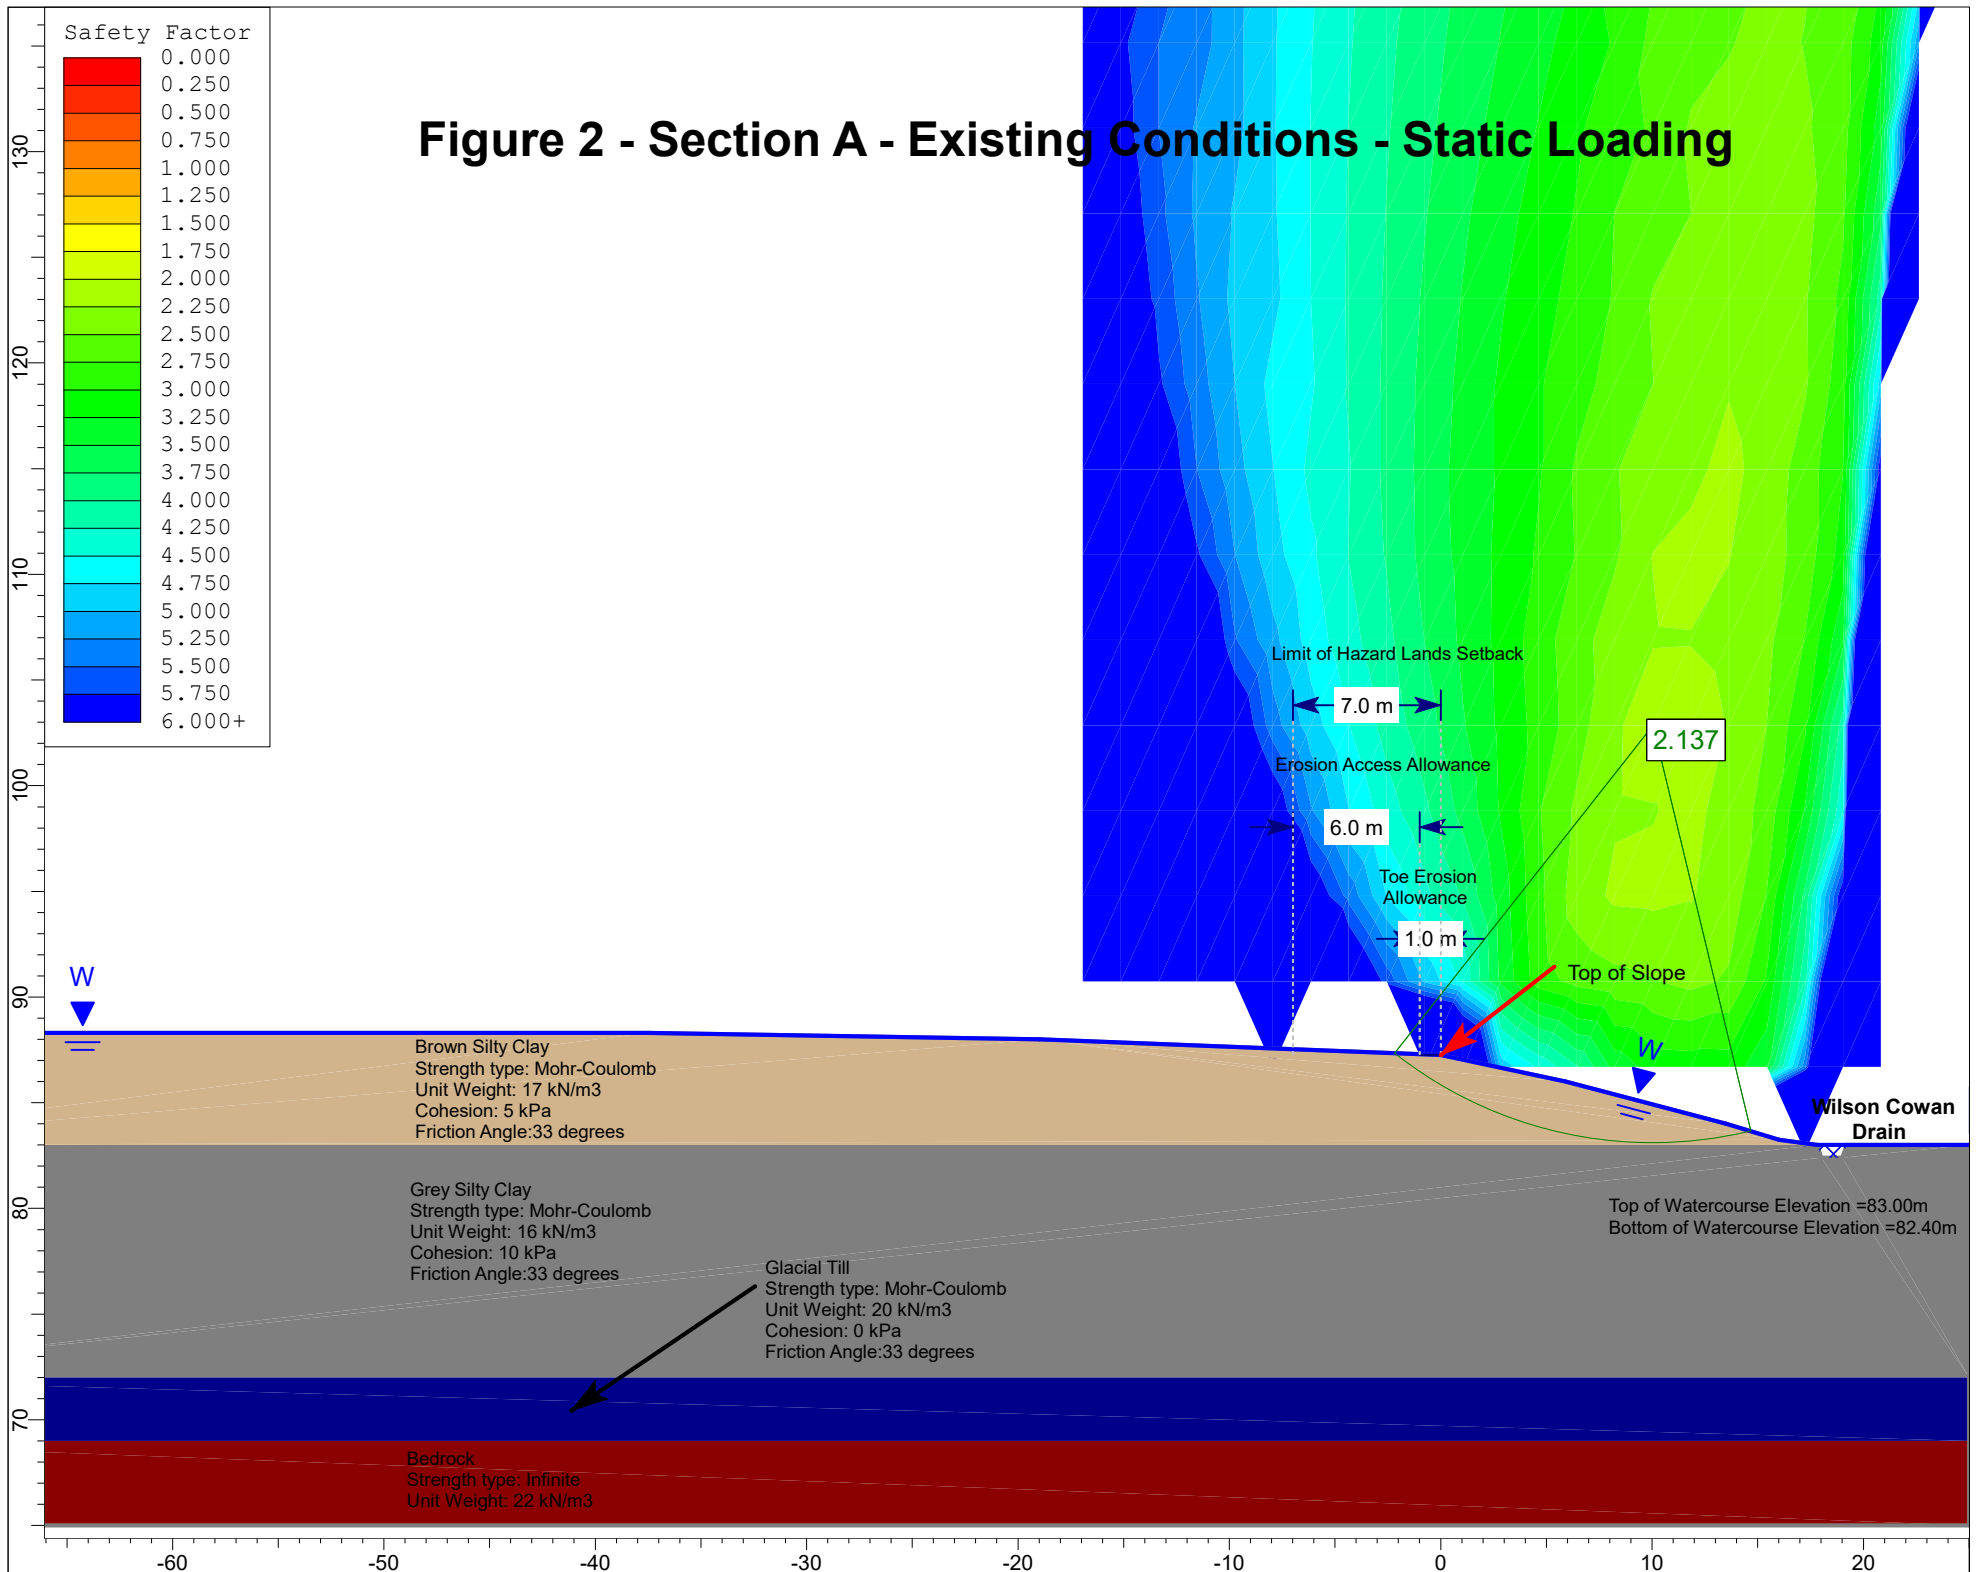
Figure 2 - Section A - Existing Conditions - Static Loading

The results are shown in Figures 2, 4, 6, 8, 10, 12, 14, & 16 in Appendix 2. The results indicate a slope with a factor of safety of 2.1 and 2.4 at Section A and Section B, respectively. The results also indicate slopes with factors of safety less than 1.5 beyond the top of slope at Section C and D. Based on these results, a stable slope setback varying between 1.3 and 5.3 m from the top of the slope are required to achieve a factor of safety of 1.5 for the limit of the hazard lands in the area of Sections C and D.

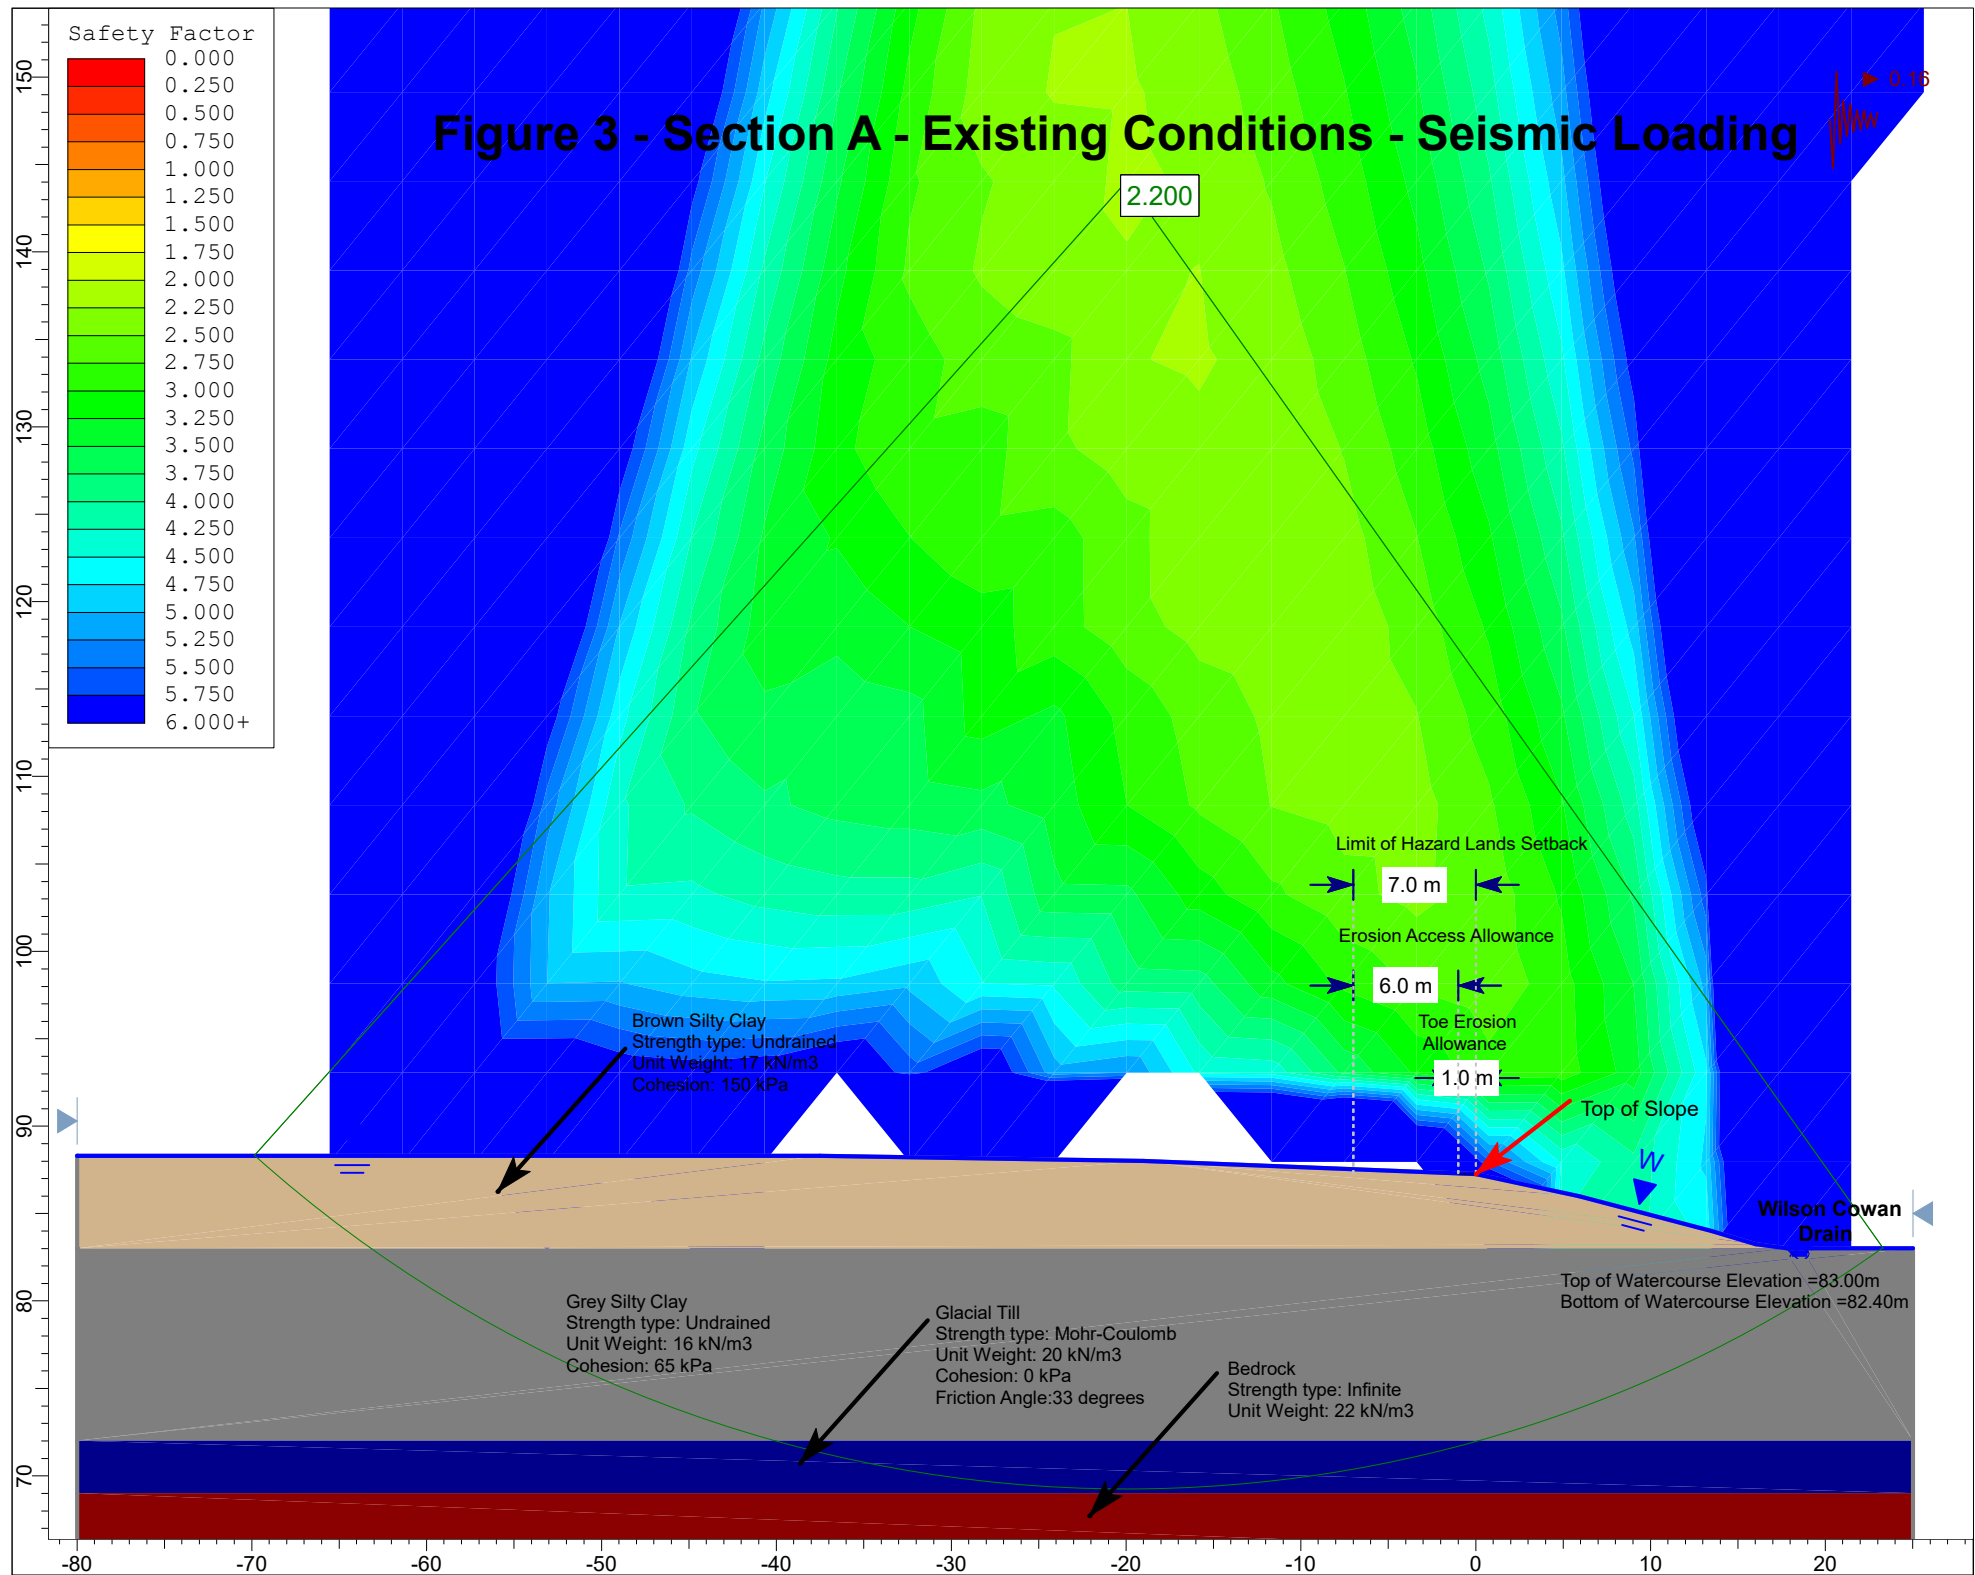
Figure 3 - Section A - Existing Conditions - Seismic Loading

The results of the analyses including seismic loading are shown in Figures 3, 5, 7, 9, 11, 13, 15, and 17 in Appendix 2. The results indicate a slope with a factor of safety greater than 1.1 at all sections. However, it should be noted that the stable slope setback associated with our static loading analysis governs the required stable slope setback required for static conditions.
