# **Geotechnical Investigation**

## **Proposed Residential Development**

4386 Rideau Valley Drive  
Ottawa, Ontario

Report PG5828-1 Revision 5 dated July 19, 2024

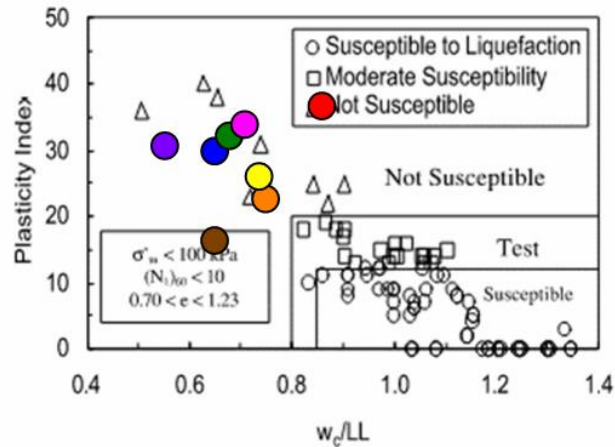
Figure 1. Criteria for evaluating liquefaction susceptibility of fine-grained soils (Bray et al. 2004).

The site class for seismic site response can be taken as **Class D** for the foundations considered at this site. The soils encountered at the subject site consist of silty clays, which are cohesive in nature. These soils were evaluated for liquefaction susceptibility in accordance with the criteria prepared by Bray at al. 2004 which determines that all soils with a plasticity index exceeding 20% are not liquifiable (Figure 1). In general, the plasticity index results completed on samples taken from the silty clay layer were found to be above 20. Therefore, soils underlying the subject site are not susceptible to liquefaction. Reference should be made to the latest revision of the 2012 Ontario Building Code for a full discussion of the earthquake design requirements.

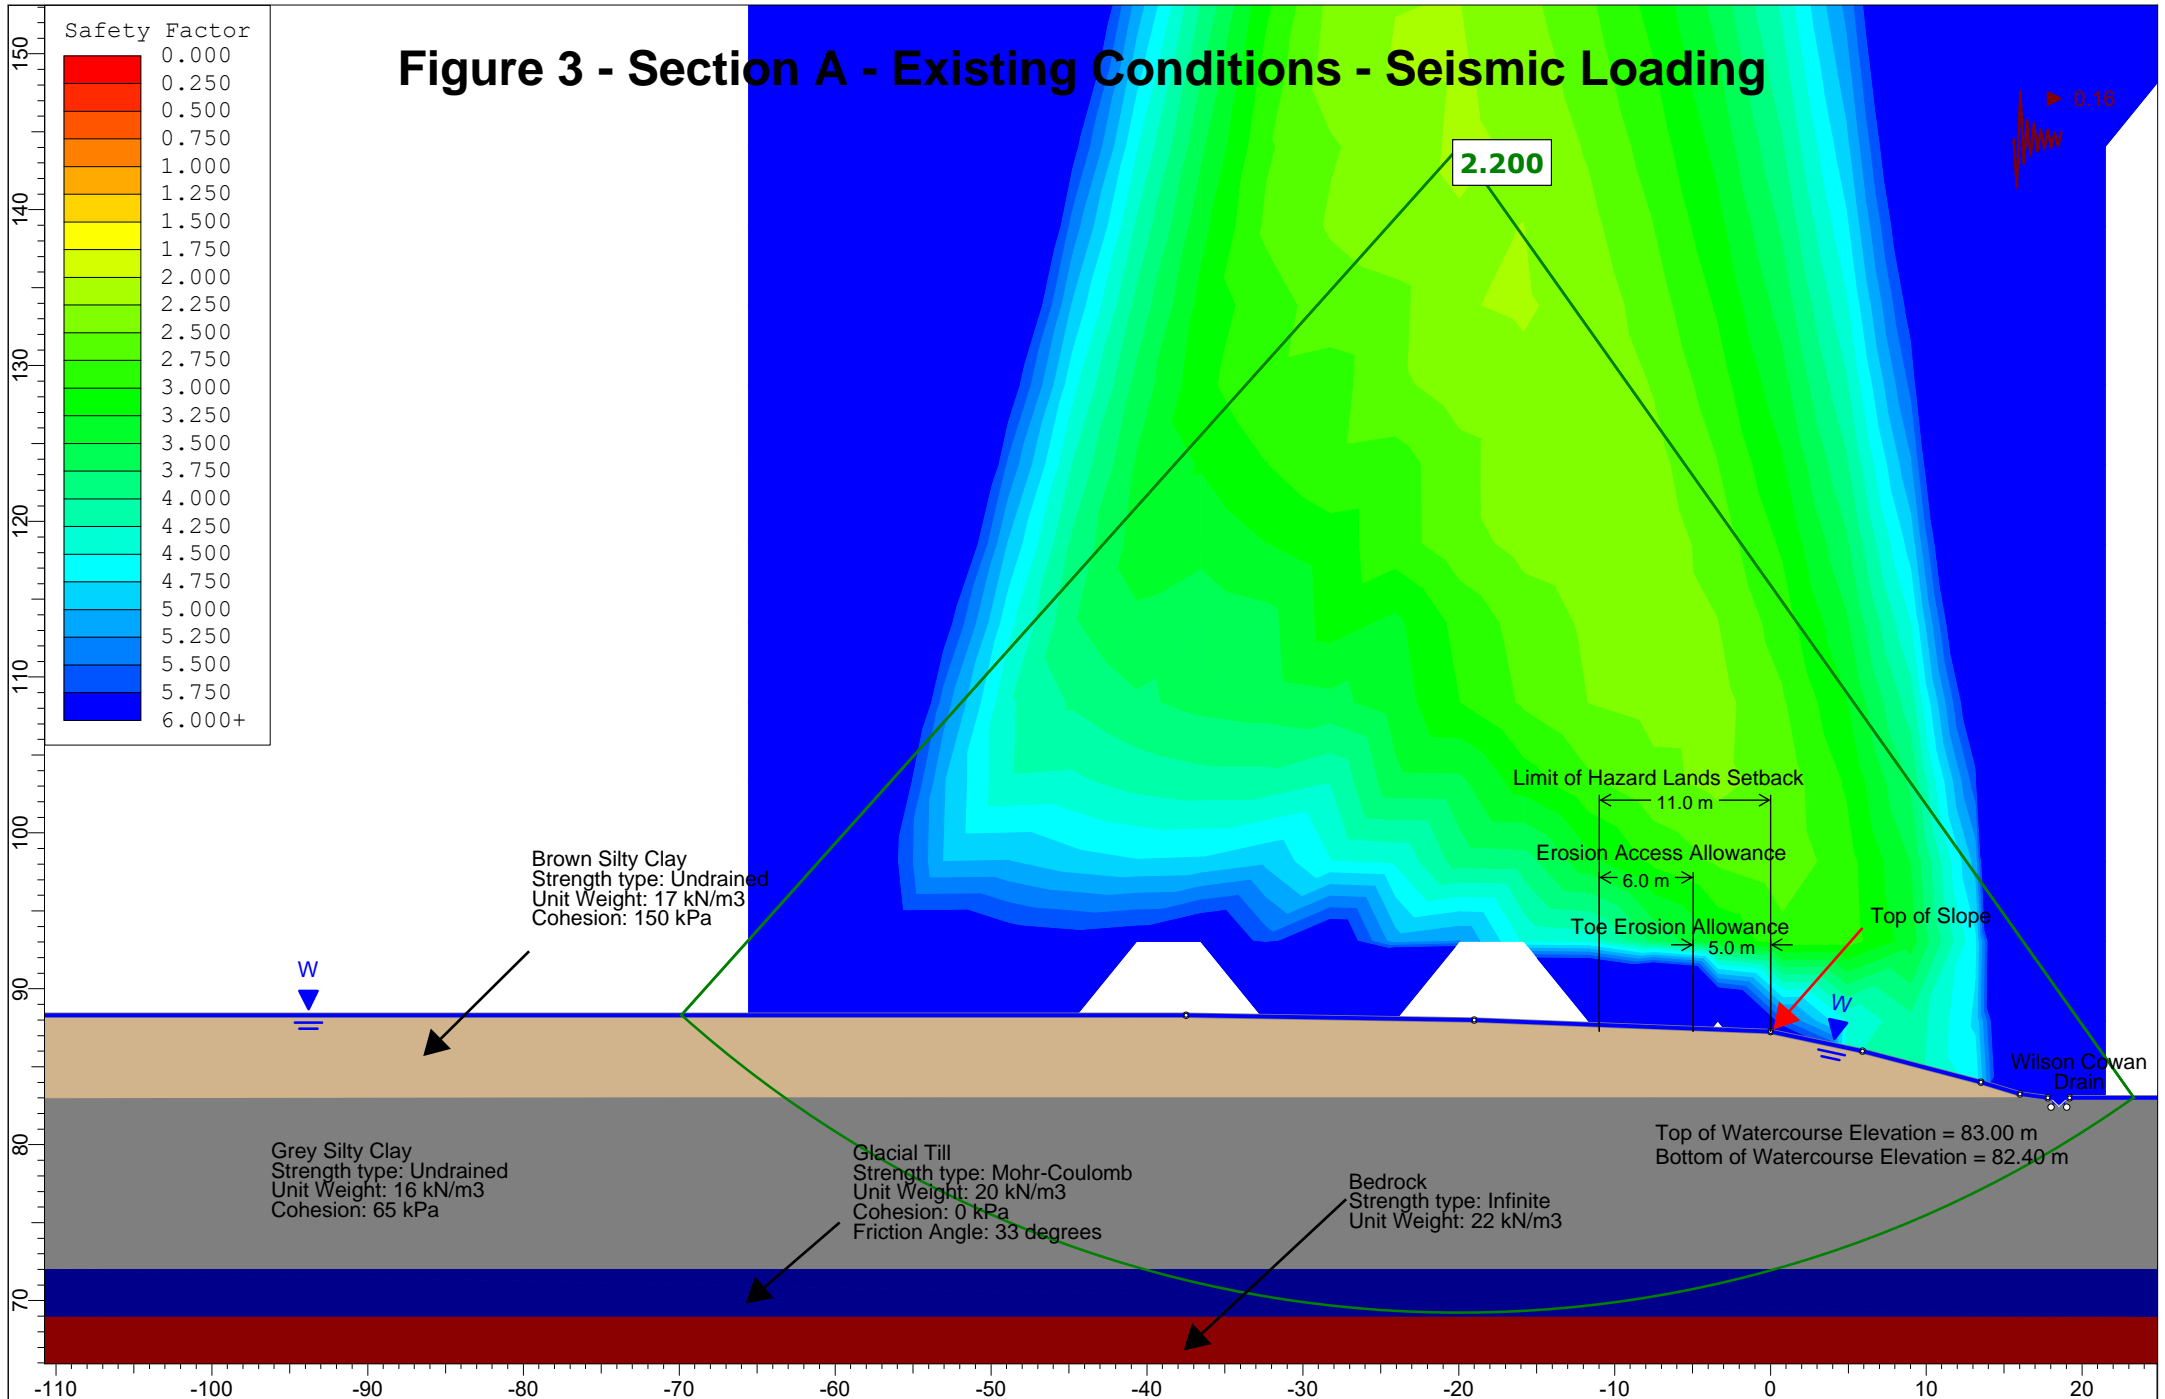
# Figure 3 - Section A - Existing Conditions - Seismic Loading

*The soil annotations on Figure 3 appear to be floating.*

Noted. The annotations for soil layers in Figure 3 have been modified in the above-mentioned revised report.

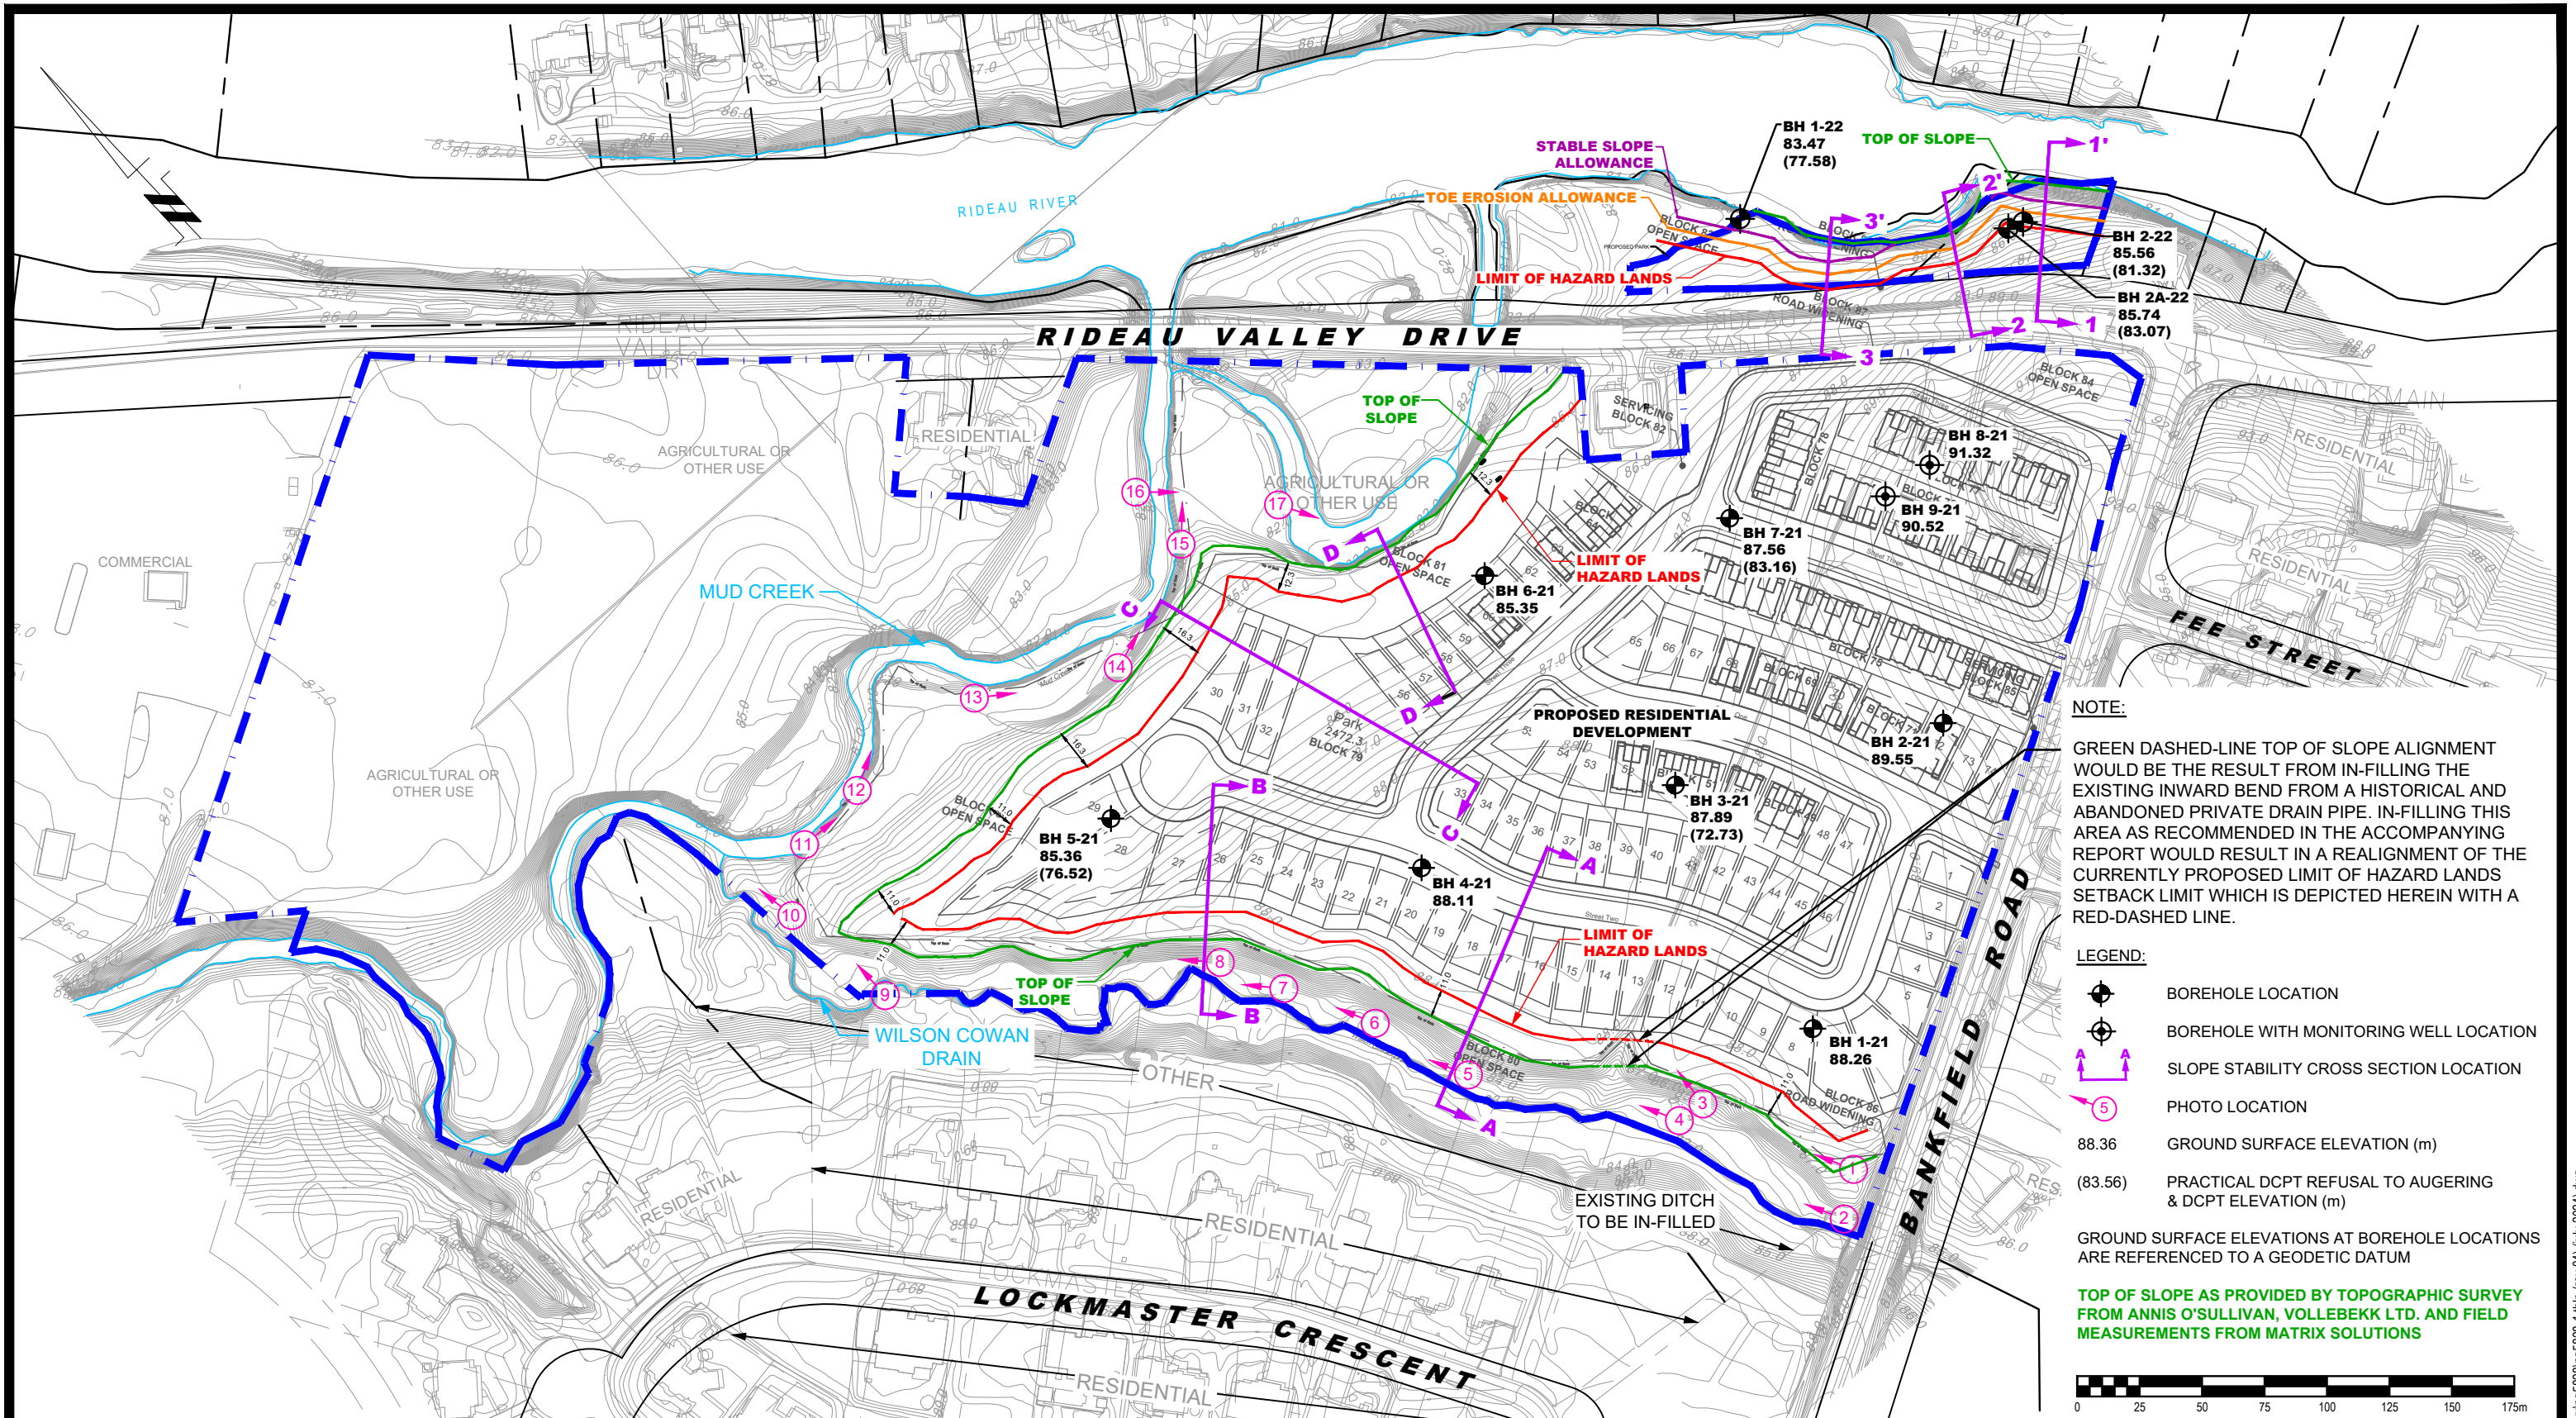
**NOTE:**  
 GREEN DASHED-LINE TOP OF SLOPE ALIGNMENT WOULD BE THE RESULT FROM IN-FILLING THE EXISTING INWARD BEND FROM A HISTORICAL AND ABANDONED PRIVATE DRAIN PIPE. IN-FILLING THIS AREA AS RECOMMENDED IN THE ACCOMPANYING REPORT WOULD RESULT IN A REALIGNMENT OF THE CURRENTLY PROPOSED LIMIT OF HAZARD LANDS SETBACK LIMIT WHICH IS DEPICTED HEREIN WITH A RED-DASHED LINE.

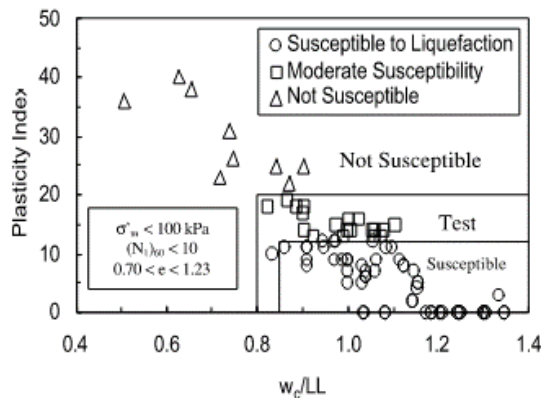
Figure 1. Criteria for evaluating liquefaction susceptibility of fine-grained soils (Bray et al. 2004).

The soils encountered at the subject site consist of silty clays, which are cohesive in nature. These soils were evaluated for liquefaction susceptibility in accordance with the criteria prepared by Bray et al. 2004 which determines that all soils with a plasticity index exceeding 20% are not liquifiable (Figure 1). In general, the plasticity index results completed on samples taken from the silty clay layer were found to be above 20. Therefore, the encountered soils are not susceptible to liquefaction. Reference should be made to subsection 5.4- Design for Earthquakes in the abovementioned revised geotechnical report, for further details on liquefaction susceptibility at the subject site.

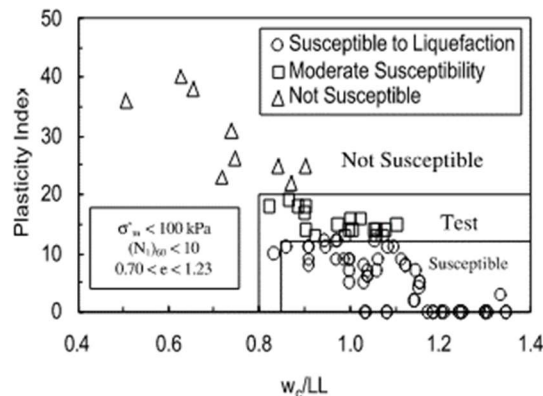
Paterson's Previous Response: The soils encountered at the subject site consist of silty clays, which are cohesive in nature. These soils were evaluated for liquefaction susceptibility in accordance with the criteria prepared by Bray et al. 2004 which determines that all soils with a plasticity index exceeding 20% are not liquifiable (Figure 1). In general, the plasticity index results completed on samples taken from the silty clay layer were found to be above 20. Therefore, the encountered soils are not susceptible to liquefaction. Reference should be made to subsection 5.4- Design for Earthquakes in the abovementioned revised geotechnical report, for further details on liquefaction susceptibility at the subject site.

Figure 1. Criteria for evaluating liquefaction susceptibility of fine-grained soils (Bray et al. 2004).

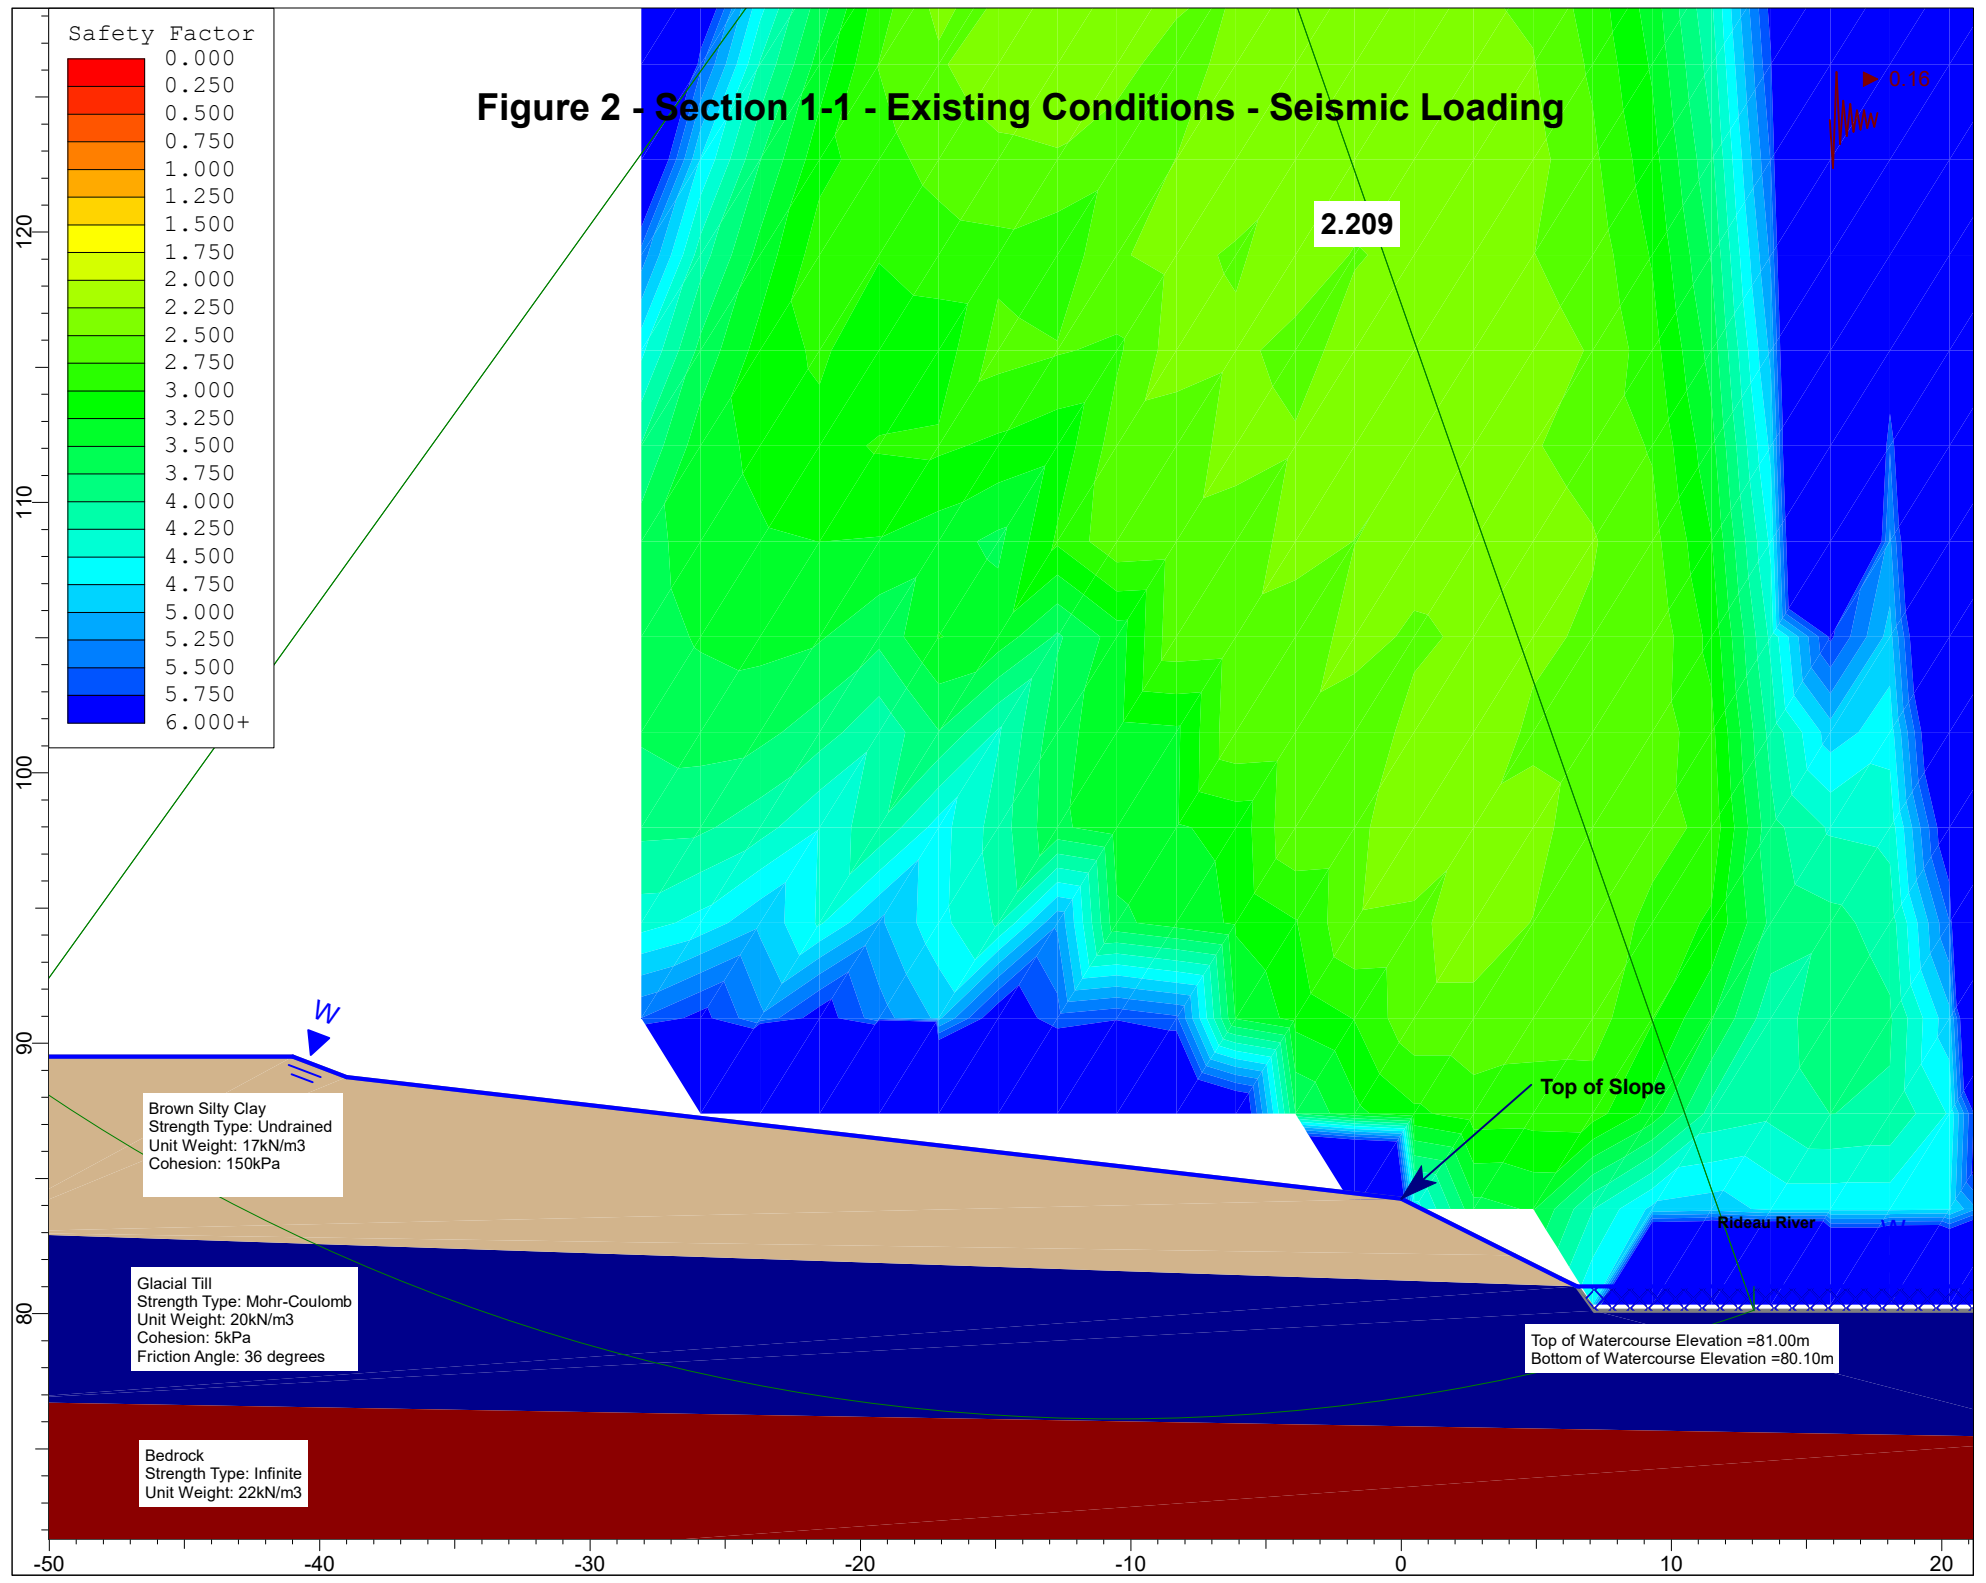
**Figure 2 - Section 1-1 - Existing Conditions - Seismic Loading**

Brown Silty Clay  
Strength Type: Undrained  
Unit Weight: 17kN/m<sup>3</sup>  
Cohesion: 150kPa

Glacial Till  
Strength Type: Mohr-Coulomb  
Unit Weight: 20kN/m<sup>3</sup>  
Cohesion: 5kPa  
Friction Angle: 36 degrees
