## TECHNICAL MEMORANDUM

**DATE** December 22, 2022

**Project No.** 21482114

### FLUVIAL GEOMORPHIC ASSESSMENT AT SUBJECT AREA OF THE RIDEAU RIVER TO SUPPORT PROPOSED DEVELOPMENT AT 3930 AND 3960 RIVERSIDE DRIVE

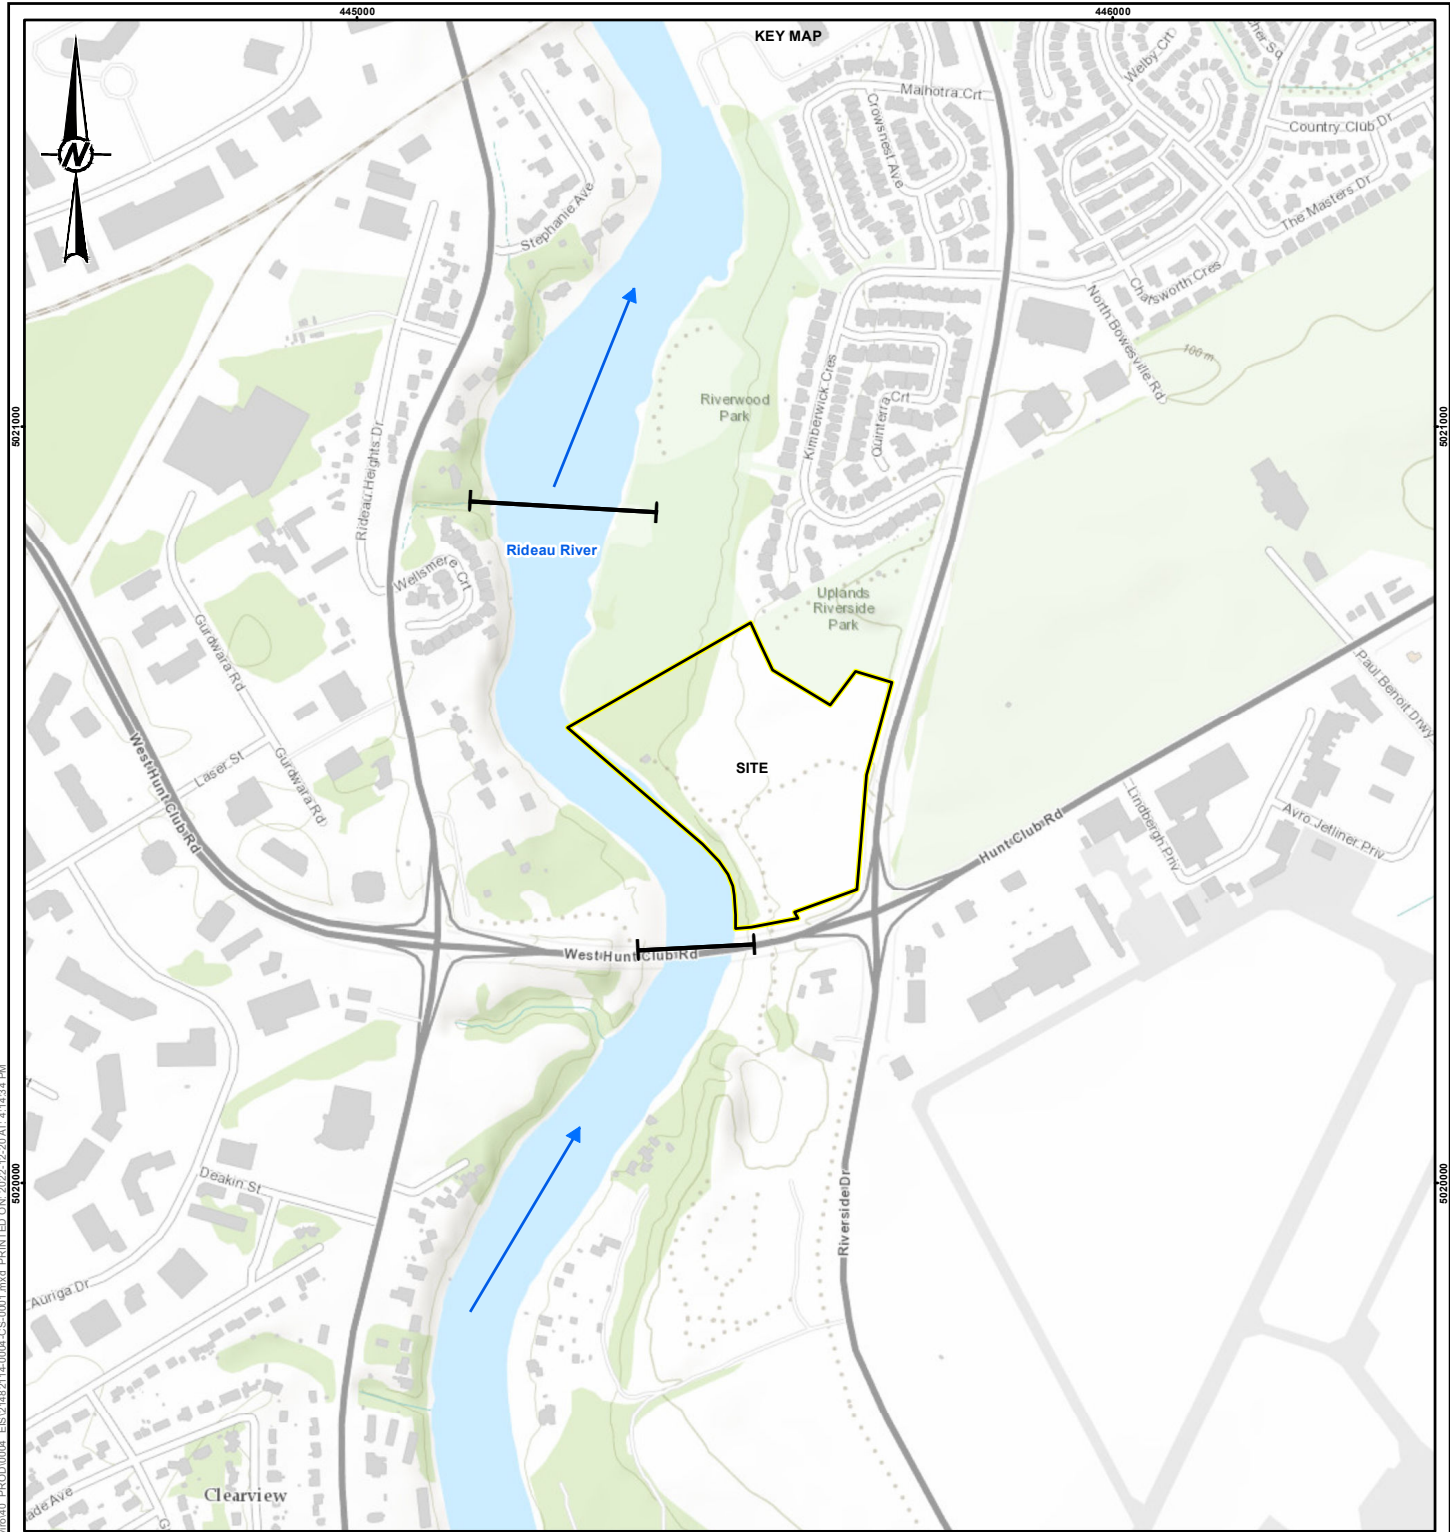
**SUMMARY OF OBSERVED CHANGES TO CHANNEL PLANFORM AT SUBJECT REACH BASED ON HISTORICAL AIR PHOTOGRAPH ANALYSIS**

The results of the air photograph analysis are illustrated in Figure 2. The key findings are as follows:
