TREE CONSERVATION REPORT

5872-5884 Hazeldean Road & 7
Savage Drive

Tree Conservation Report submitted as Partial
Requirements for a Site Plan Control Application.

December 3, 2024

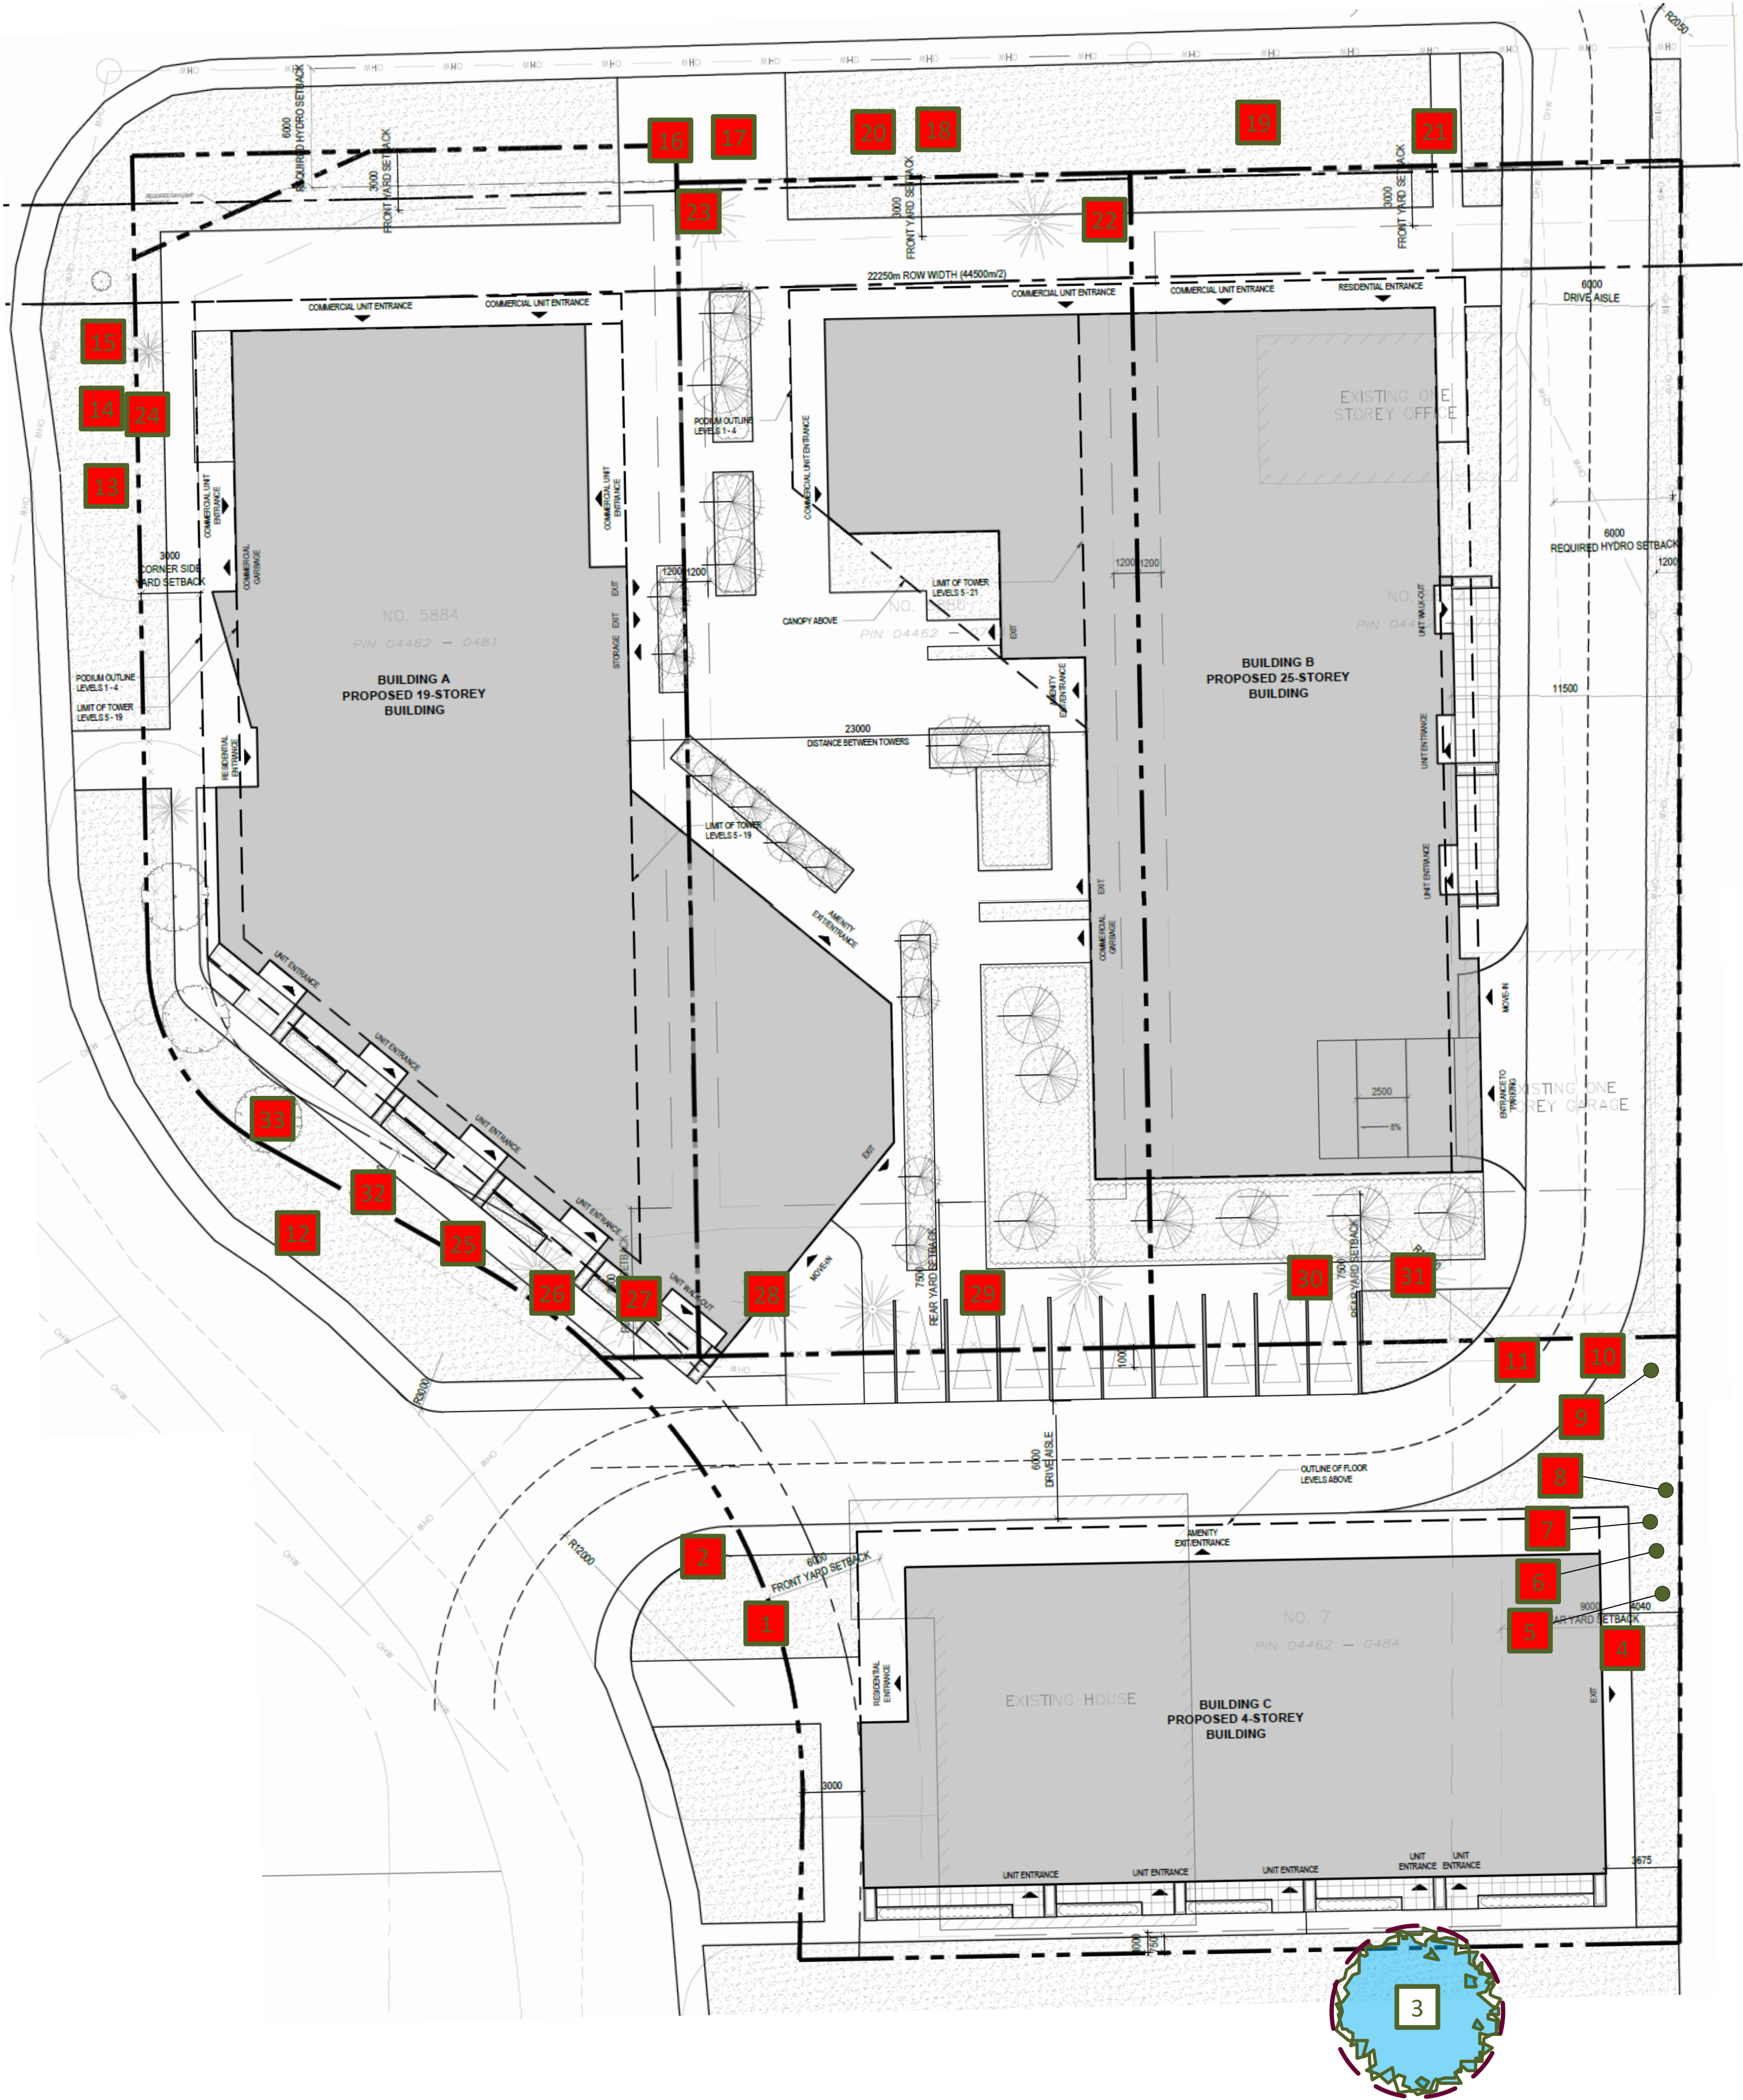
**TCR - 5872-5884 Hazeldean and 7 Savage
Map 2 - Proposed Development**

The proposed development includes 2 levels of underground parking covering a large majority of the lots. The required excavation will necessitate the removal of all private trees (specifically Trees **4-11 and 22-31**). Given these plans, it is unlikely engineering documents will change these recommendations.

Tree 2 is in direct conflict with the proposed driveway, and the tree is in poor condition.

Tree 12 is a likely self-seeded cluster of young ash stems. These are showing signs of insect damage, and it is possible they have already been infested with Emerald Ash Borer. It is unlikely these trees will survive long, despite construction, and the stress of construction will further hasten their decline.

Trees 13-21 are in poor condition – large wounds around the bases of the trees are pathways for infections, and with the added stress of construction, regardless of protections, these trees are likely to decline very quickly. It is recommended they be removed and replaced with healthier specimens.
