# PATERSON GROUP

February 20, 2026  
PG6557-LET.01 Revision 2

Subject: **Preliminary Geotechnical Investigation  
Proposed Commercial Development  
2175 Prince of Wales Drive – Ottawa, Ontario**

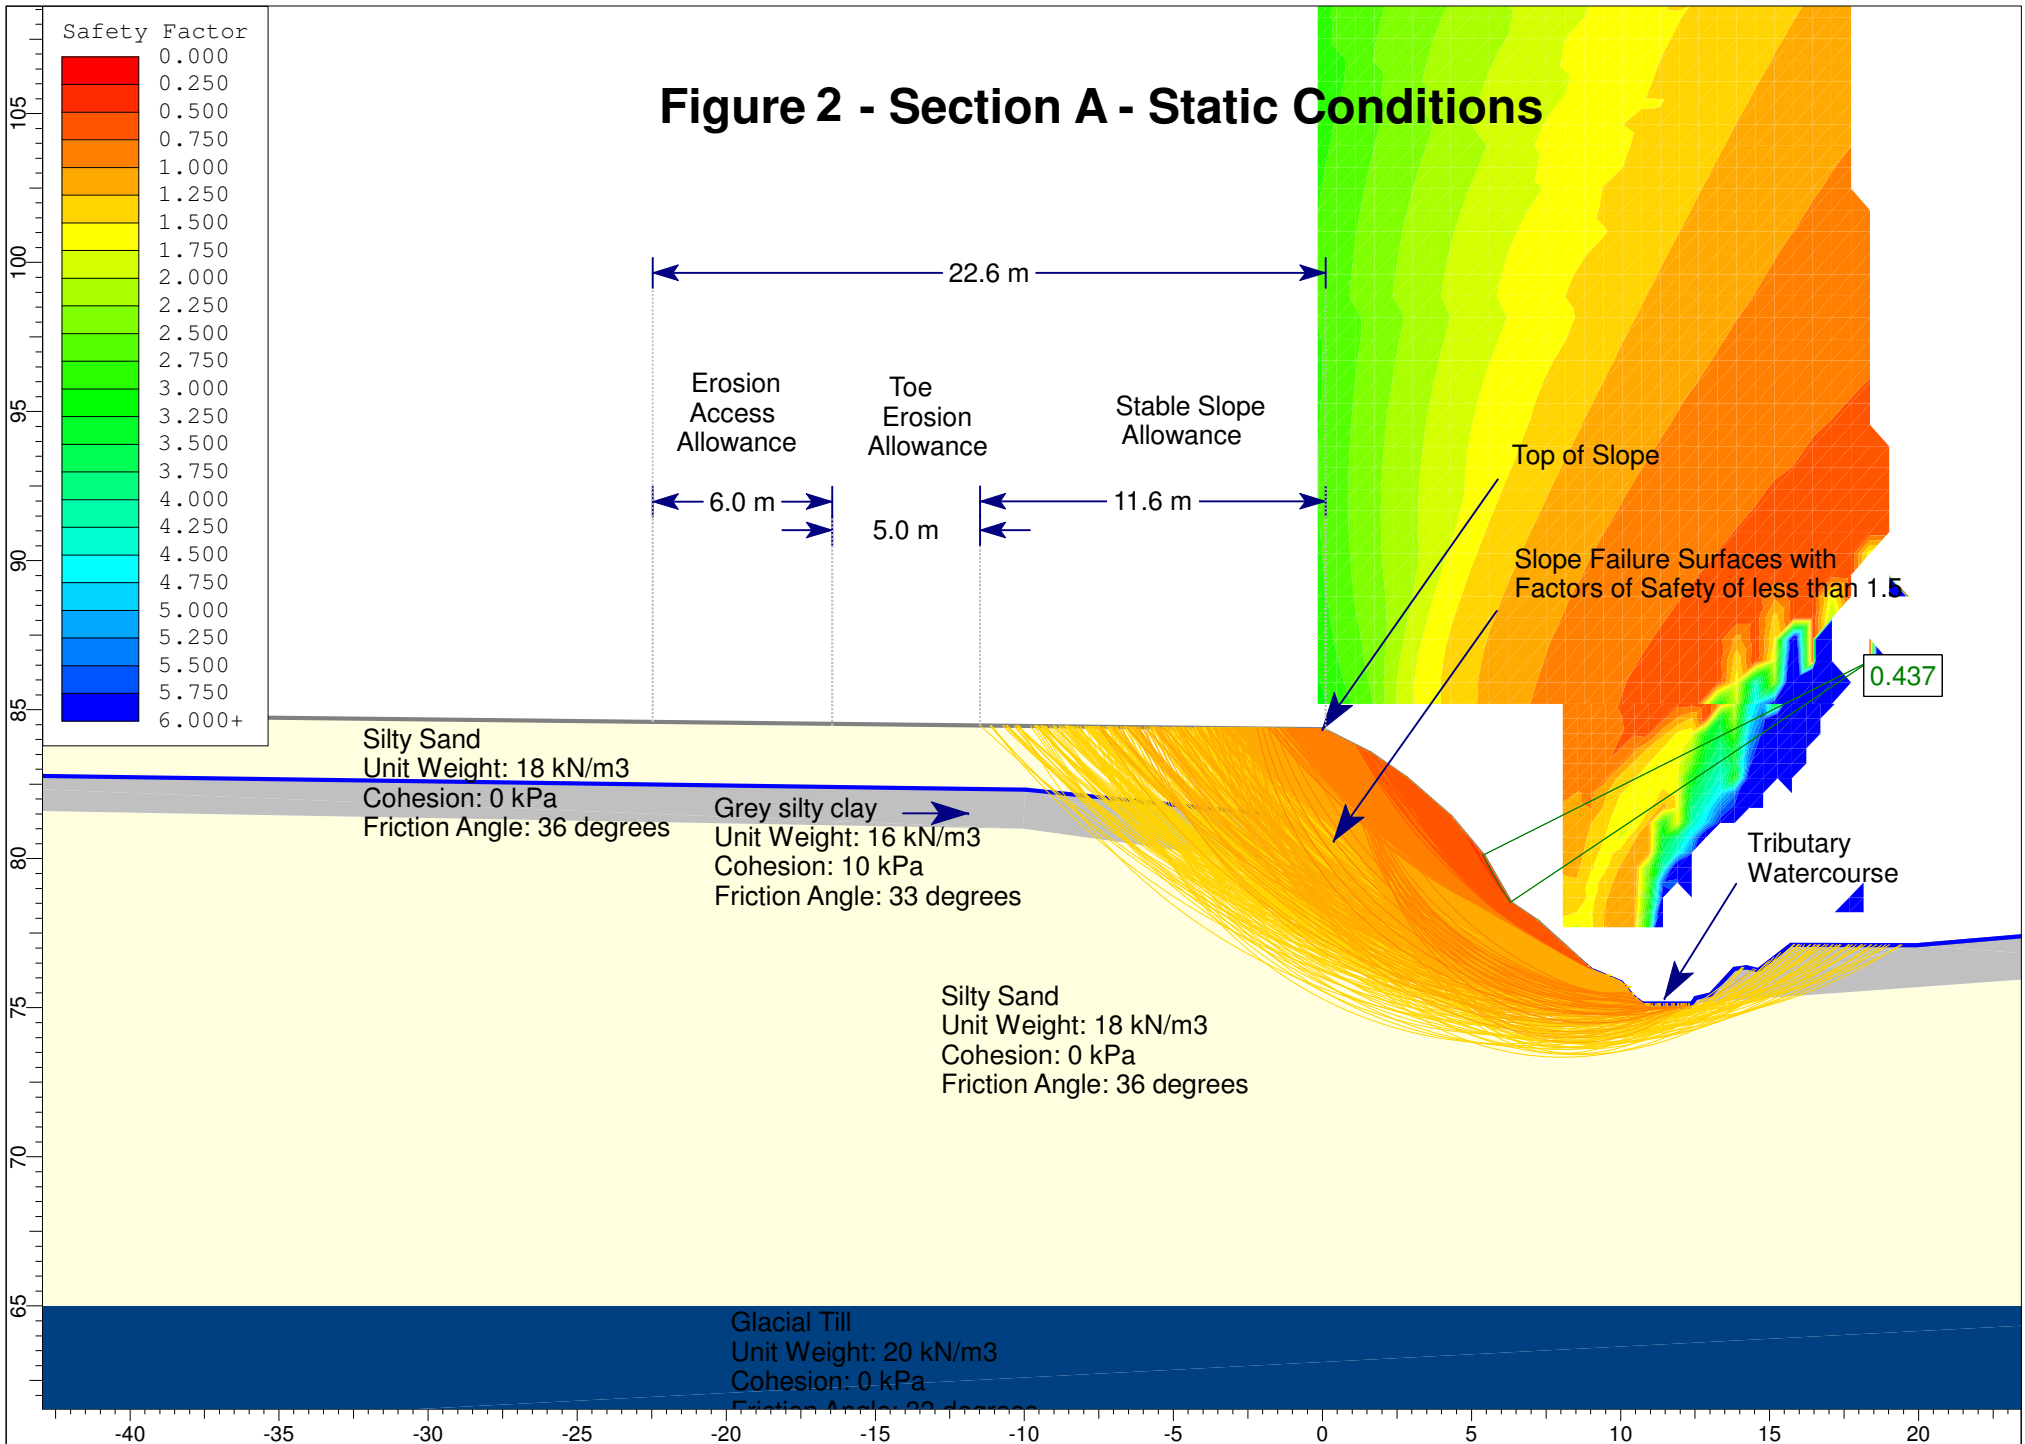
# Figure 2 - Section A - Static Conditions

The results of the existing slope conditions under static loading at Section A, Section B, and Section C are shown in Figures 2, 4, and 6, respectively, attached to the present report. The overall slope stability factors of safety for the subject sections were found to be less than 1.5, except for Section C. The stable slope allowance from the top of slope required for slope with a minimum factor of safety of 1.5 is identified for each profile in the attached figures.

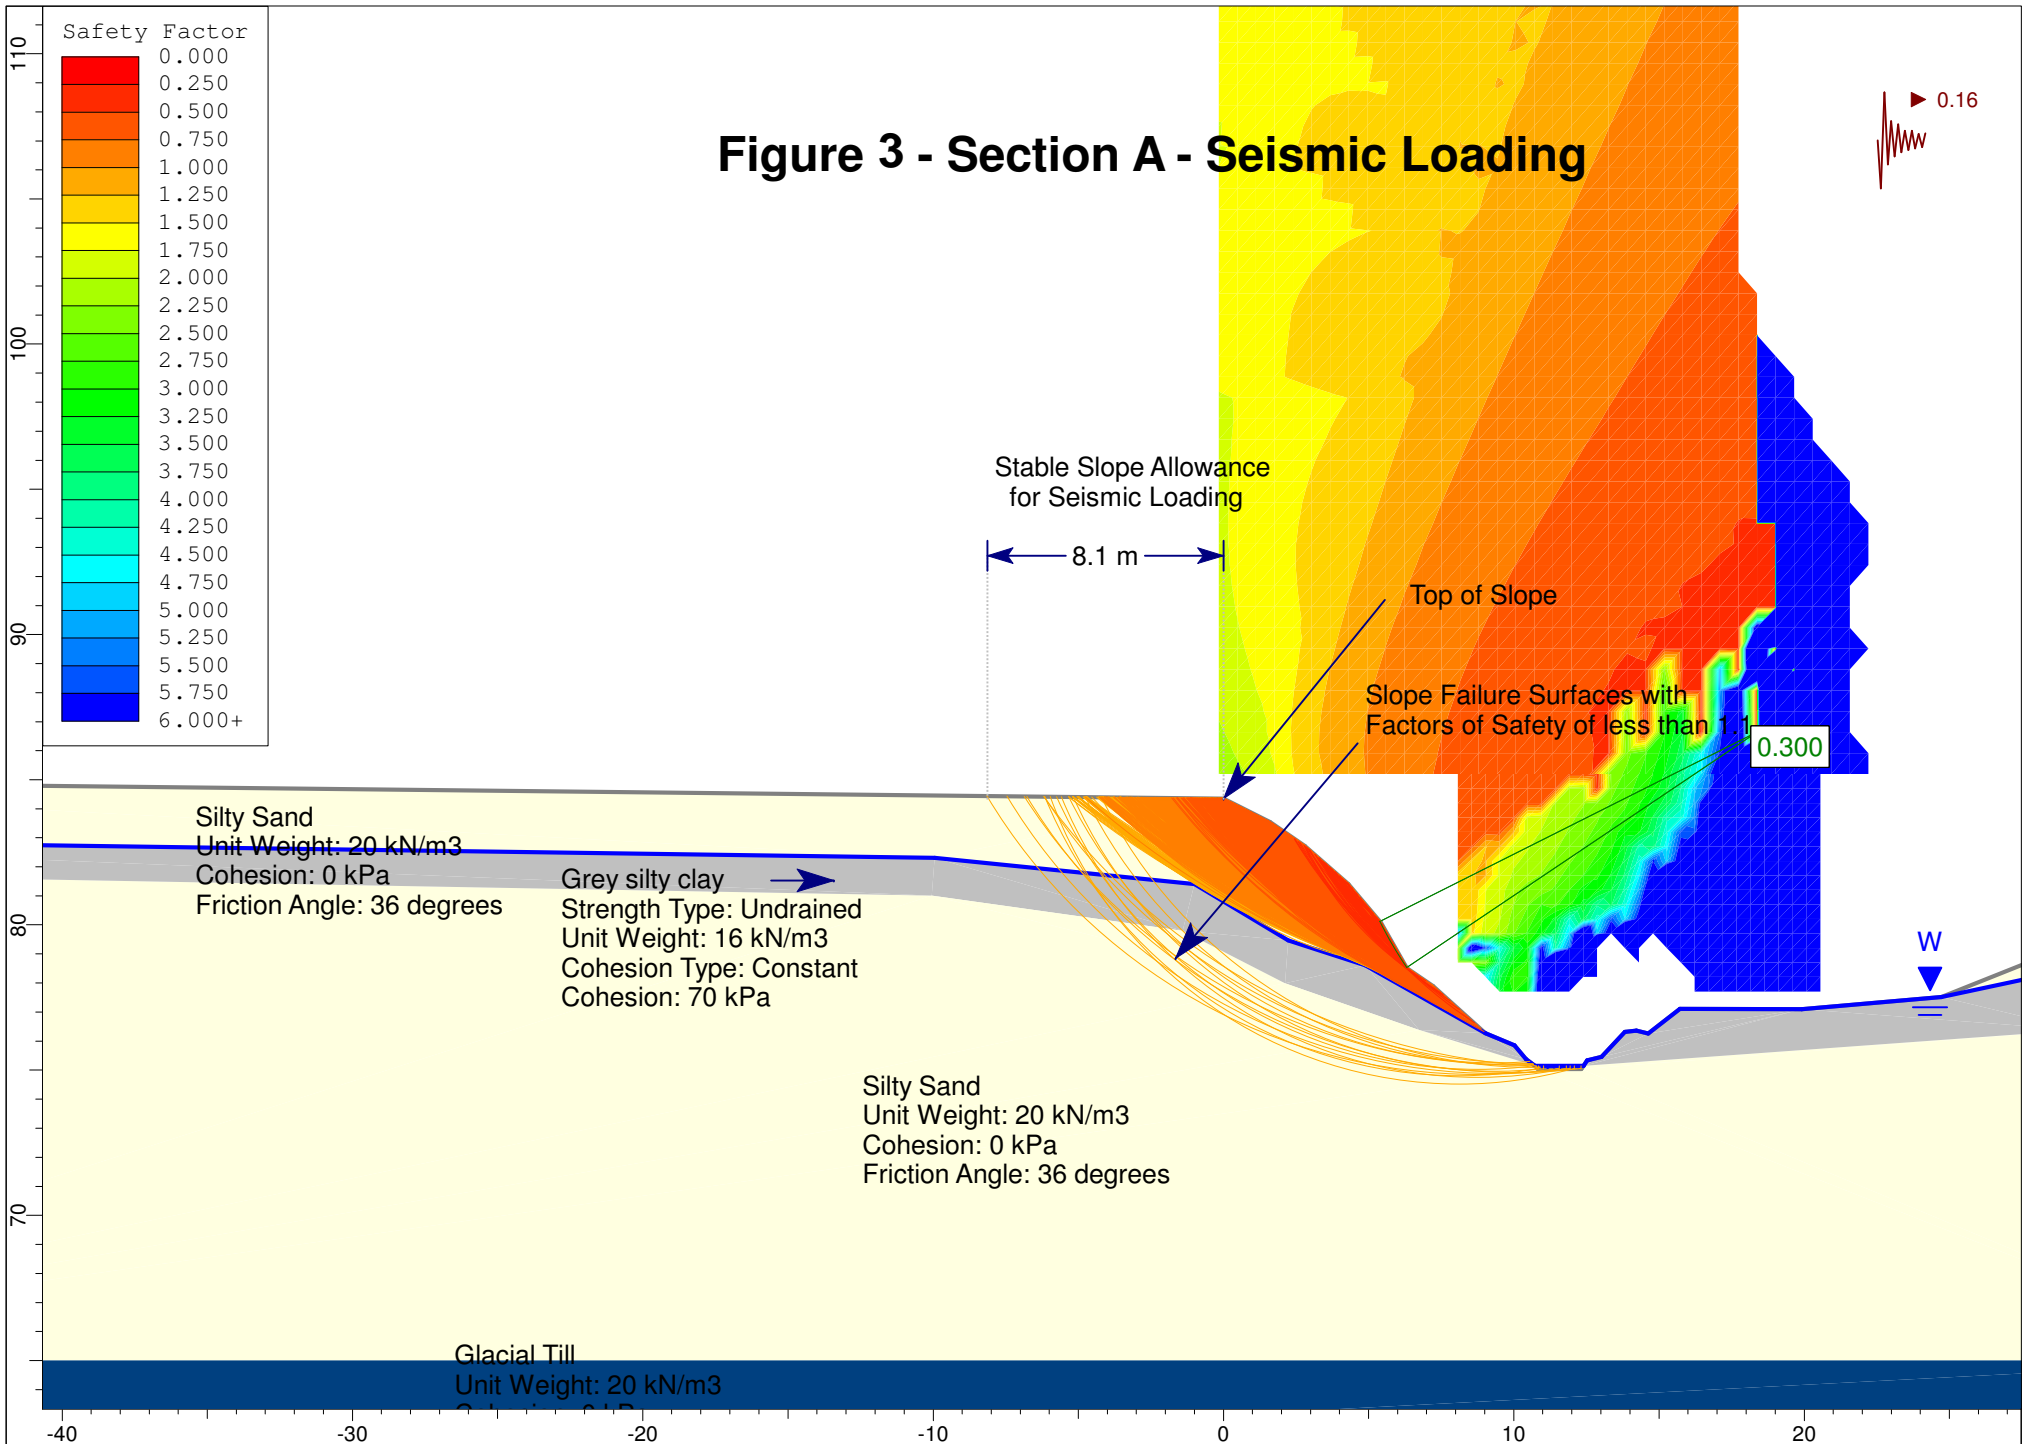
# Figure 3 - Section A - Seismic Loading

The results of the analysis including seismic loading, are shown in Figures 3, 5, and 7 for the slope sections. Where the minimum factor of safety is less than 1.1, the stable slope allowance from the top of slope required for the slope section is identified in the attached figures.
