June 19, 2026  
PG6557-LET.01 Revision 4

Subject: **Preliminary Geotechnical Investigation  
Proposed Commercial Development  
2175 Prince of Wales Drive – Ottawa, Ontario**

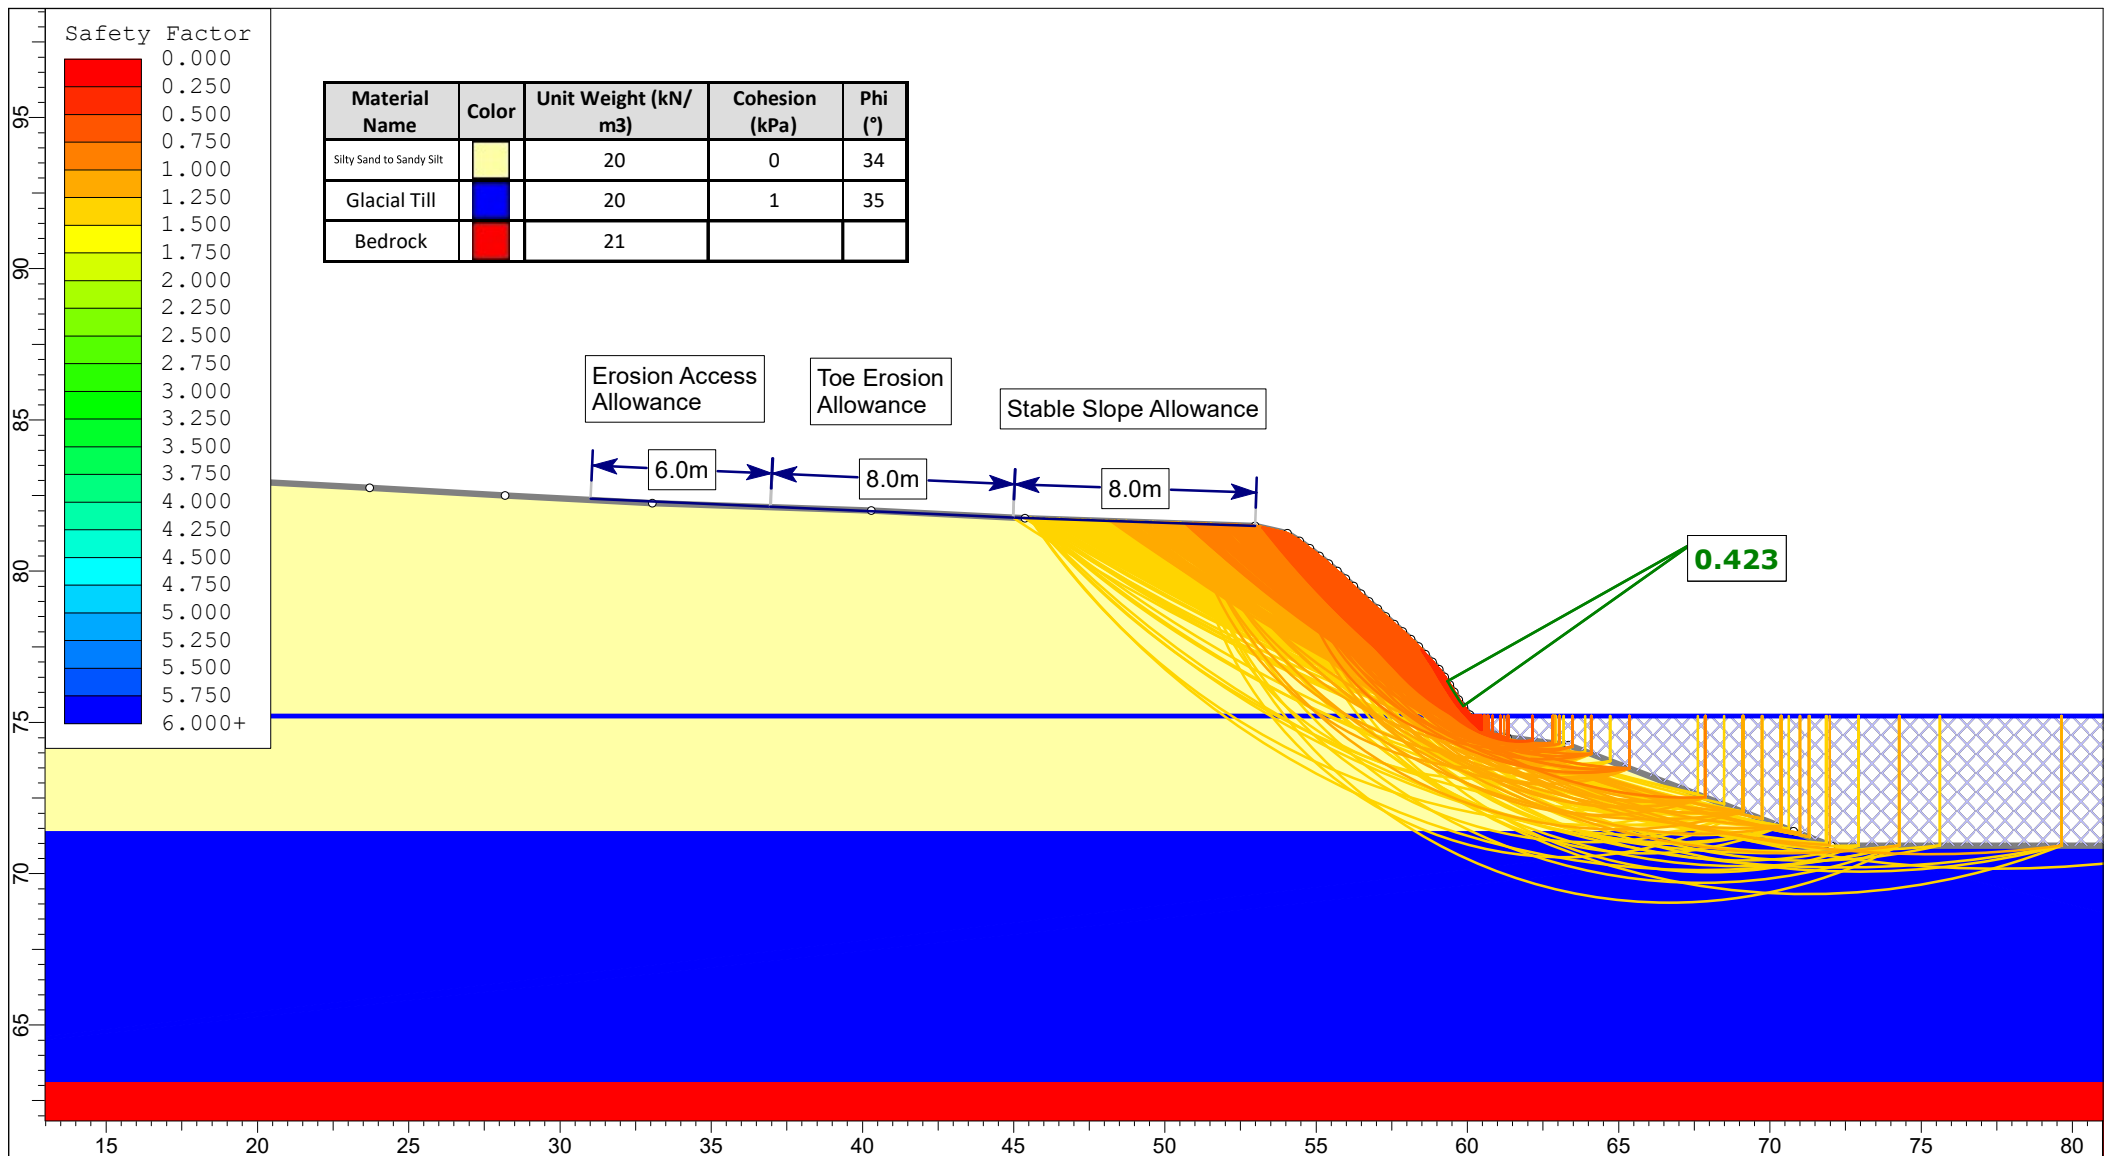
| Drawing No.: Figure 2A - Section B - Static Loading | | |

The results of the existing slope conditions under static loading at Sections A, B, C, D, and E, are shown in Figures 1A, 2A, 3A, 4A, and 5A, respectively, and are attached to the present report. The overall slope stability factors of safety for the subject sections were found to be less than 1.5. The stable slope allowance from the top of slope required for slopes with a minimum factor of safety of 1.5 is identified for each profile in the attached figures.

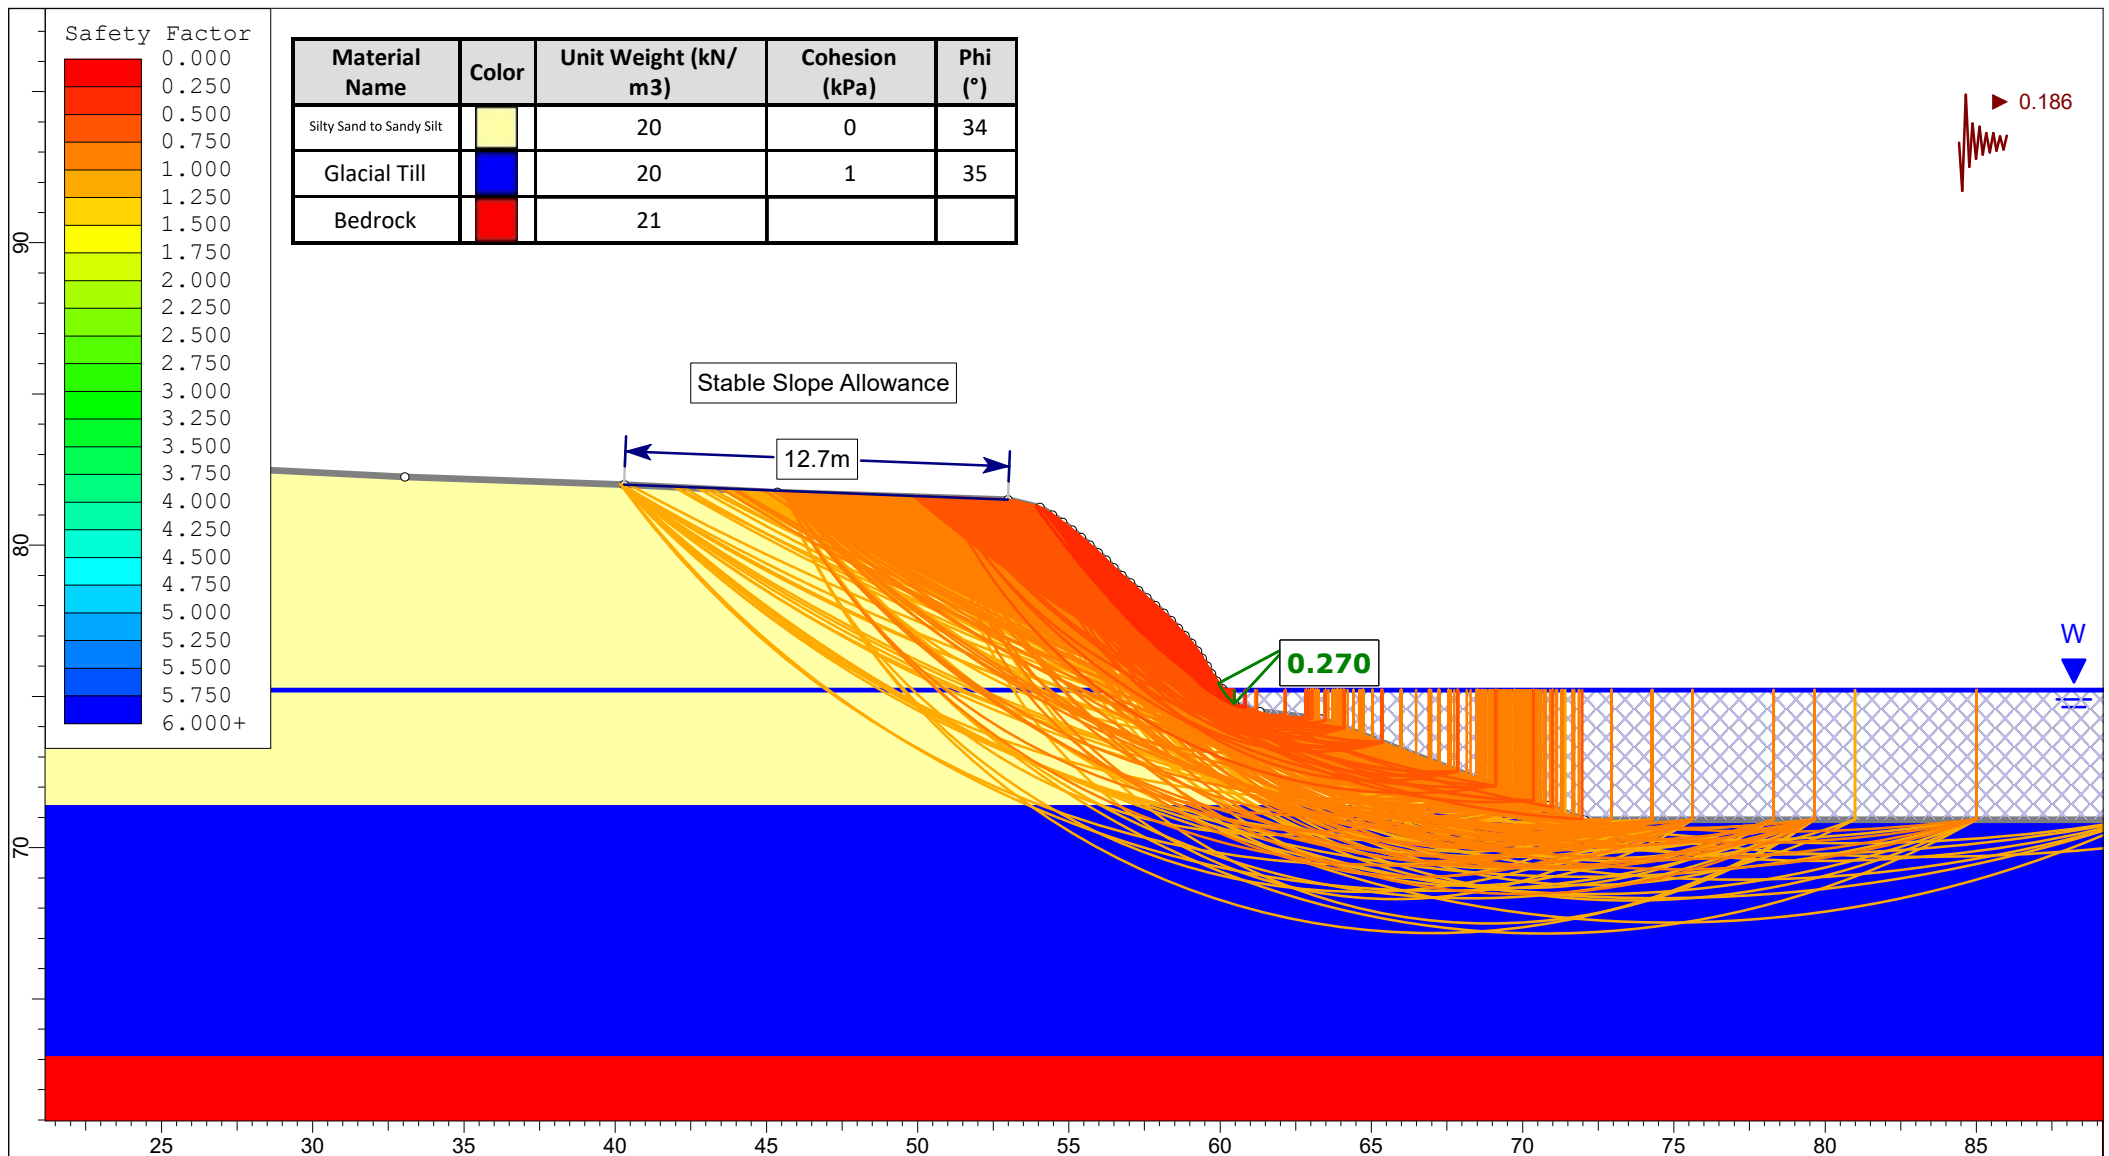
| | <b>Drawing No.:</b> Figure 2B - Section B - Seismic Loading | |

An analysis considering seismic loading was also completed as part of the slope stability analysis. A horizontal seismic loading acceleration,  $K_h$ , of 0.186g was considered for the analyzed sections. A factor of safety of 1.1 is considered to be satisfactory for stability analysis including seismic loading. The results of the analysis including seismic loading, are shown in Figures 1B, 2B, 3B, 4B, and 5B for the slope sections. Where the minimum factor of safety is less than 1.1, the stable slope allowance from the top of slope required for the slope section is identified in the attached figures.
