TREE CONSERVATION REPORT

1110 Fisher

Tree Conservation Report submitted as Partial
Requirements for a Zoning Application

Date: May 21, 2019

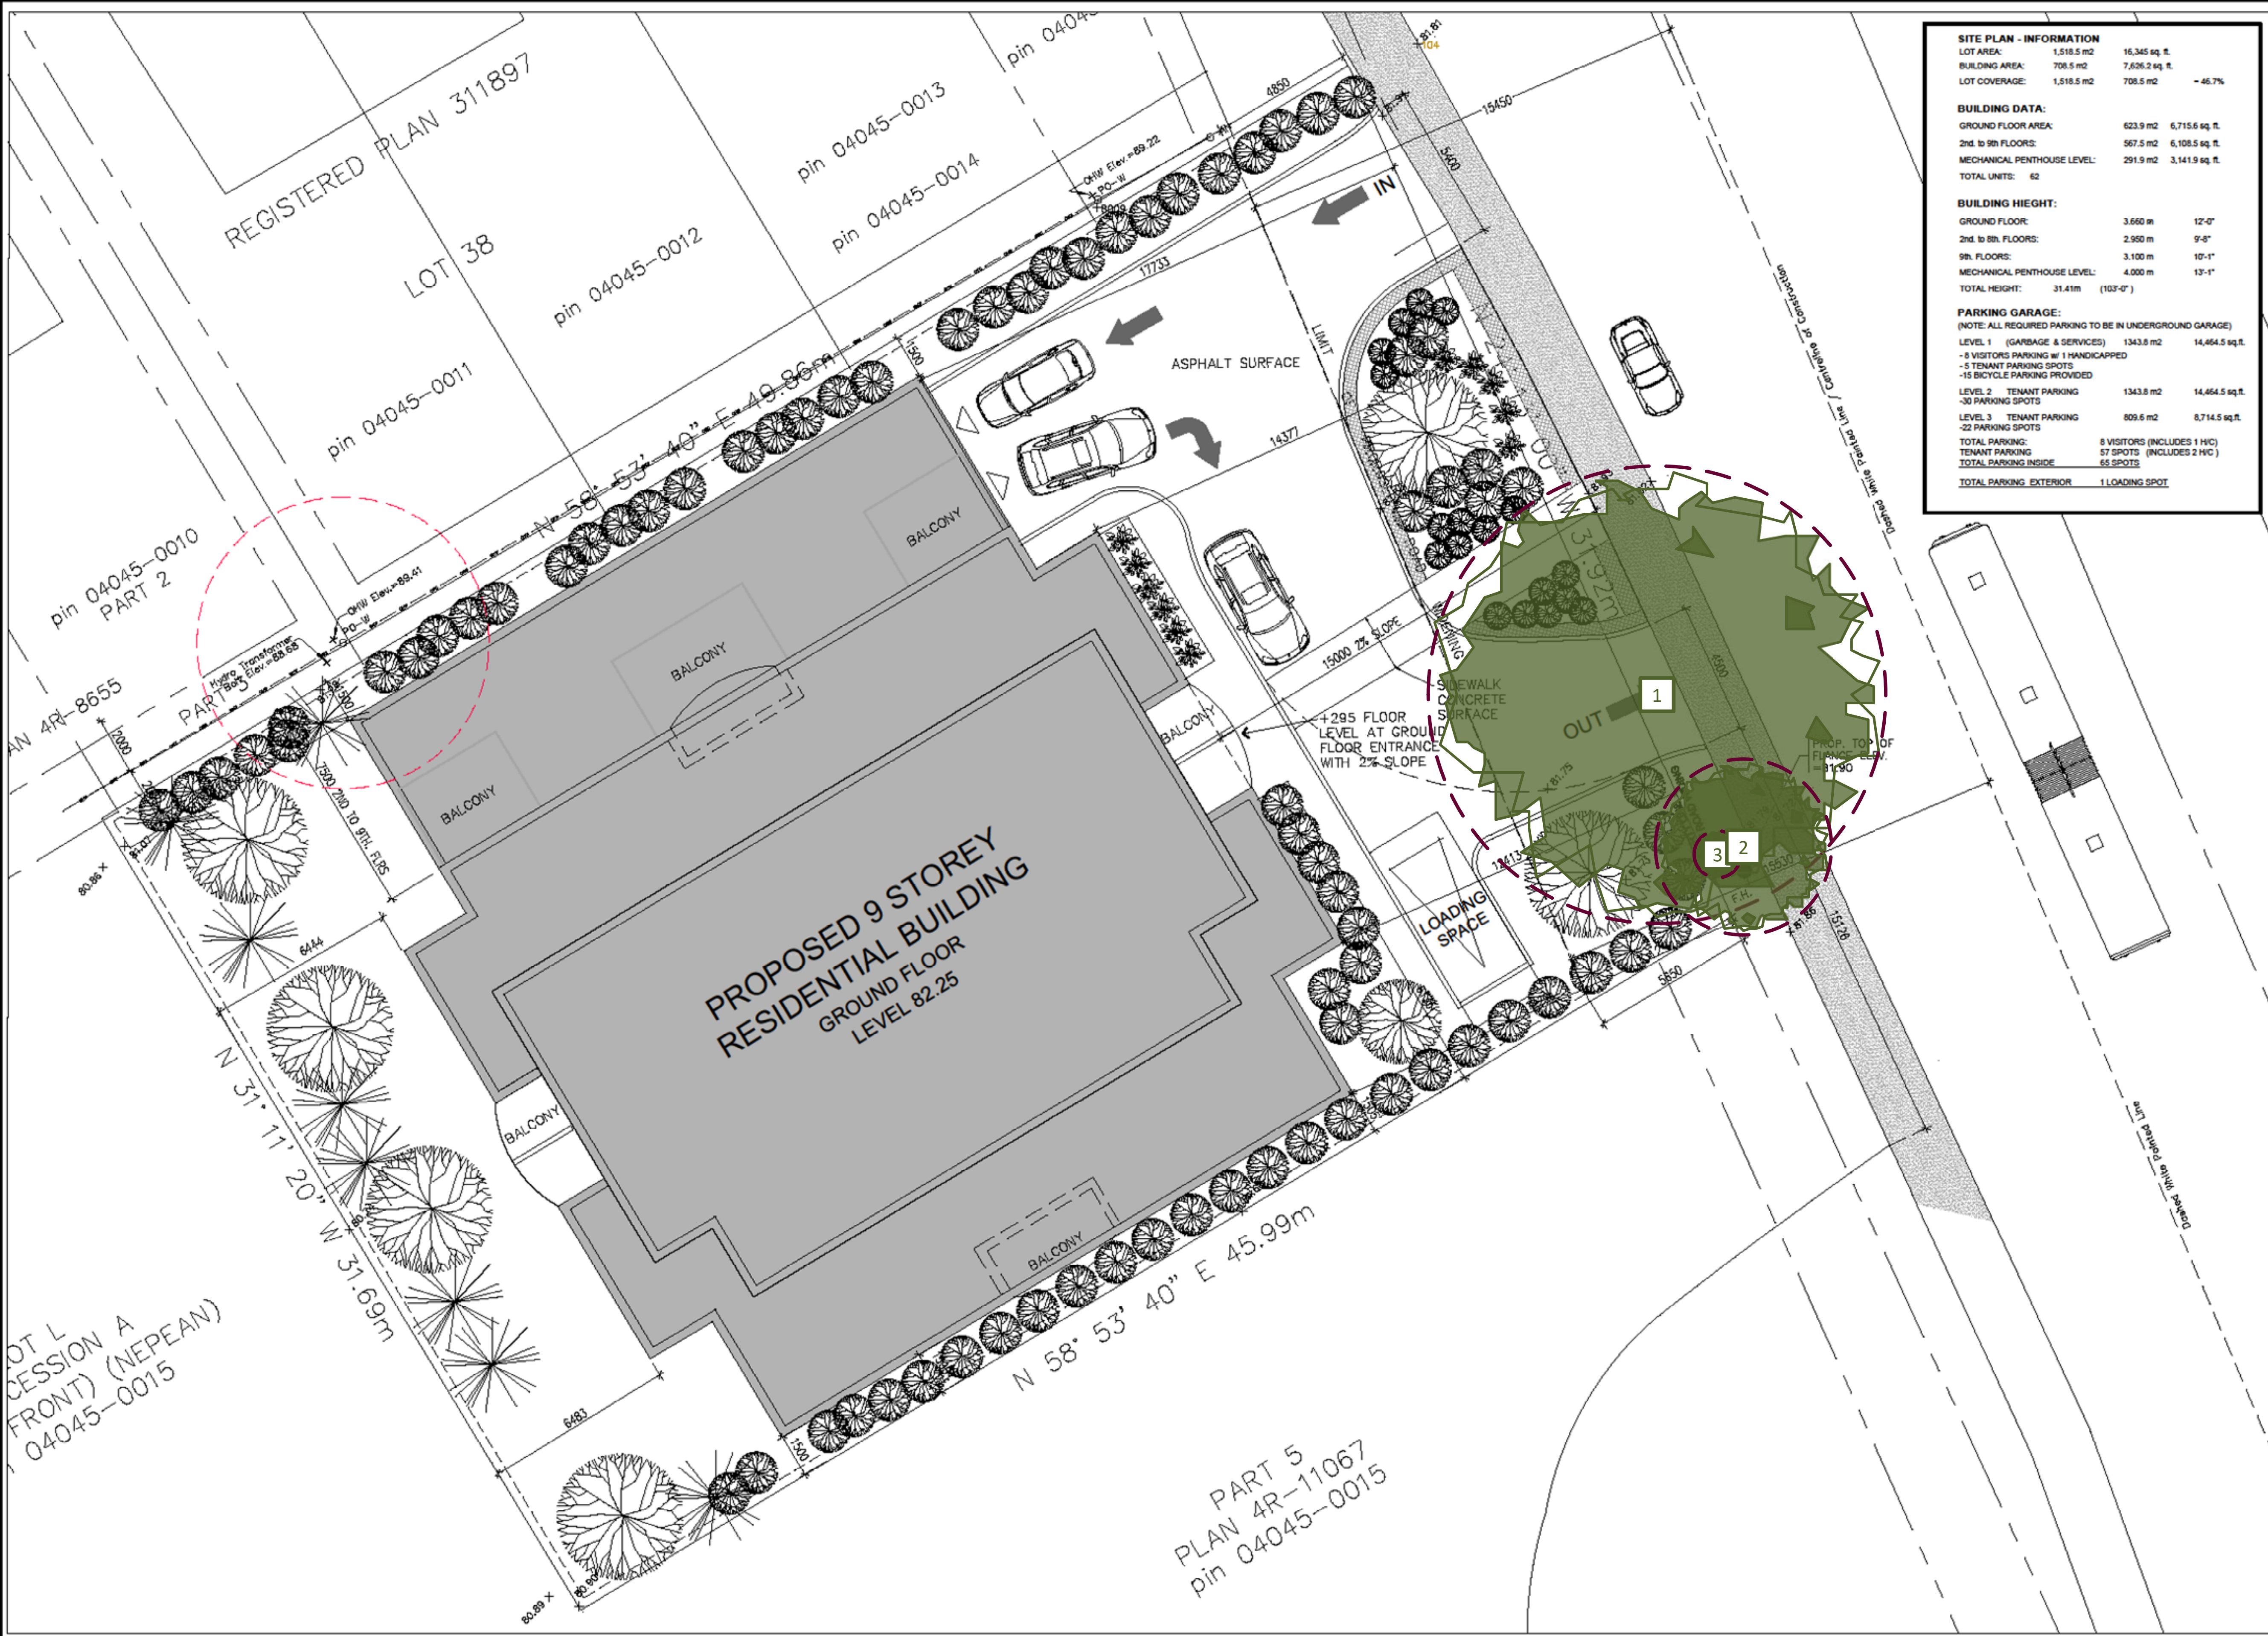
The proposed development is shown in the Tree Conservation Report Map. This map shows a tree layer created by Dendron Forestry Services overlaying the Site Plan provided by Prestige Design & Construction. Note that locations of the trees on this map are estimates only. No survey or grading plan was available at the time of report preparation and geoOttawa was used to estimate their locations.

Based on the level of construction proposed at this site, it is recommended that the Norway maples at the front of the property be removed and replaced once construction is complete. Trees no.2 and 3 have been naturally seeded and were most likely not planted by the City.

For those trees on neighbouring property that are close to the property line and whose roots will be impacted by the proposed development, it is recommended that the following protection measures be implemented prior to construction:

- Erect a fence at the critical root zone (CRZ) of trees;
- Do not place any material or equipment within the CRZ of the tree;
- Do not attach any signs, notices or posters to any tree;
- Do not raise or lower the existing grade within the CRZ without approval;
- Tunnel or bore when digging within the CRZ of a tree;
- Do not damage the root system, trunk or branches of any tree;
- Ensure that exhaust fumes from all equipment are NOT directed towards any tree's canopy.

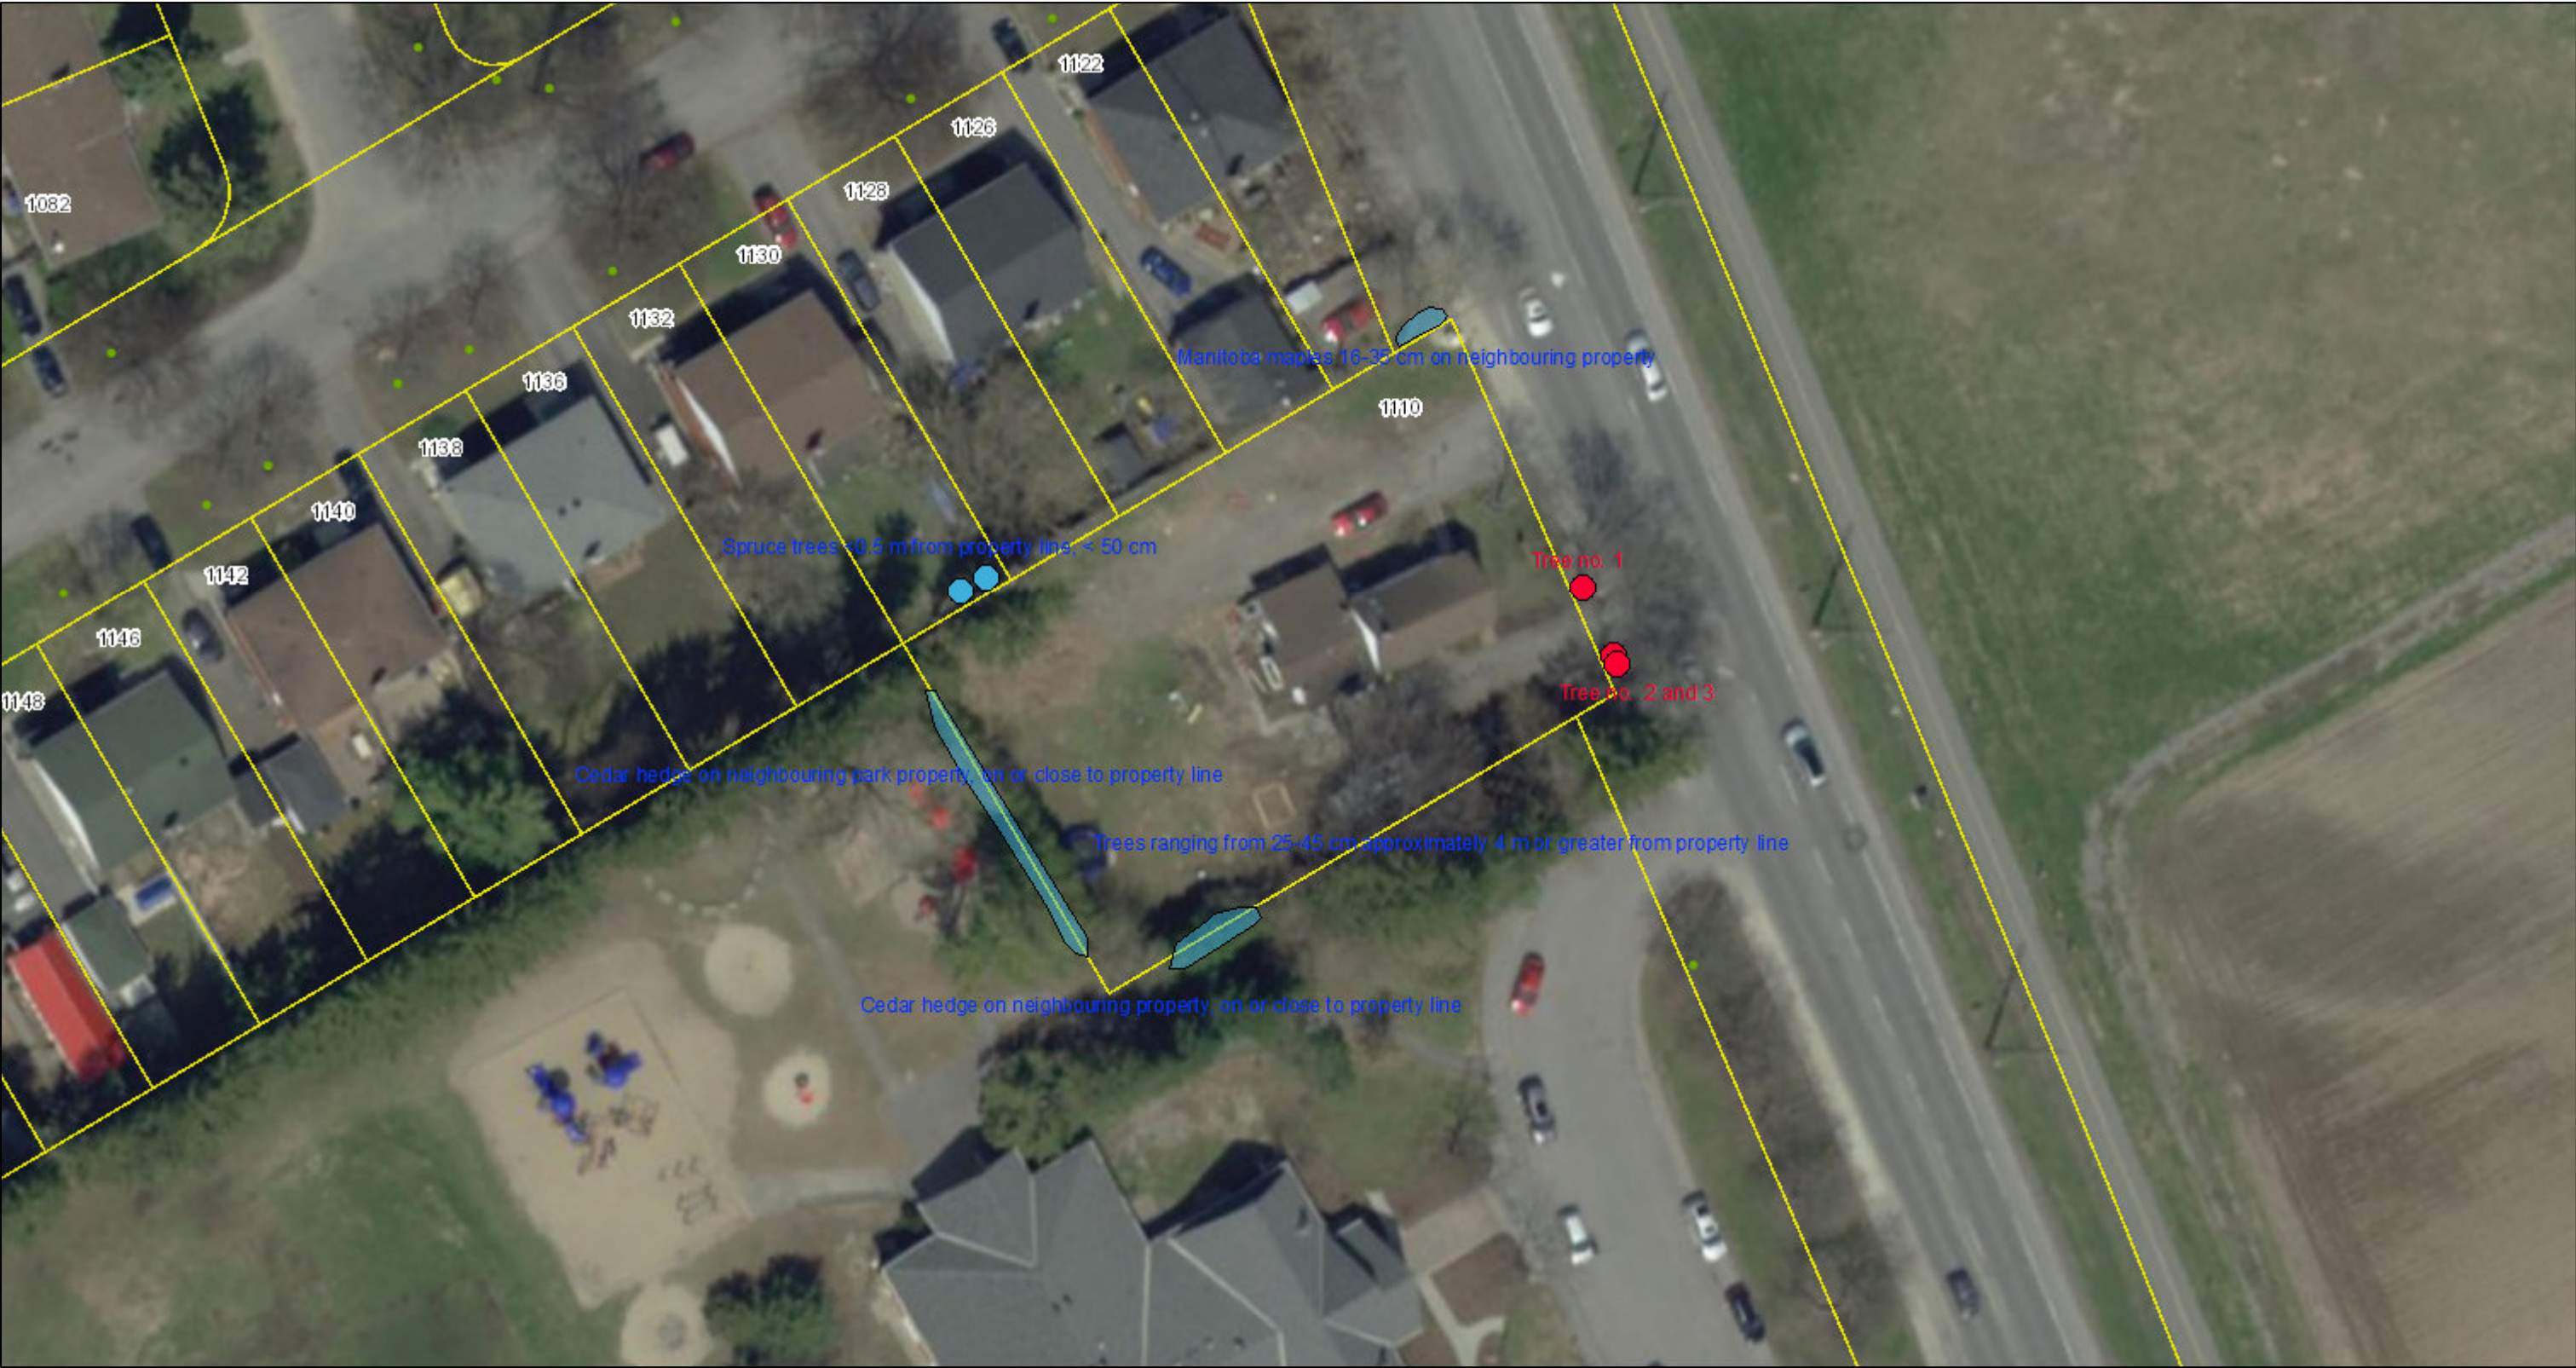
1110 Fisher - Existing Conditions

In addition to the above, there are also trees and vegetation located close to the property line on neighbouring property. These have been identified in the Existing Conditions Map provided in this report. This map used the 2015 imagery from geoOttawa. Note that the locations of the vegetation are approximate only. Along the southern property line, there are trees along the east side that range from 25-45 cm in diameter. Along the same southern line, there is a cedar hedge along the west side that is hanging over the property line. A cedar hedge also extends along the west property line. On the northern property line, there are two white spruce on the west side that are close (within a metre) of the property line whose roots may be impacted by work done on the site. Some soil within the root zone has already been disturbed from previous activity. Along the east side, there are some Manitoba maples along the neighbouring property that may require pruning over the property line.

In addition, any pruning that is required for trees hanging over the property line should be completed according to good arboricultural practices.
