# Heritage Impact Assessment

**593, 601, 603 Laurier Avenue West  
Ottawa, Ontario**

Prepared for: Heritage Investments Ltd. and Project1 Studio | RMA+SH 24007

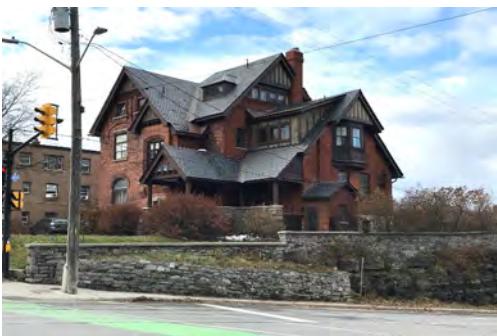
Figure 2: 593 Laurier Avenue, side (south-west) façade of existing building. (RMA)

The building at 593 Laurier Avenue West (*Figure 2*), also known as the Alexander Fleck House, was designated as an Individually Designated Property under *Part IV* of the *Ontario Heritage Act* (OHA) in 2014. Further description of the heritage property is included in *Sections 4.1 and 4.2* below.

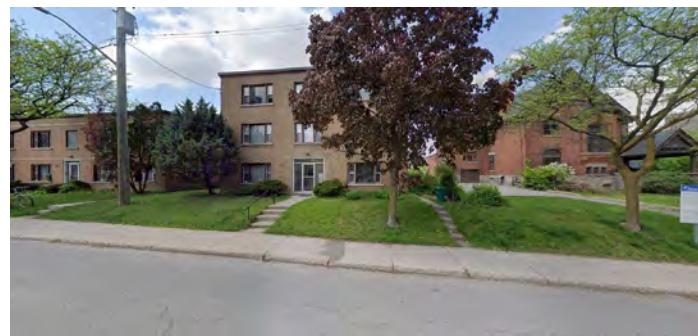
Figure 3: 593 Laurier Avenue (right), 601 Laurier Avenue (center) and 603 Laurier Avenue (left), viewed from Laurier Avenue (<https://www.google.com/maps>, 10.07.24)

The existing buildings on the 601-603 Laurier Avenue West site include a two-storey and a three-storey residential building (*Figure 3*), as well as other accessory structures. The residential buildings are flat-roofed, brick-clad structures. Accessory structures include storage sheds on the west end of the site as well as between the two residential buildings. The buildings at 601-603 Laurier Avenue West hold no

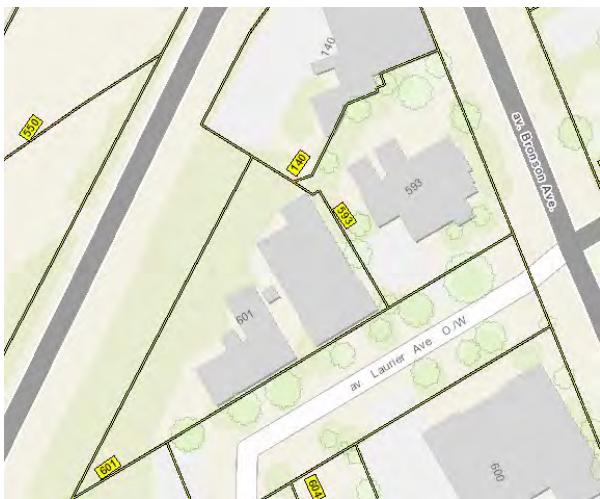
Figure 4: Site Plan for 593 and 601-603 Laurier Avenue West (GeoOttawa, 2024)

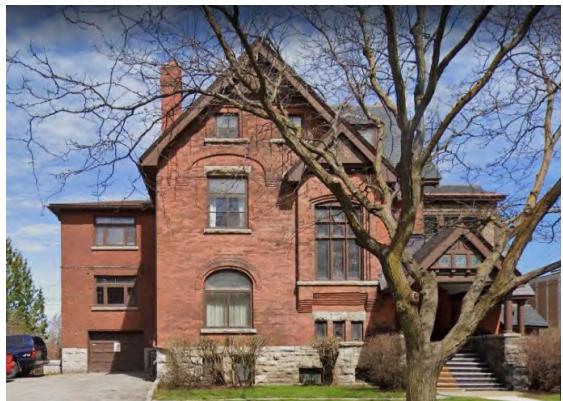
Figure 8: 593 Laurier Avenue, front (south) façade of existing building. (Google)

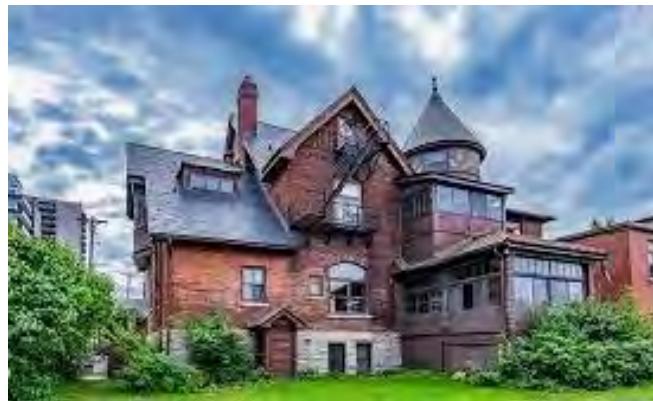
Figure 9: 593 Laurier Avenue, rear (north) façade of existing building. (<https://bennettpros.com/>)

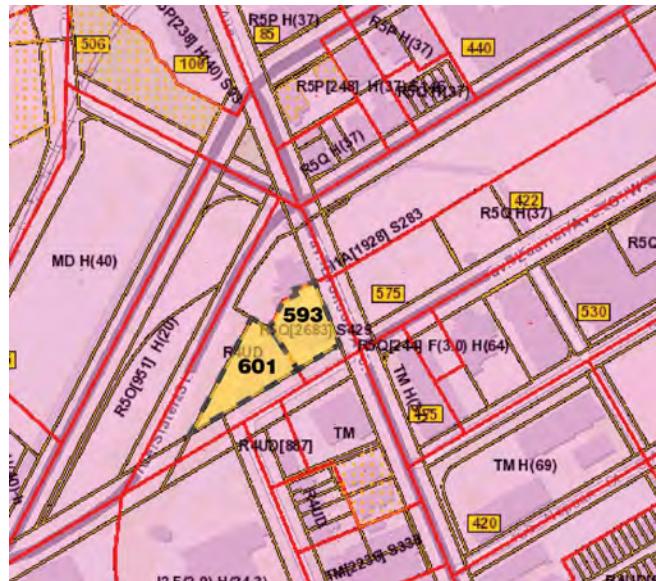
Figure 10: Zoning map of the properties. ([maps.ottawa.ca/geoottawa/](http://maps.ottawa.ca/geoottawa/), 10.07.24)

Under the *City of Ottawa Comprehensive Zoning By-Law* (2008-250), the development site currently falls along the boundary line of the *R5Q – Residential Fifth Density, Subzone Q* in the case of the 593 Laurier Avenue West parcel, and *R4UD – Residential Fourth Density, Subzone UD* in the case of the 601-603 Laurier Avenue parcel (see *Figure 10*).

The *R5* zone category, as found at the 593 Laurier Avenue West parcel, permits a wide range of residential building forms and densities (from detached to mid-high rise apartment dwellings) as well as development which is compatible with existing land use patterns to maintain or enhance the character of a neighbourhood. The zoning of 593 Laurier Avenue West is a result of the previous site-specific Zoning By-Law Amendment in 2020, which was done as part of the previous iteration of the proposed development from 2020.

The *R4* zone category, as found at the 601-603 Laurier Avenue West parcel, permits a wide range of residential building forms and densities (from single detached to low rise apartment dwellings to a maximum of four storeys), as well as development which is compatible with existing land use patterns to maintain or enhance the character of a neighbourhood.

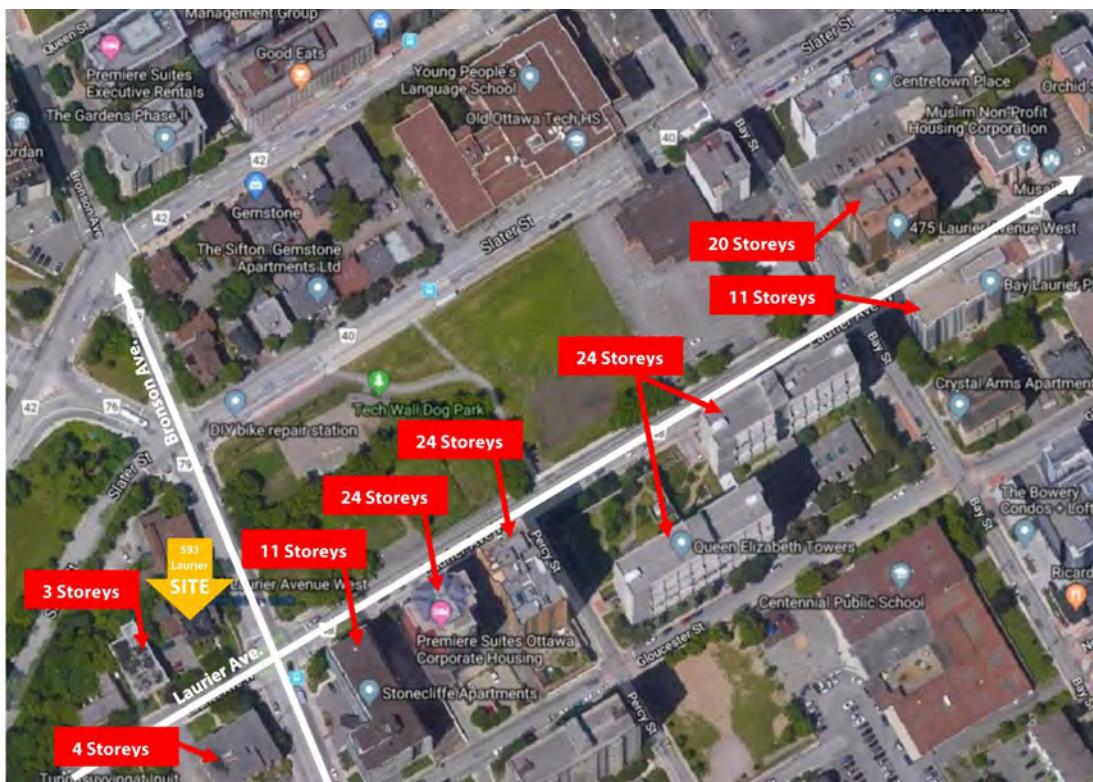
Figure 11: Height of surrounding buildings. (Google)

The site of the proposed development is situated on the corner of Laurier and Bronson Avenues, and along Laurier Avenue West. This neighbourhood underwent considerable densification through time. It consists of a mixture of low, medium and high-rise apartment buildings along Laurier Avenue with heights ranging between 11-24 storeys (see *Figure 11*). These new developments are mainly located to the south of Laurier Avenue, as the *Nanny Goat Hill Community Garden* occupies the area to the north of Laurier Avenue. However, the adjacent buildings to the development site do not exceed 4 storeys. Single residential units cannot be found at the immediate boundary of the development site; however, a few more modest single residential properties are located on Cambridge Street close to Laurier Street. Further north, similar heritage buildings are still preserved at the corner of Bronson Avenue and Slater Street (see *Figure 11*, *Figure 12* and *Figure 13*).

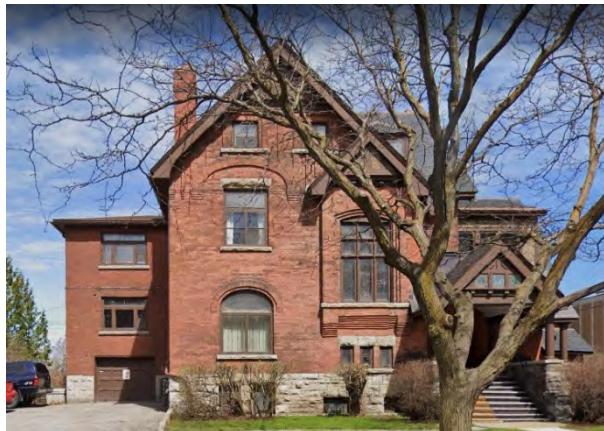
Figure 14: 593 Laurier Avenue, front (south) façade of existing building. (Google)

The Alexander Fleck House, located at 593 Laurier Avenue West, has architectural, historical and contextual values. It is unique in its composition and an excellent example of its architectural style (see *Figure 14*, *Figure 15*, *Figure 16*, *Figure 17* and *Figure 18*). It is associated with the prominent Fleck family and contributes as well to understanding the historical socioeconomic evolution of the Centertown area.

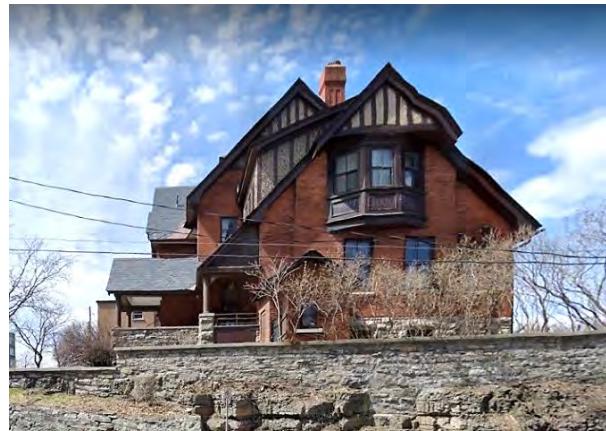
Figure 15: 593 Laurier Avenue, corner (south and east) façades of existing building. (Google)

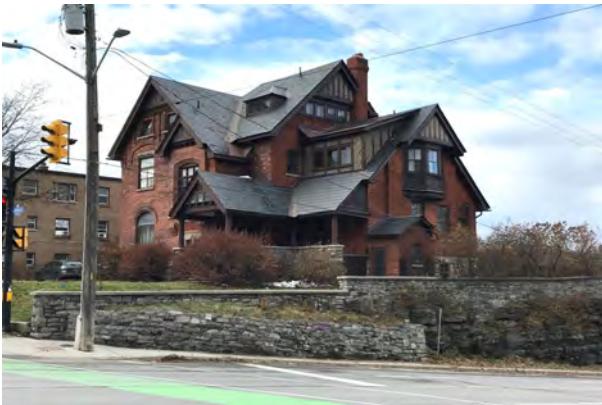
Figure 16: 593 Laurier Avenue, side (south-west) façade of existing building. (RMA)

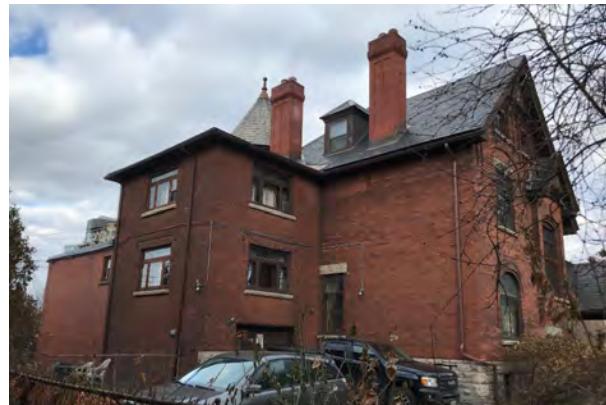
Figure 17: 593 Laurier Avenue, front and side (south and west) façades of existing building. (RMA)

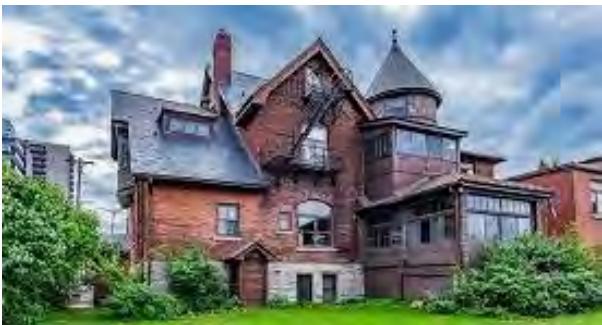
Figure 18: 593 Laurier Avenue, rear (north) façade of existing building. (<https://bennettpros.com/>)

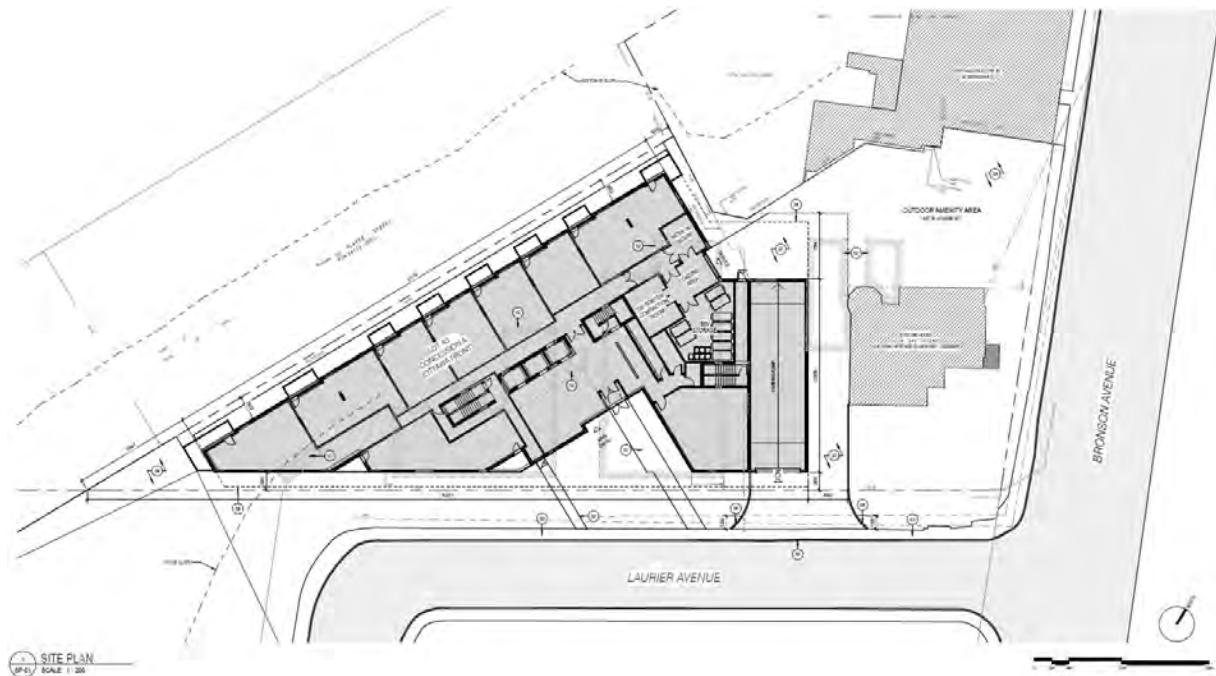
*Figure 19: Site Plan, showing demolished structure in hatched outline, (Project1 Studio, 29.04.24)*

As noted on the Site Plan by Project1 Studio, the proposed development includes demolition of low-rise residential structures at 601-603 Laurier Avenue West and select, partial demolition of 593 Laurier Avenue West (see *Figure 19*).

The proposed development retains the primary structure of the building at 593 Laurier Avenue, as well as its primary heritage elements. The exterior of the building at 593 Laurier Avenue will be retained. However, the later additions to the building at the west will be removed to create space for the new 28-storey residential building and to bring the historic building closer to its original form. As noted in *Section 6.0*, the west and north additions of the building are not included of the heritage designation of the building. Refer to *Section 7.3* for more information on the proposed work at 593 Laurier Avenue.

The mid-rise residential structures and accessory structures at 601 Laurier Avenue West (previously 601, 603, 605) will be demolished in their entirety to make way for the new construction.

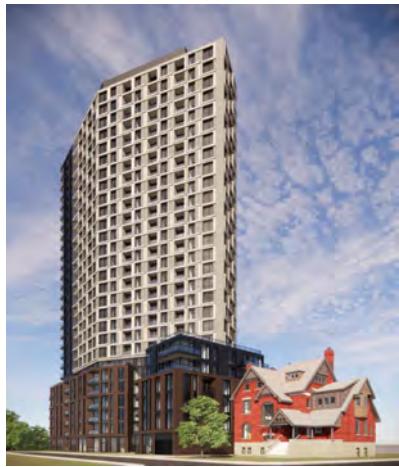
*Figure 20: View of 593 Laurier Avenue next to proposed development, viewed from the corner of Bronson and Laurier Avenue (Project1 Studio, 29.04.24)*

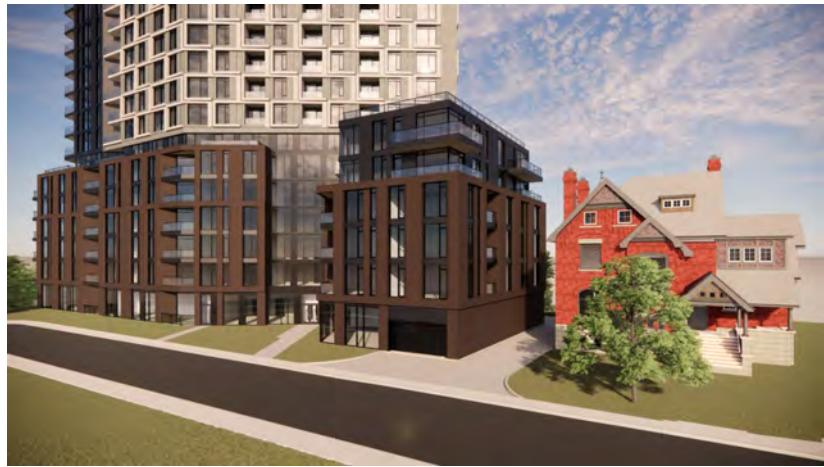
Figure 21: View of 593 Laurier Avenue next to proposed development, viewed from Laurier Avenue (Project1 Studio, 29.04.24)

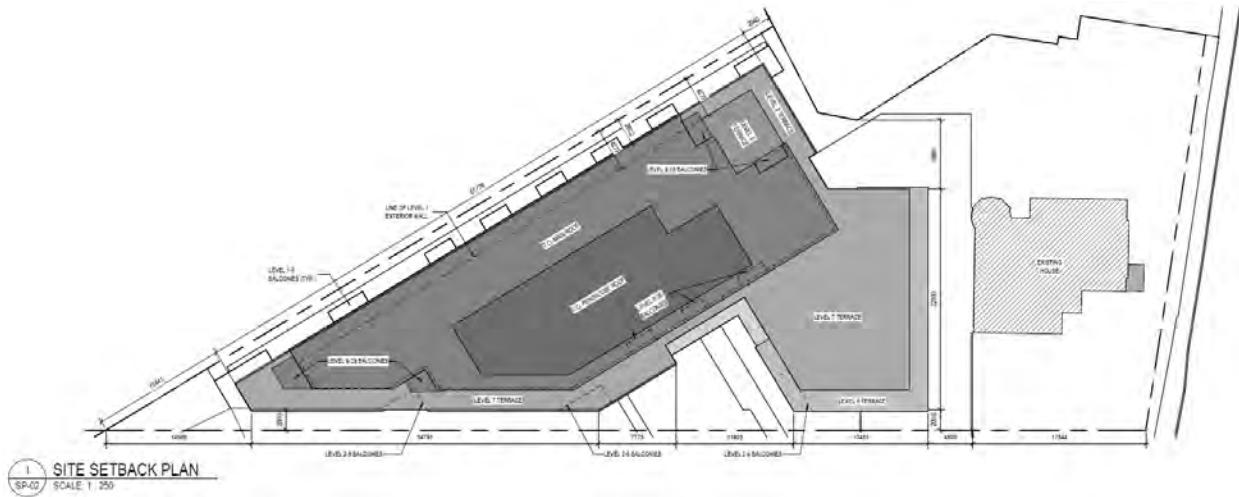
Figure 22: Site Setback Plan (Project1 Studio, 29.04.24)

The proposed new building will be located 2.0 m from the front property line at the south, 2.802 m from the north-west property line and 2.94 m from the north-east property line.

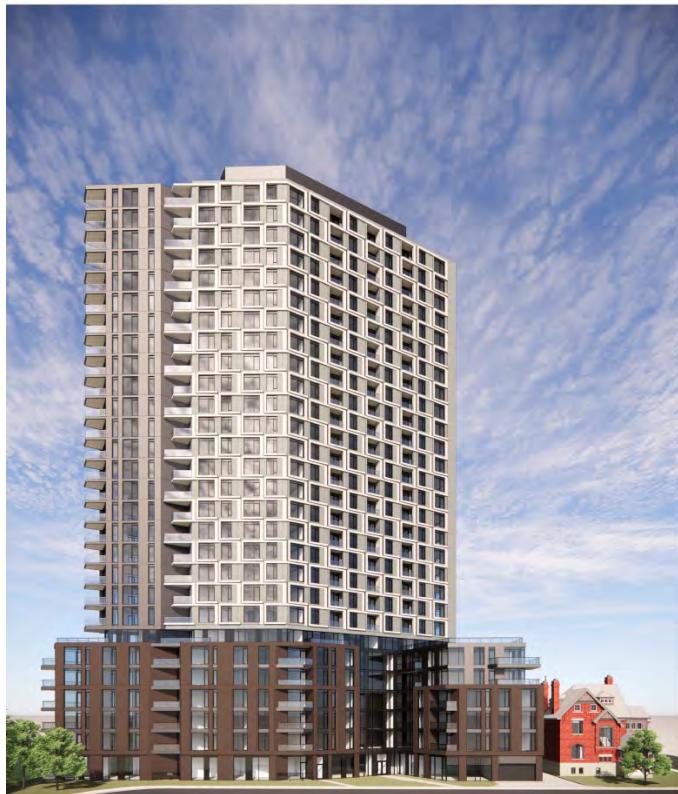
*Figure 23: Proposed development, viewed from Laurier Avenue (Project1 Studio, 29.04.24)*

The facades of the new development have a contemporary design. The 6-storey podium is clad with red/brown brick, with the exception of the two top storeys of the easternmost wing adjacent to 593 Laurier, which is clad with dark grey precast concrete. The design of the podium emphasizes the verticality and rhythm of the window openings. The use of brick is continuous with the character of the neighbourhood, with numerous brick buildings being located around the site.

The tower is clad with aluminum composite panels and precast concrete with a dark grey or natural finish, articulated to create a dynamic pattern along the facades. It is punctuated by balconies, integrated along the window openings and in the recesses of the building.

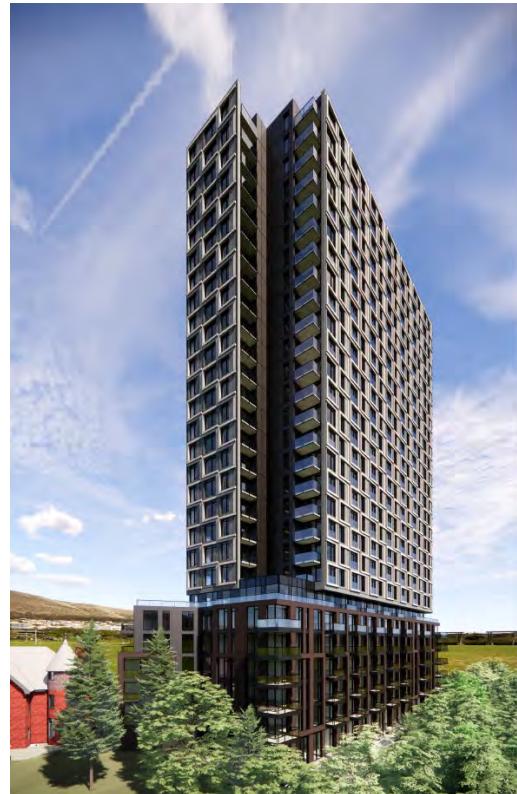
*Figure 24: East corner of proposed development (Project1 Studio, 29.04.24)*

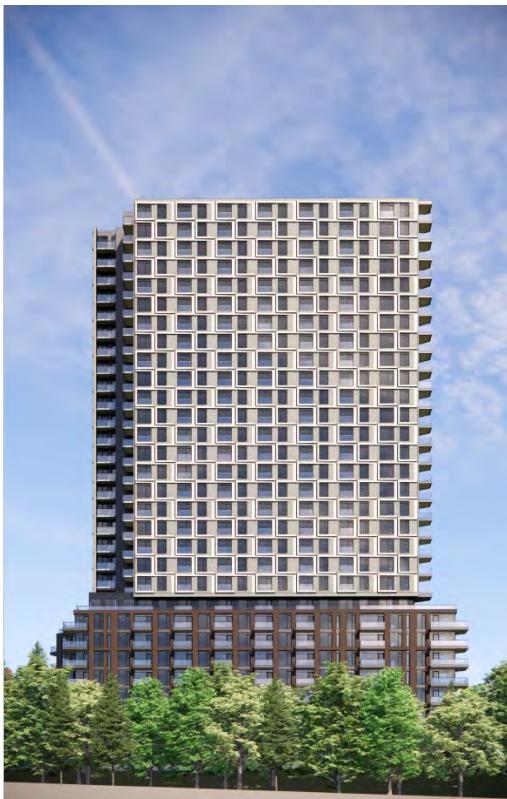
Figure 25: Proposed development, viewed from Albert Street  
(Project1 Studio, 29.04.24)

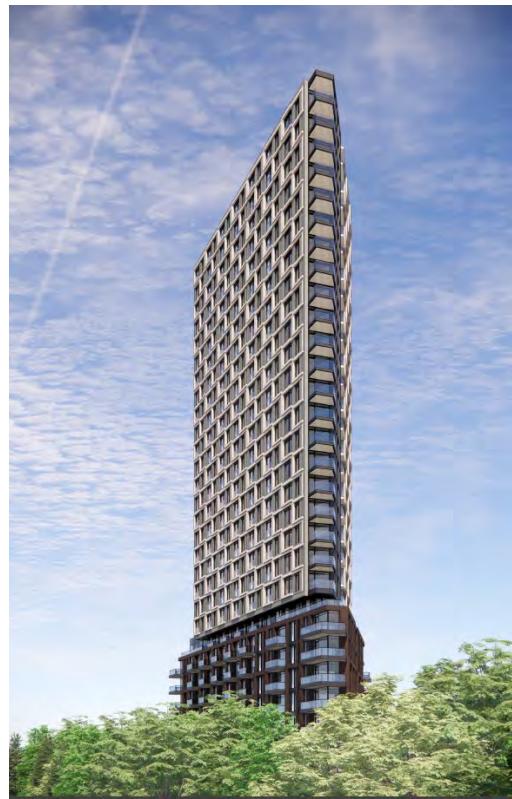
Figure 26: West corner of proposed development (Project1 Studio, 29.04.24)

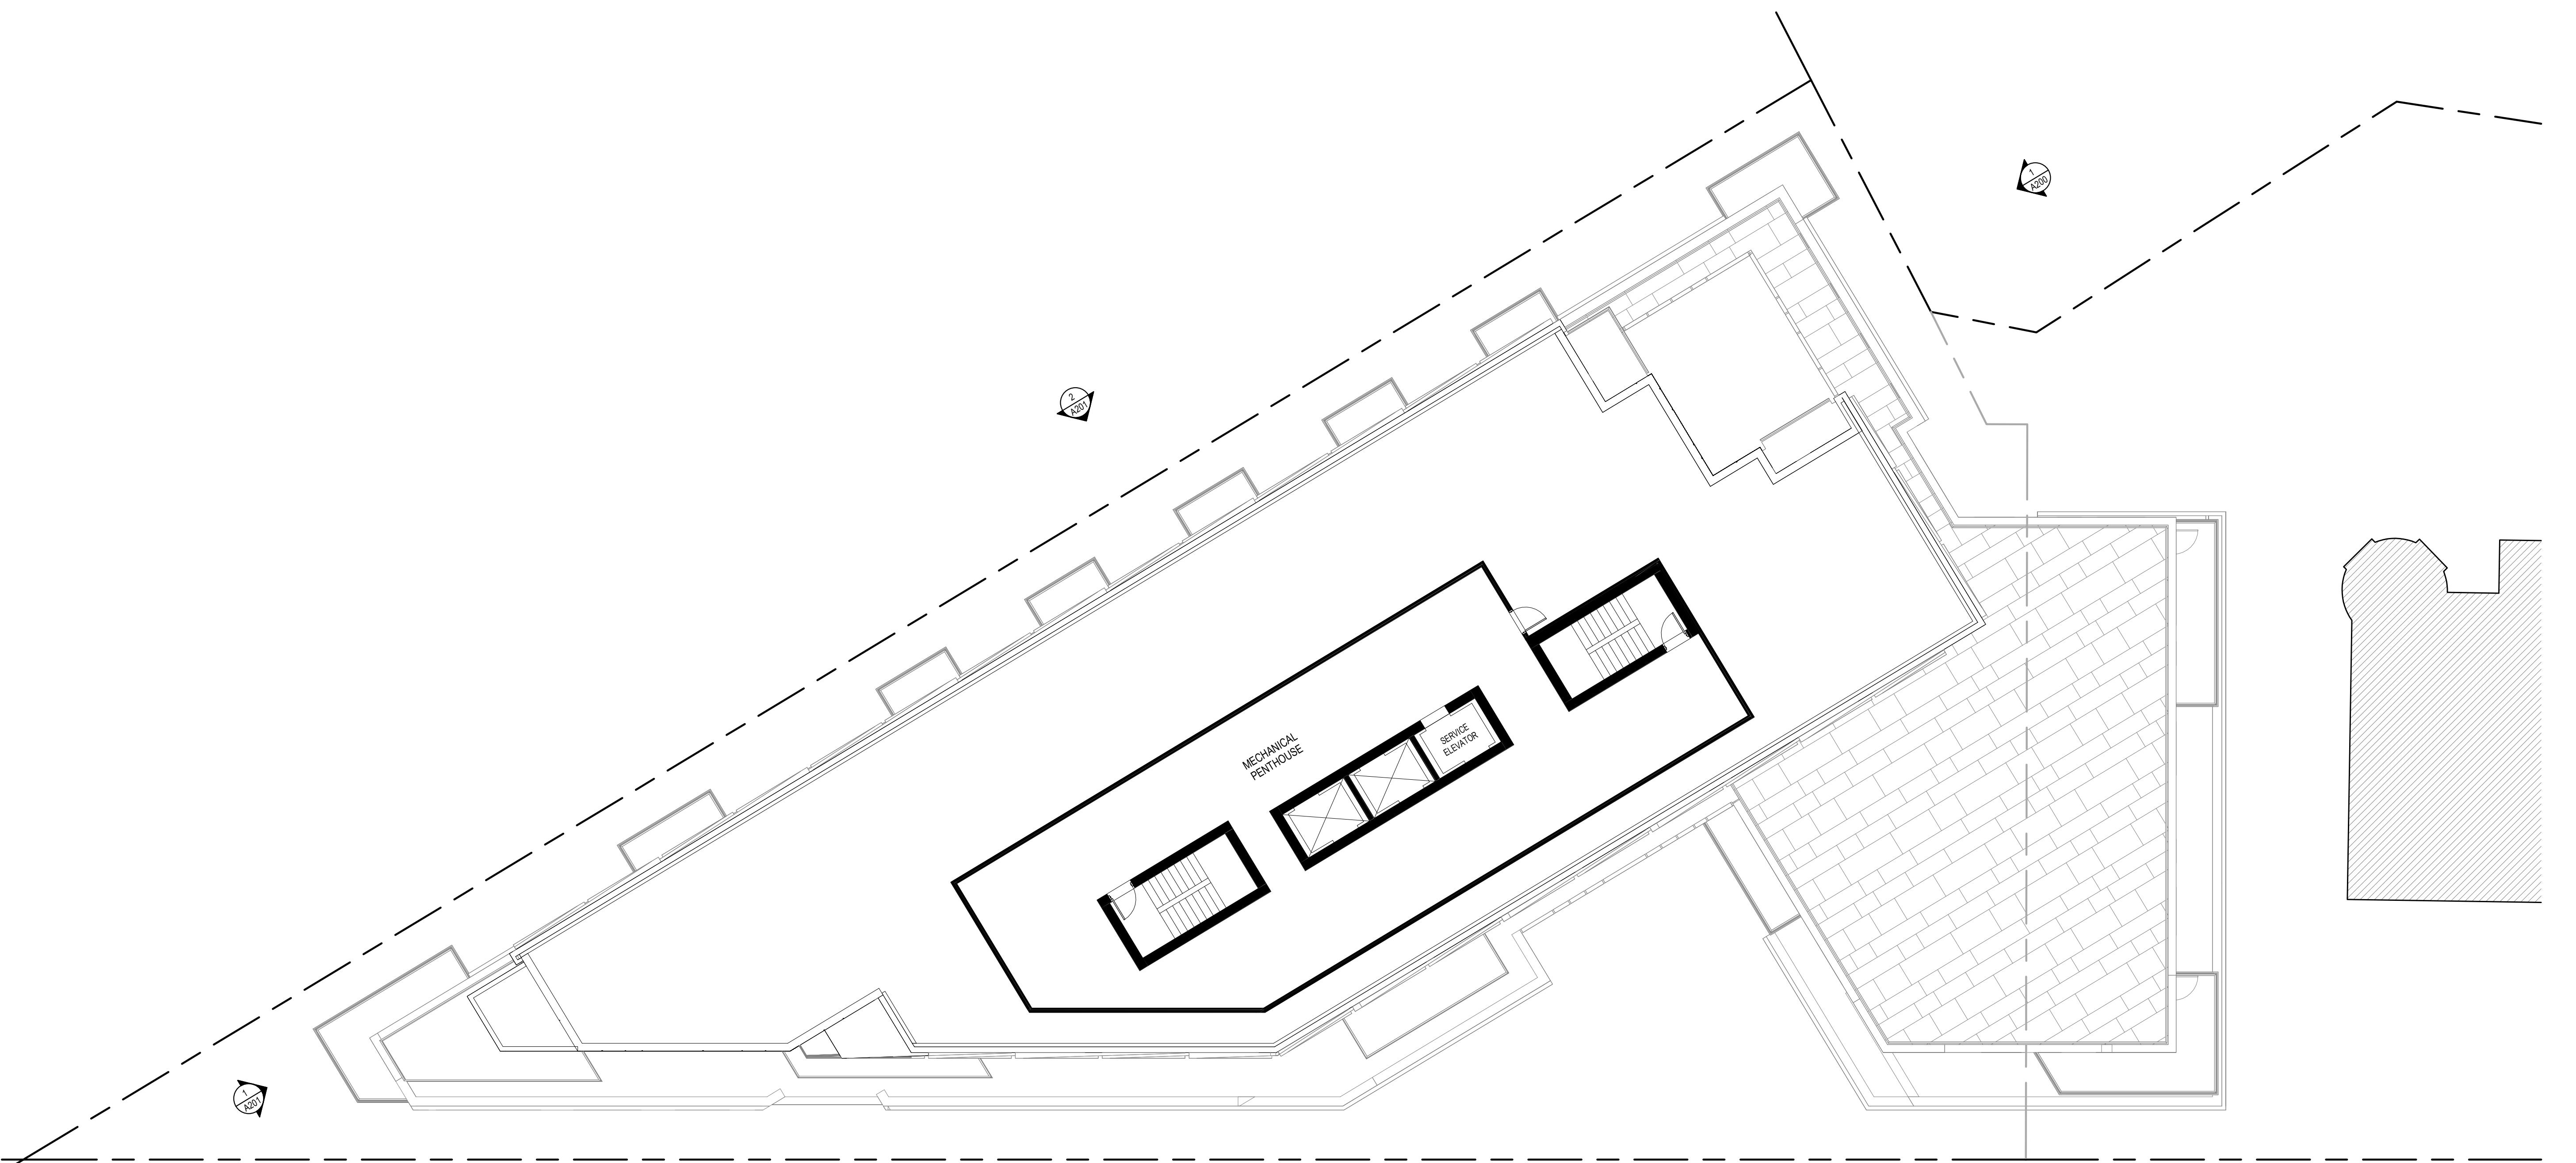
FLOOR PLAN - PENTHOUSE  
LEVEL

A107

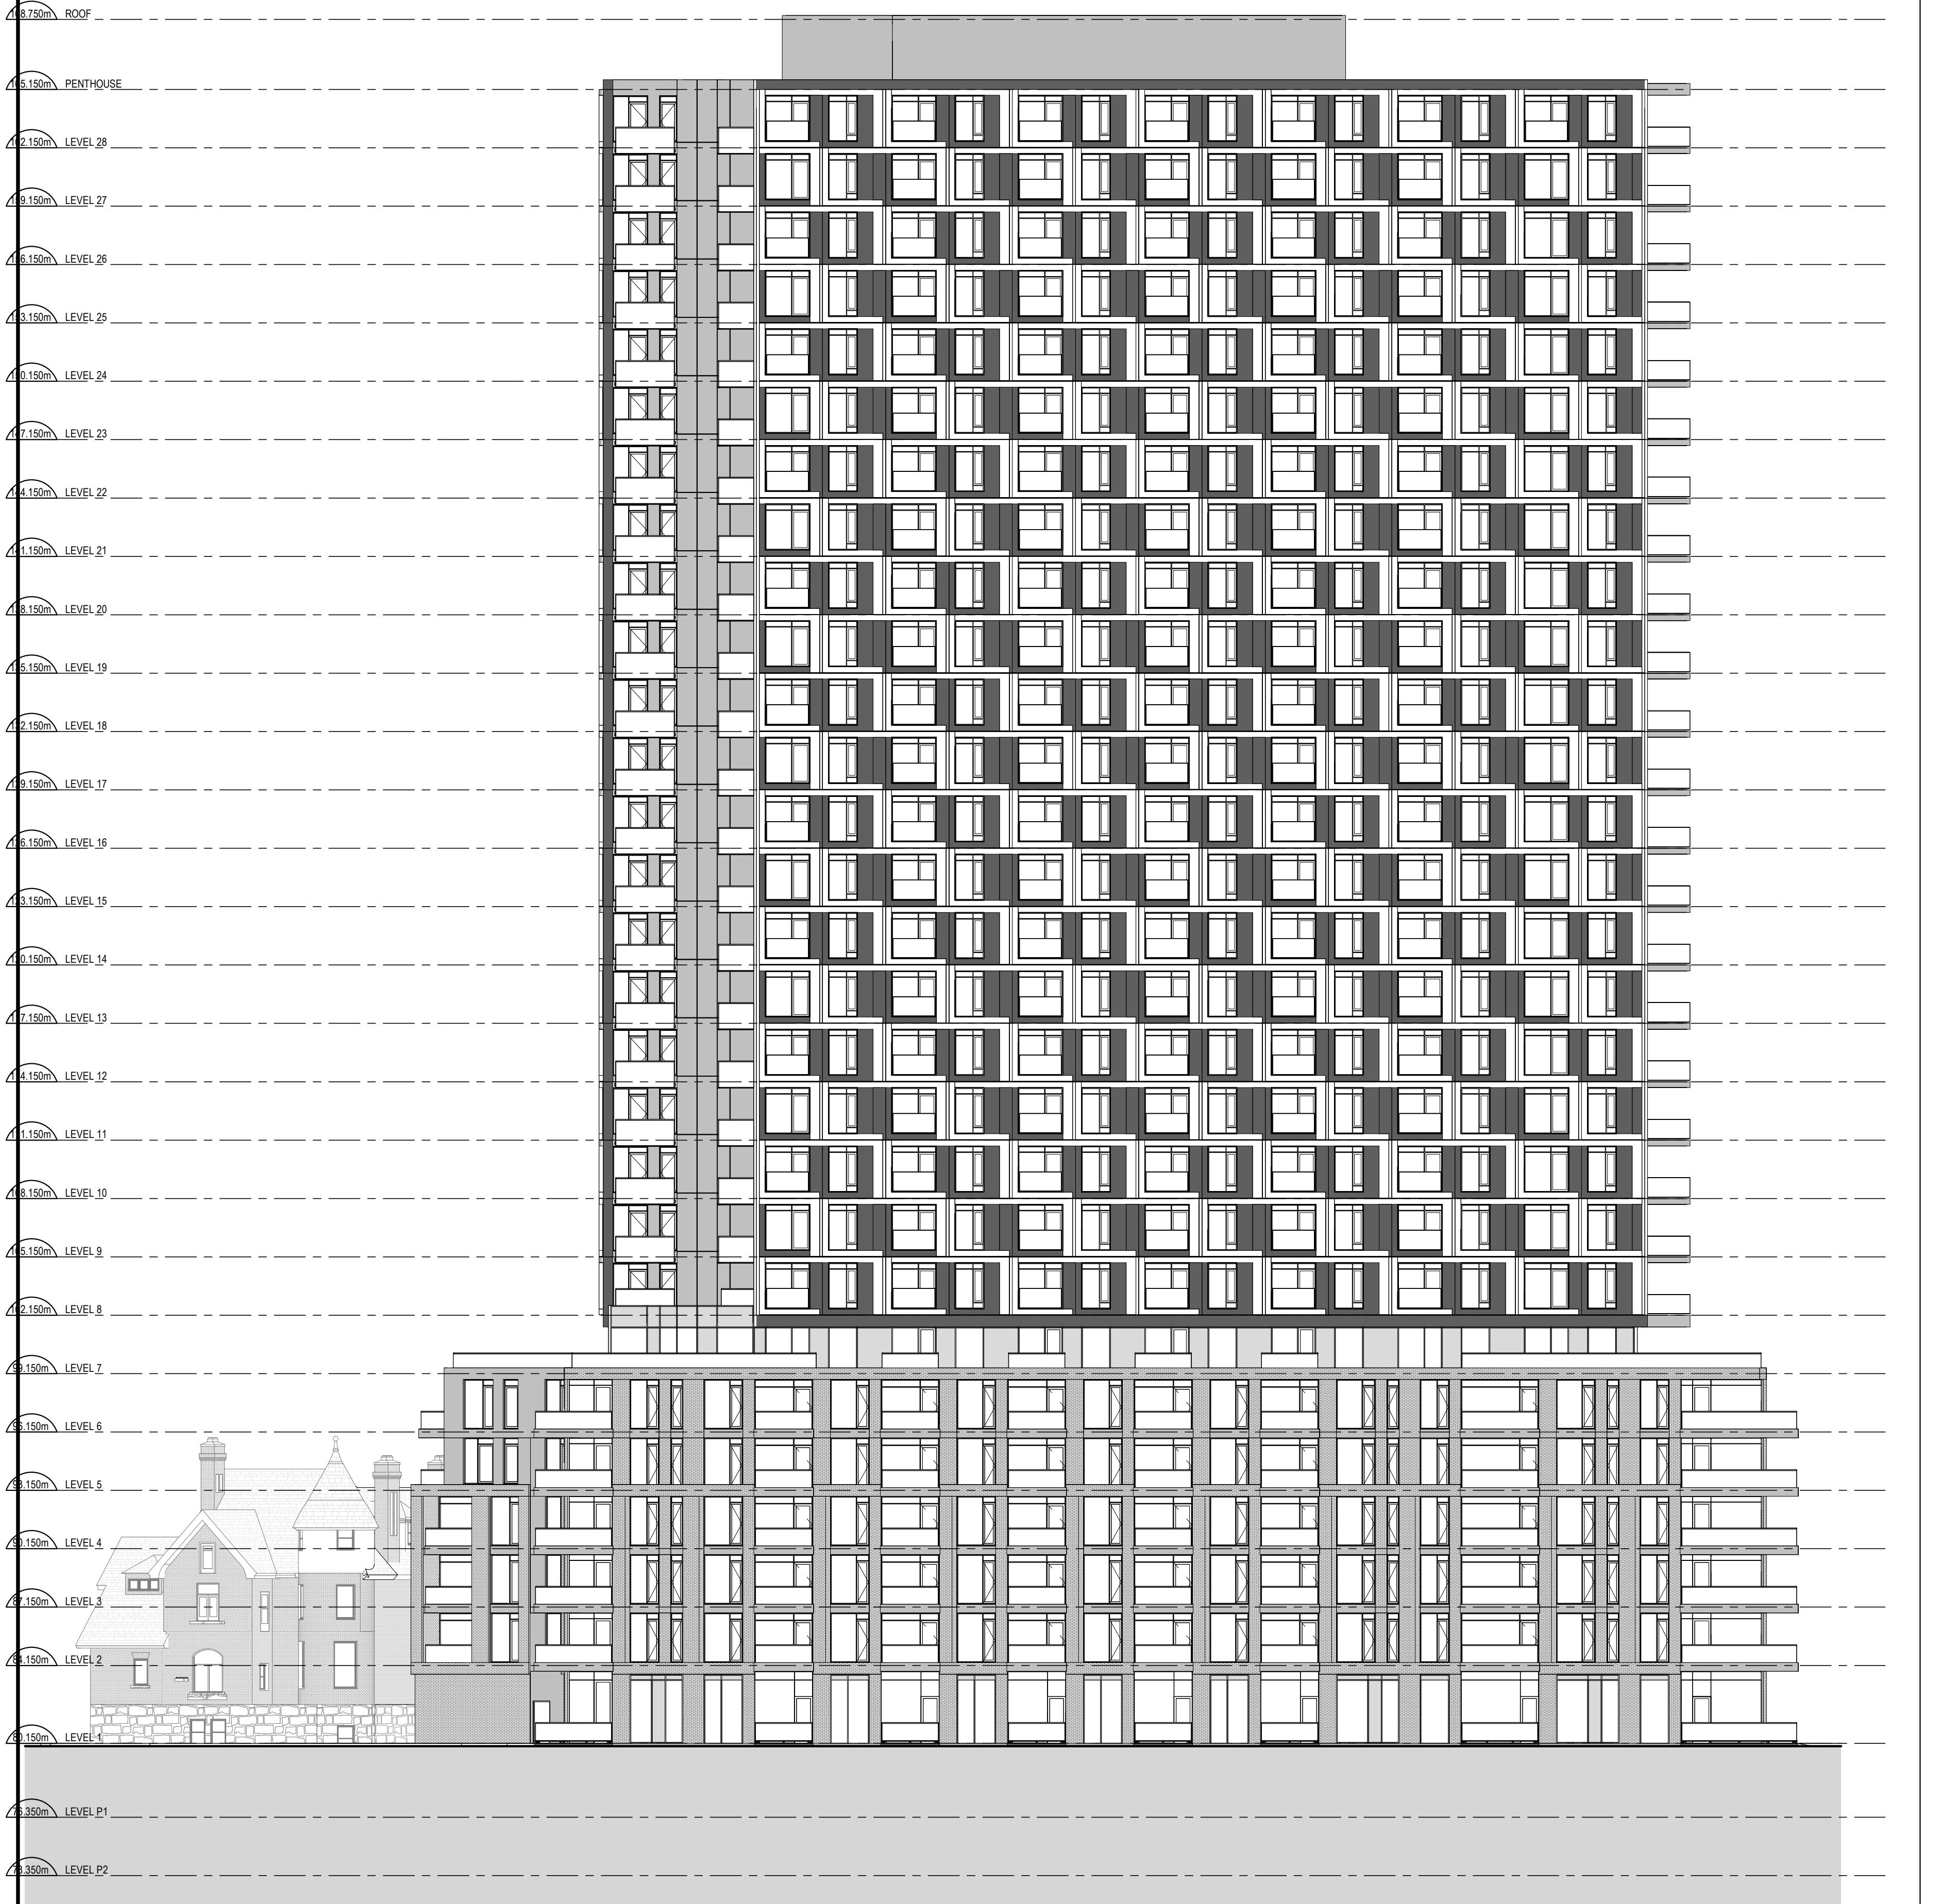
2 WEST ELEVATION  
A201

SCALE: 1:200

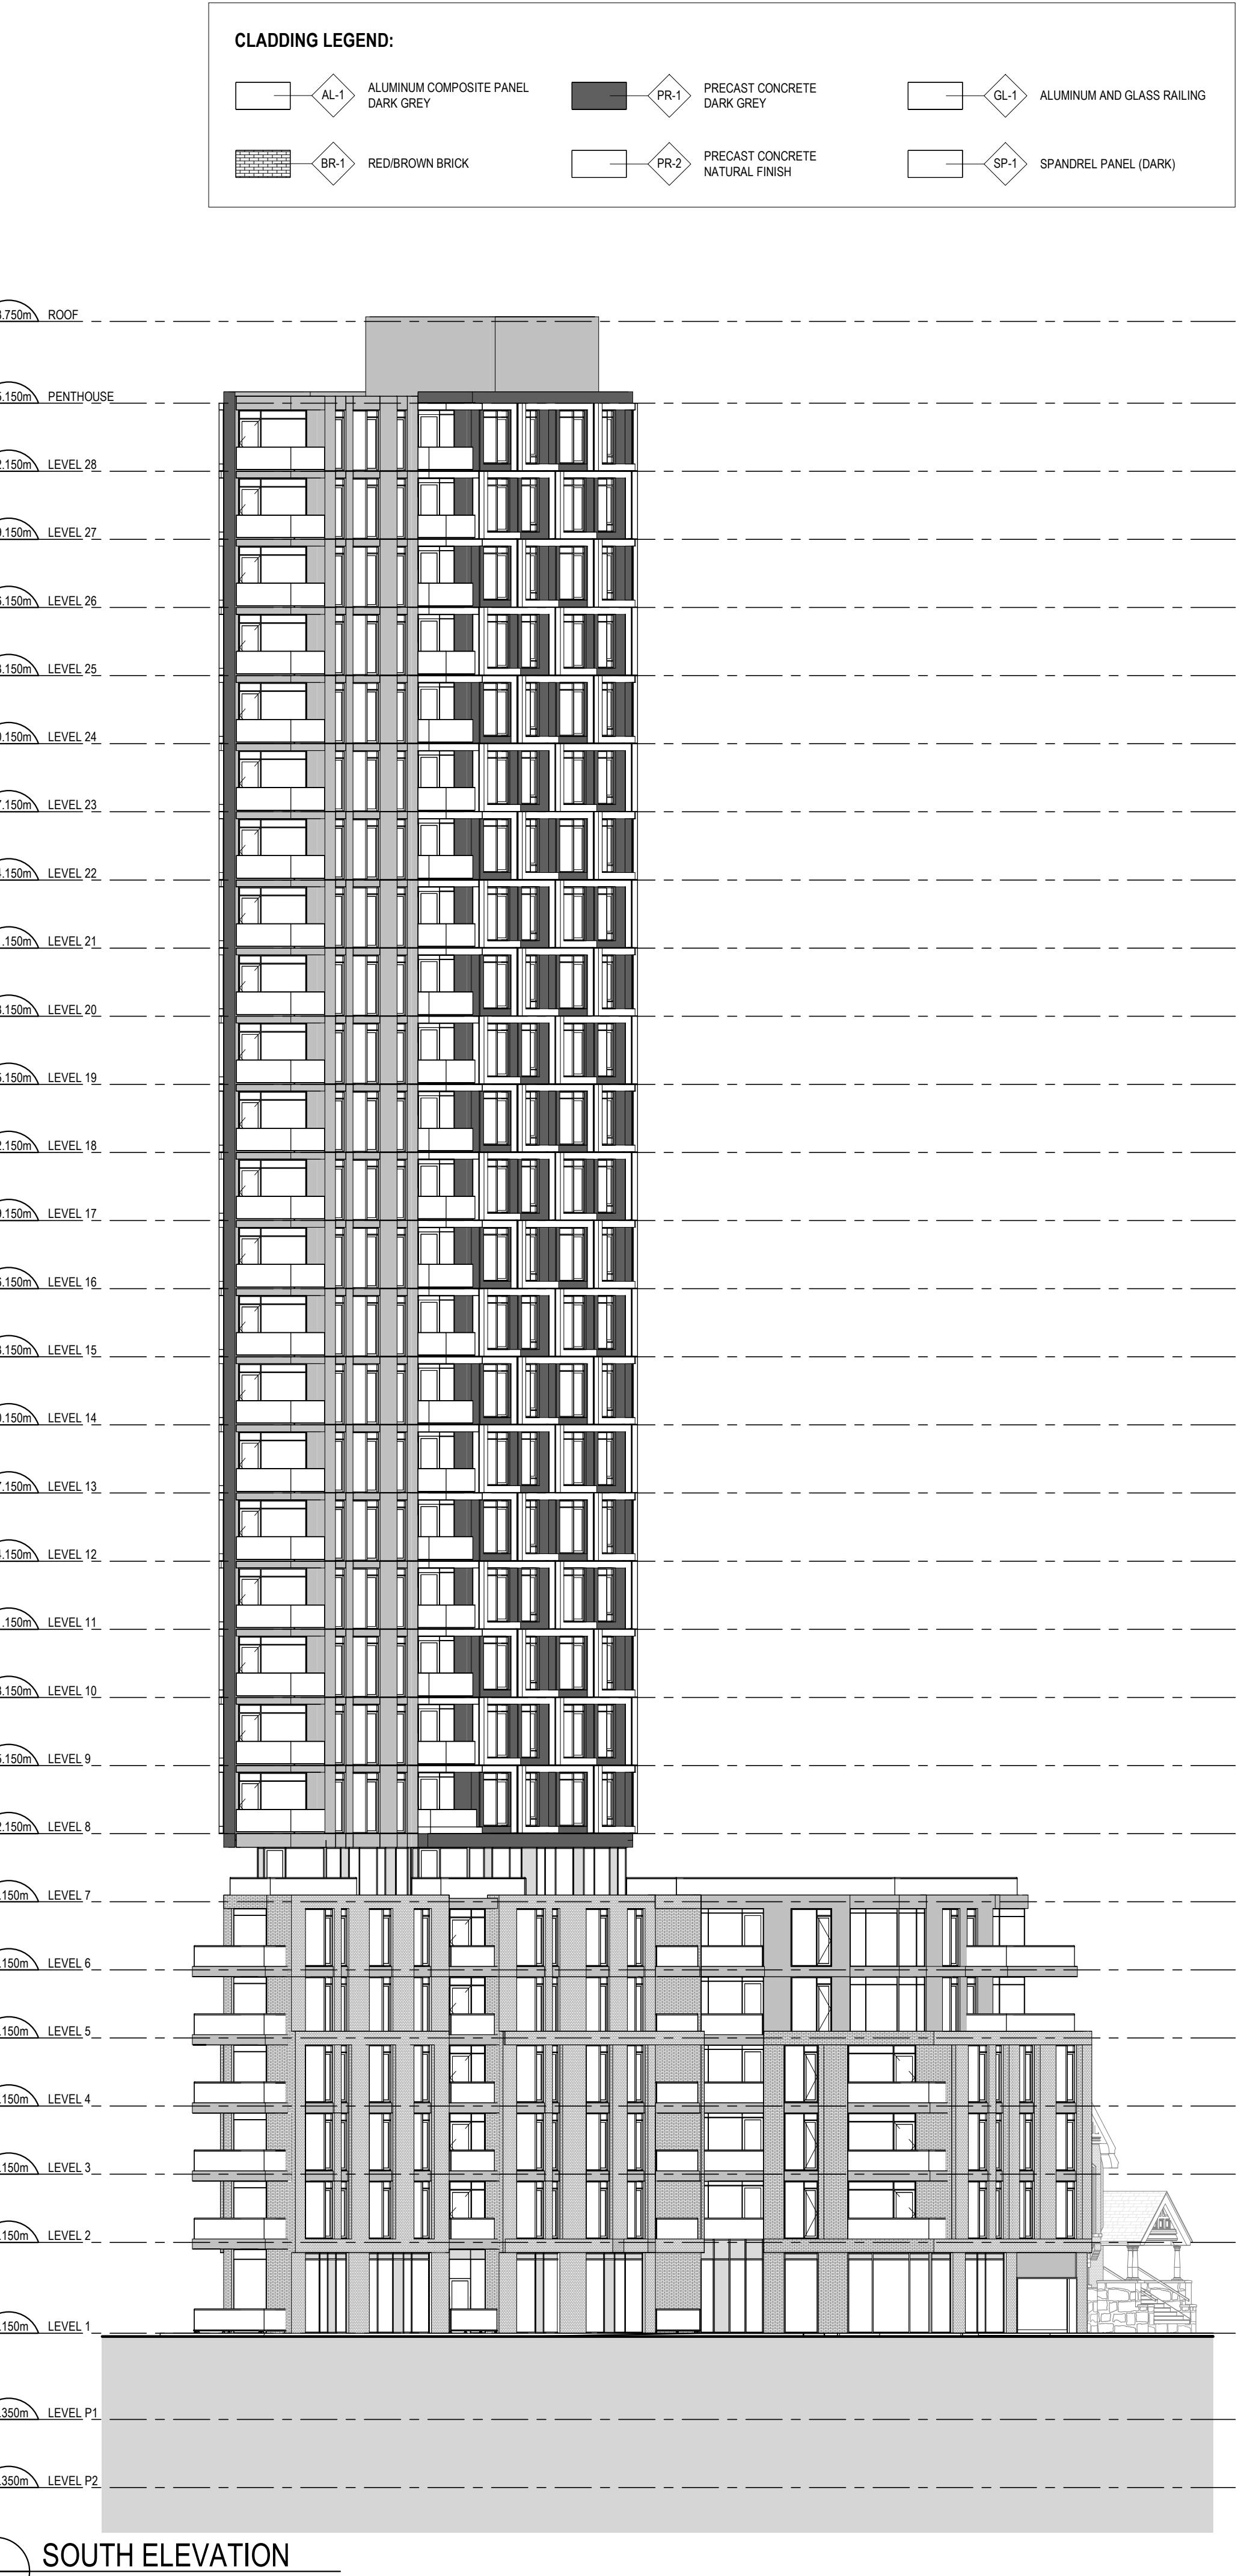
1 SOUTH ELEVATION  
A201

SCALE: 1:200
